Aircraft Accident Investigation Bureau of Myanmar

**FINAL REPORT OF LOSS OF SEPARATION BETWEEN AIRBUS 320,
REGISTRATION HS-TXB AND ATR 72-600, REGISTRATION XY-AJP ON 18
DECEMBER, 2017**

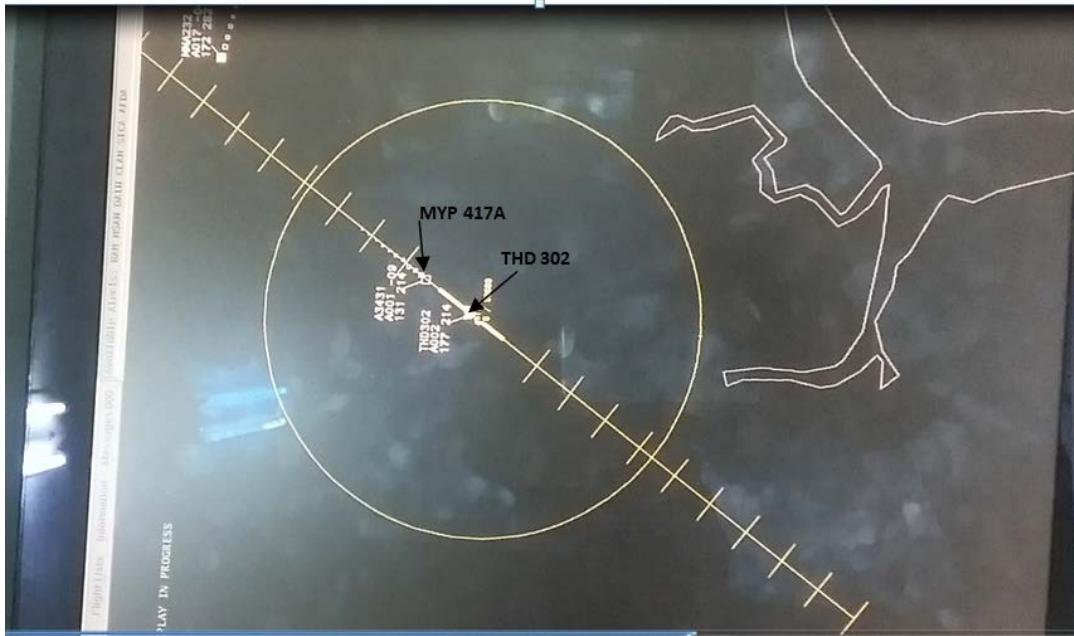
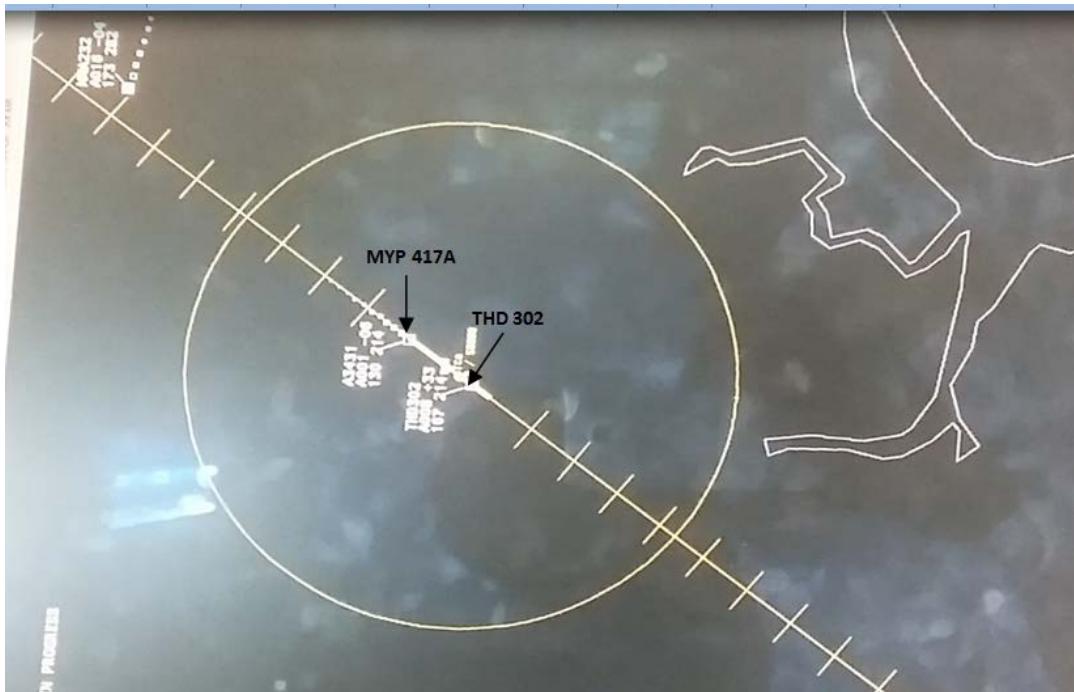
2.1.5 Radar Play Back

From the radar play-back, it was confirmed that another landing aircraft (MYP 417A) had crossed the runway threshold on its final approach before the preceding departing aircraft (THD 302) was clear of the runway-in-use. That was contrary to the **control of arriving aircraft** as per Clause 7.10 of ICAO Doc 4444 as well as **control of arriving aircraft** as per Manual of Air Traffic Service of Myanmar.

- a) The breakdown in separation between the A320 (HS-TXB) and the ATR 72-600(XY- AJP) was the result of the instruction given by the tower controller to the A320 (HS-TXB) "behind landing aircraft on final, line up and wait" when the A320 (HS-TXB) had already lined up and waited on runway-21 of the Yangon International Airport.
- b) ATC did not inform Aircraft Accident Investigation Bureau of Myanmar of the incident.

- 4.1 The trainee controller should be given the training course on Control of Arriving Aircraft as per ICAO Doc 4444.
- 4.2 The watch controller should be with the trainee controller on duty all the time.
