DUTCH
SAFETY BOARD

Threshold lights damaged during landing

The Hague, July 2018

Identification number:	2017002
Classification:	Serious incident
Date, time of occurrence:	13 January 2017, 18.23 UTC
Location of occurrence:	Amsterdam Airport Schiphol
Registration:	VQ-BLR
Aircraft type:	Boeing 747-8F
Aircraft category:	Freighter
Type of flight:	Freight
Phase of operation:	Landing
Damage to aircraft:	Multiple scratches and dents
Flight crew:	Four
Passengers:	None
Injuries:	None
Other damage:	Three threshold lights disintegrated
Light conditions:	Dark

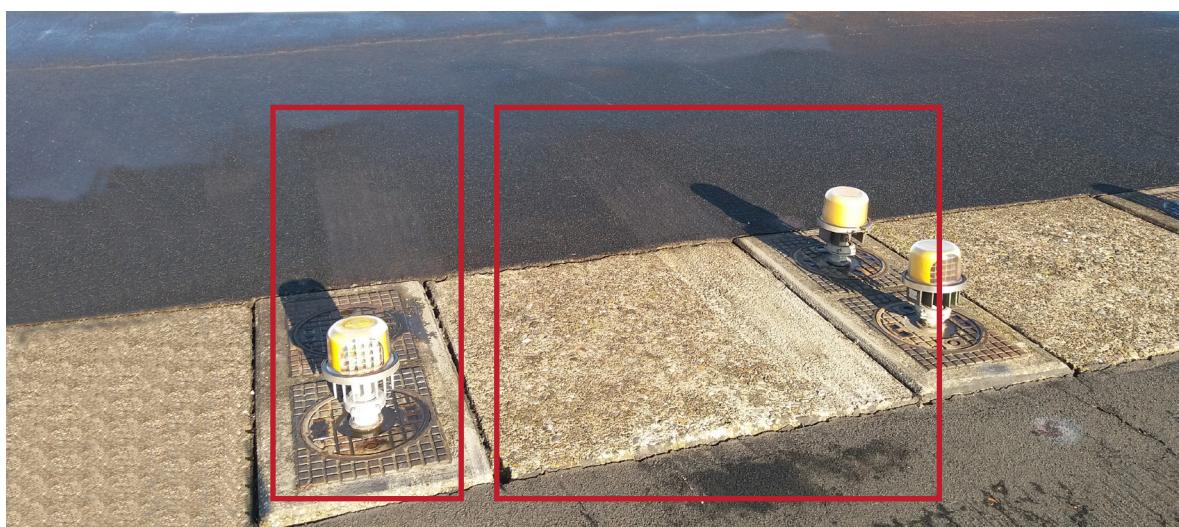
Figure 1: Traces of the main landing gear (marked with a red frame) visible on the runway edge after the occurrence.
The three damaged lights had already been replaced. (Photo: Amsterdam Airport Schiphol)

The damage to the aircraft was caused during the first initial contact with the runway while hitting three runway threshold lights of runway 36R.

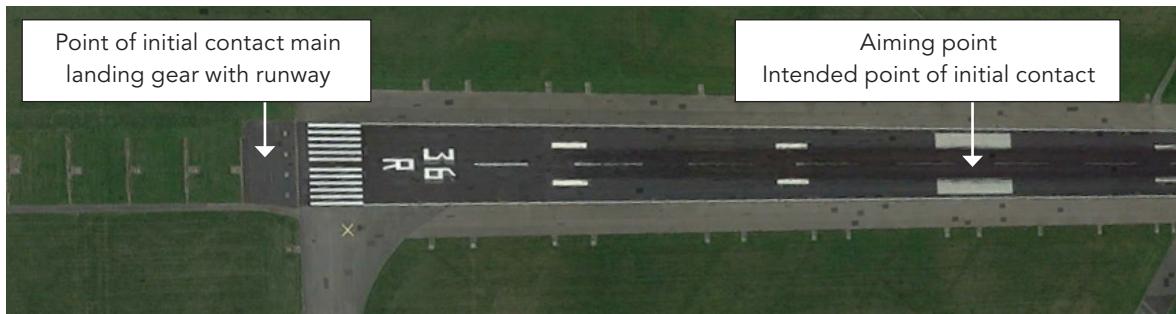
During this occurrence the difference between the actual landing and a landing before the runway threshold was minimal (see Figures 1 and 2). The Dutch Safety Board classified this occurrence as a serious incident in accordance with ICAO³ Annex 13.

Figure 2: Top view of the first part of runway 36R with the initial point of contact of the main landing gear with the runway and the intended point of initial contact. (Source: Google Earth)

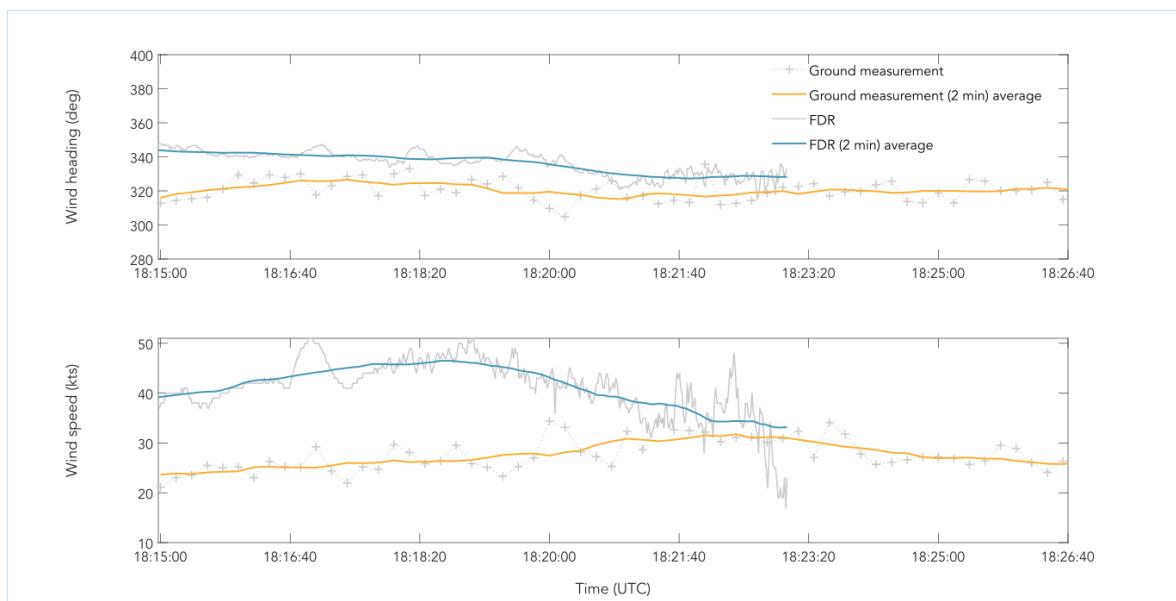
At the time of the approach a strong wind was blowing from the northwest with significant variations in speed and direction. The ATIS⁴ weather information at AMS reported a wind coming from 320 degrees varying from 290 to 360 degrees and a windspeed of 26 knots with wind gusts of 38 knots (see Figure 3 for a comparison between the wind direction and speed as measured at ground level and by the aircraft). The flight crew was fully aware of the wind conditions at AMS and were convinced that the landing conditions were within the operational limits of flight crew and aircraft as laid down by the operator. In preparation for the approach and landing, the wind conditions were noted by the flight crew.

Figure 3: Wind speed and wind direction as measured at the ground and by the aircraft. Because the wind direction and velocity as measured by the aircraft become inaccurate at low airspeeds, measurements after touchdown were omitted.

The wind data recorded by the flight data recorder and the wind measurement at the beginning of runway 36R were in agreement with each other. Shortly before landing the flight crew received the measured wind at the beginning of runway 36R from air traffic control. During the subsequent approach and landing the wind didn't deviate significantly from the reported wind conditions.

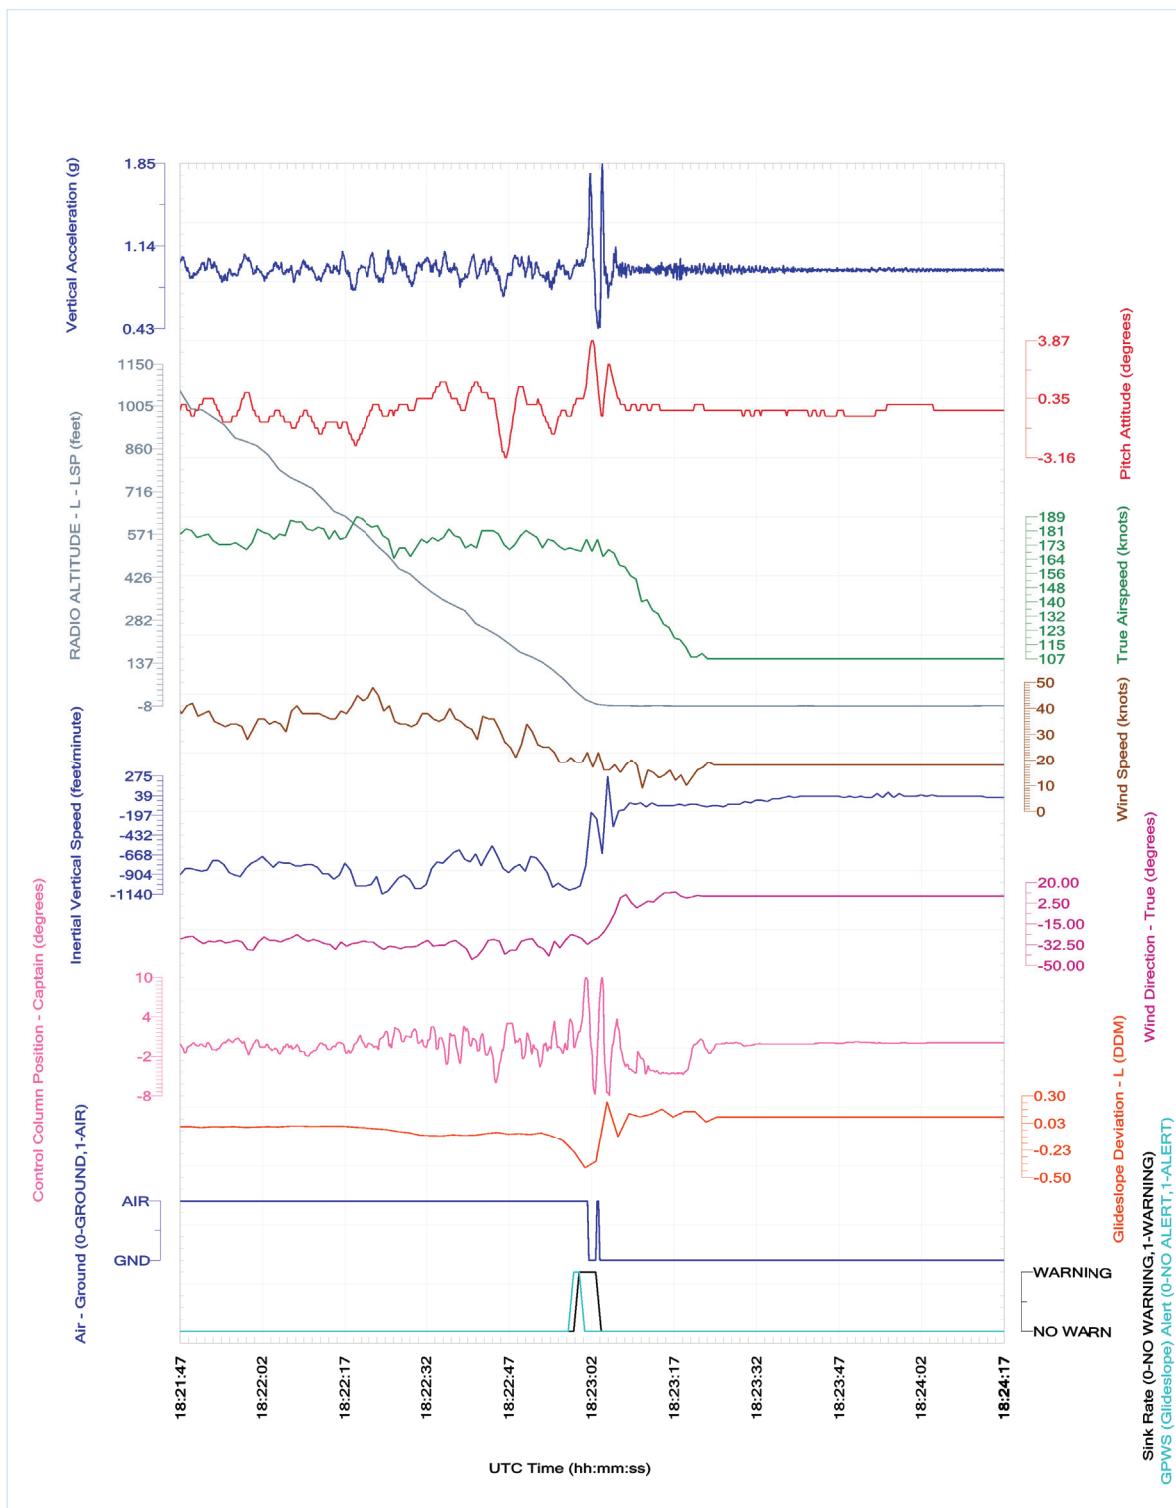
The flight data recorder showed that the approach was normal until 700 feet altitude was passed (see Figure 4). At 700 feet the captain disconnected the autopilot and flew the remainder of the approach and landing manually. Almost instantly the aircraft was flying below the 3 degrees glidepath of the ILS⁵ approach for runway 36R (see Figure 5 for the radio altitude profile and the ILS glidepath from an altitude of approximately 330 feet). The ILS deviation limit is 1 dot. Operator policies prescribe that a go-around must be flown if the deviation exceeds 1 dot below 500 feet altitude during visual flight conditions (VMC). During this incident the glideslope deviation remained within 1 dot until passing 100 feet altitude where after the deviation increased.

The airplane's GPWS⁶ provides aural alerts based on radio altitude, glideslope deviation, and rate of descent. Between two and three seconds before touchdown, the glideslope deviation exceeded 3 dots and the "glidescope" aural alert sounded. Shortly thereafter, the rate of descent increased to 1070 feet/minute and the "sink rate" aural alert sounded. The captain stated that he was unable to execute a go-around because the touchdown followed almost immediately. The flare manoeuvre reduced the rate of descent to 500 feet/minute. This resulted in a first touchdown with a load factor of 1.76 g and the threshold lights being hit. The aircraft became airborne again where after a second touchdown followed with a load factor of 1.84 g. Both touchdowns didn't cause any control problems for the flight crew. The aircraft normally decelerated to a safe taxi speed where after the runway was vacated and the aircraft taxied to the assigned parking position.

Figure 4: Overview of a selection of parameters obtained from the FDR.

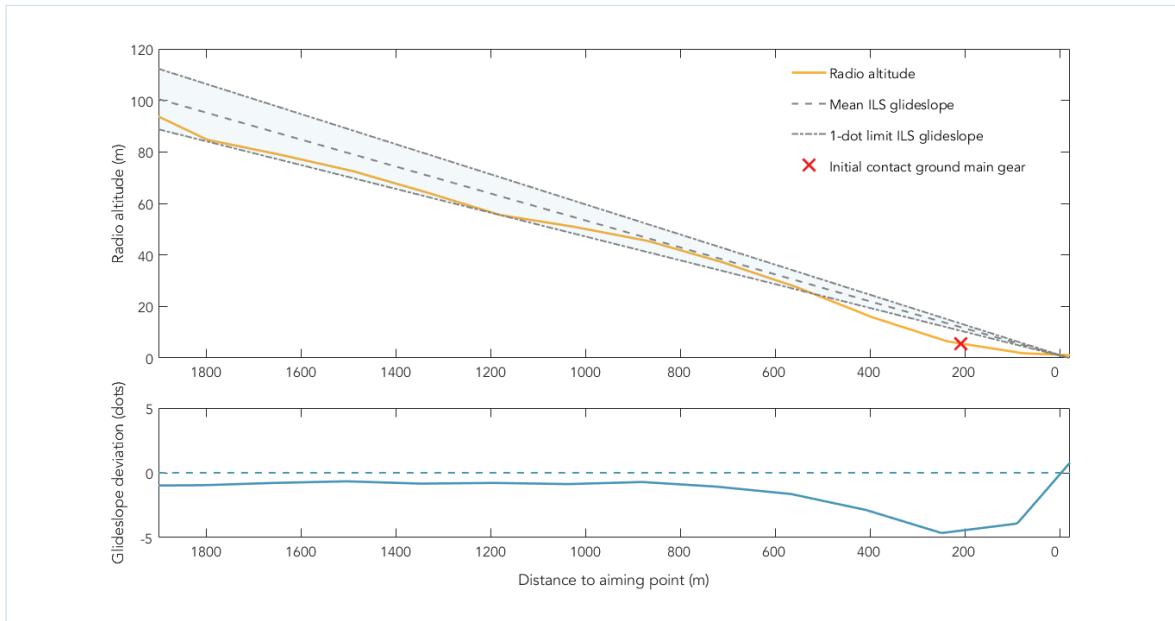
Figure 5: The ILS glide path of runway 36R with the radio altitude profile and the glideslope deviation of the aircraft versus the distance to the aiming point from an altitude of 100 meters or approximately 330 feet.

During the approach the aircraft was continuously flying below the glideslope but to a degree that a go-around based on the stable approach criteria was not necessary. While the aircraft approached the runway the deviation from the 3 degree glidepath increased. At an altitude of 100 feet the glideslope deviation exceeded 1 dot whereby one of the stable approach criteria was not met. This should have been a trigger to execute a go-around.

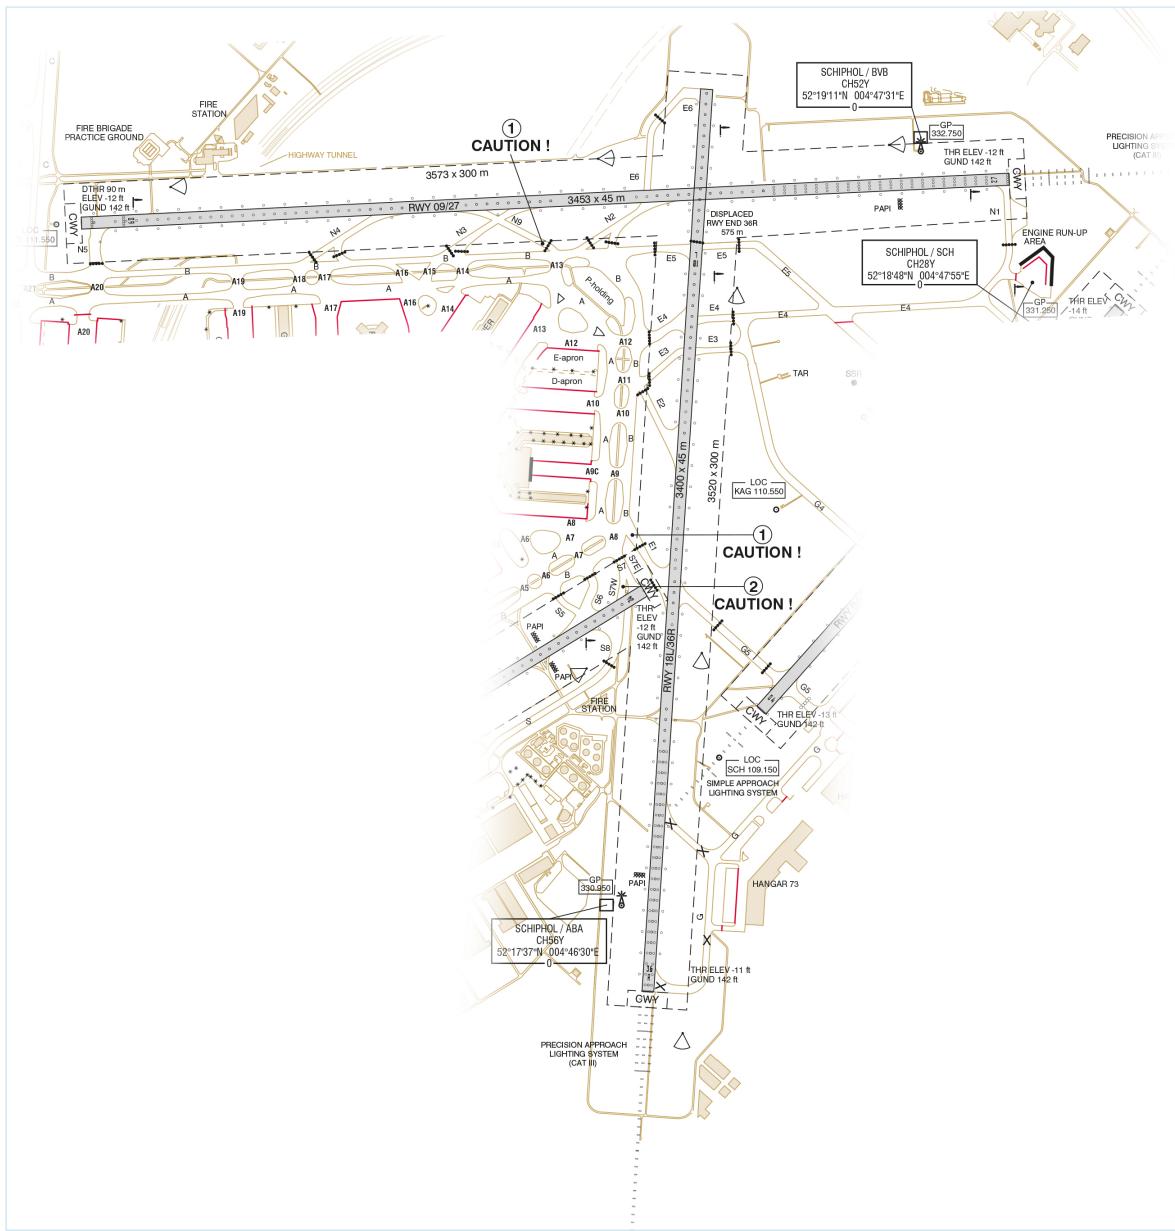
The available runway distance for runway 36R is 2825 meters, which is relatively short for a heavy full freighter aircraft. The flight crew calculated a landing distance of 2549 meter for the given landing configuration. Runway 36R is shortened to avoid crossing runway 09/27. Therefore, the last 575 meters for runway 36R is unavailable for landing. In the opposite direction the available runway lengths is 3400 meter for take-offs (for an overview of the runway layout, see Figure 6).

Figure 6: Overview of runways 09/27 and 18L/36R at AMS. (Source: AIS the Netherlands)
