**UNITED STATES AIR FORCE**  
**AIRCRAFT ACCIDENT INVESTIGATION**  
**BOARD REPORT**

**C-130H, T/N 88-4404**

**C-27J, T/N 10-27030**

**DATE OF ACCIDENT: 1 DECEMBER 2014**

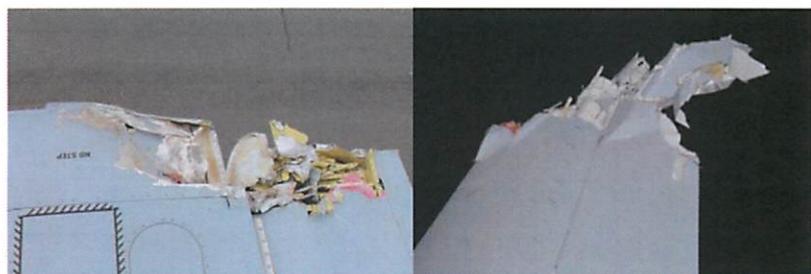
**Figure 1. Mishap C-27 Right Wing Tip**

Flying at 1500' MSL, the right wing tip of the mishap C-27 grazed the right underside of the C-130 at the nose gear door. The mishap C-130 was at 1511' MSL at the time of impact (Tab EE-34). The right wing tip of the mishap C-27 damaged the mishap's C-130's gear door, followed a path that tore the mishap's C-130 flare dispenser hood from its fuselage, and then proceeded beneath the C-130's right wing (Tabs S-4 to S-6; S-9; Figures 1; 2).

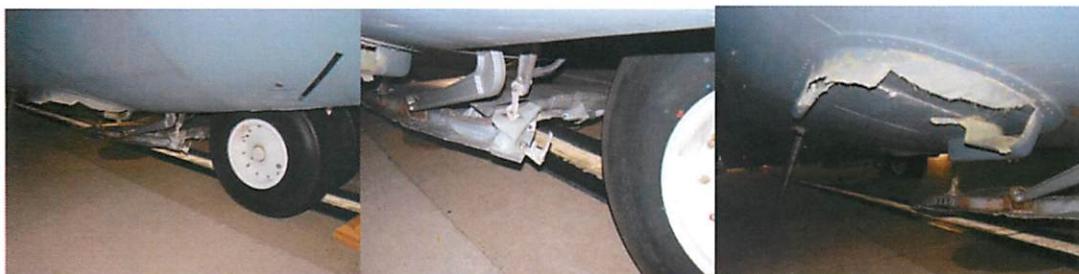
**Figure 2. Mishap C-130 Gear Door and Flare Dispenser Hood**

Damage assessments showed the mishap C-130's nose landing gear door, flare dispenser hood, right wing external fuel tank and the number four engine, along with the wing leading edge section where the engine mounts, were significantly damaged on impact (Tab P-3 to P-27). The AIB performed a thorough inspection of the mishap C-130 systems and reviewed the DFDR data. All systems performed normally up to the time of the mishap.

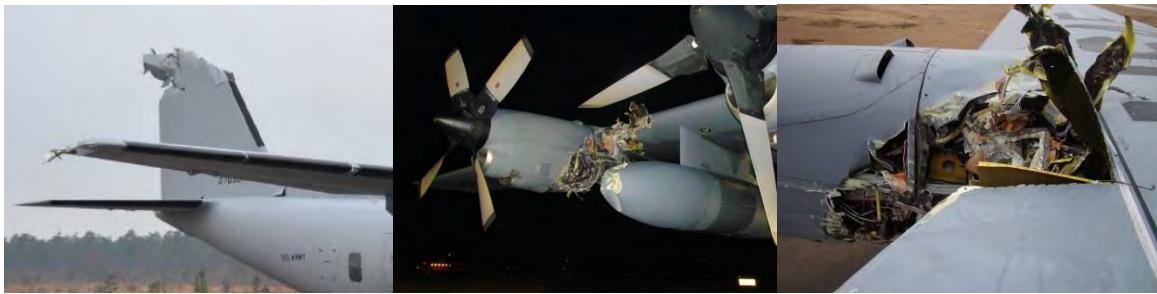
**Figure 3. Mishap C-27 Vertical Stabilizer (left); Mishap C-130 Right Wing and Number Four Engine**

The mishap C-27's vertical stabilizer crossed immediately in front of the nose of the C-130 and proceeded between the prop arcs of the C-130's number 3 and 4 engines (Tabs S-3; S-8). The mishap's C-27 vertical stabilizer then came into contact with the front of the C-130's right external fuel tank and continued on a path impacting midway down the inboard side of the number 4 engine and leading edge of the right wing in the vicinity of the engine mount (Tabs S-2 to S-3; S-6 to S-8). The mishap C-130 sustained damage to the leading edge of the right wing and number 4 engine (Tab S-3). The C-27 sustained significant damage to the top third of the vertical stabilizer and rudder (Tab S-8).

The mishap C-27 sustained damage to the vertical stabilizer, rudder, right outboard wing, right aileron, and empennage on impact (Tab S-7 to S-9). The AIB performed a thorough inspection of the all mishap C-27 systems and reviewed the FDR data. All systems are required for aircraft airworthiness performed normally up to the time of the mishap. However, the mishap C-27's IFF transponder and TCAS were not functioning prior to impact (Tab U-13 to U-65).

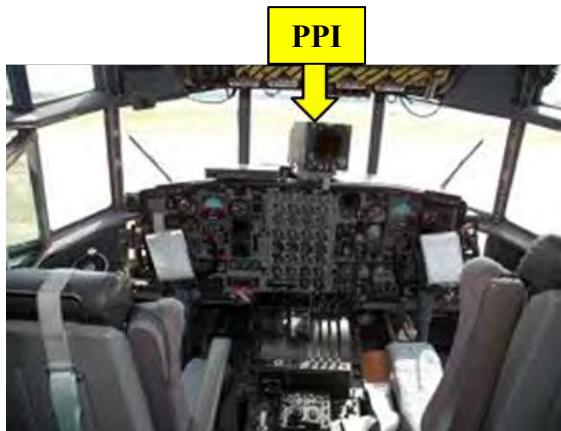
Figure 6. C-130H Canopy

MP3 and MCP had been scanning, but their views were obscured by window posts on the C-130H (Figures 6; 10; 11). Additionally, at the time of impact, MP3 was channelized on maintaining aircraft control prior to the next turn point (Tab EE-34). The MCP was distracted with turn point identification and scanning to the right to clear for the upcoming turn (Tab V-4.15).

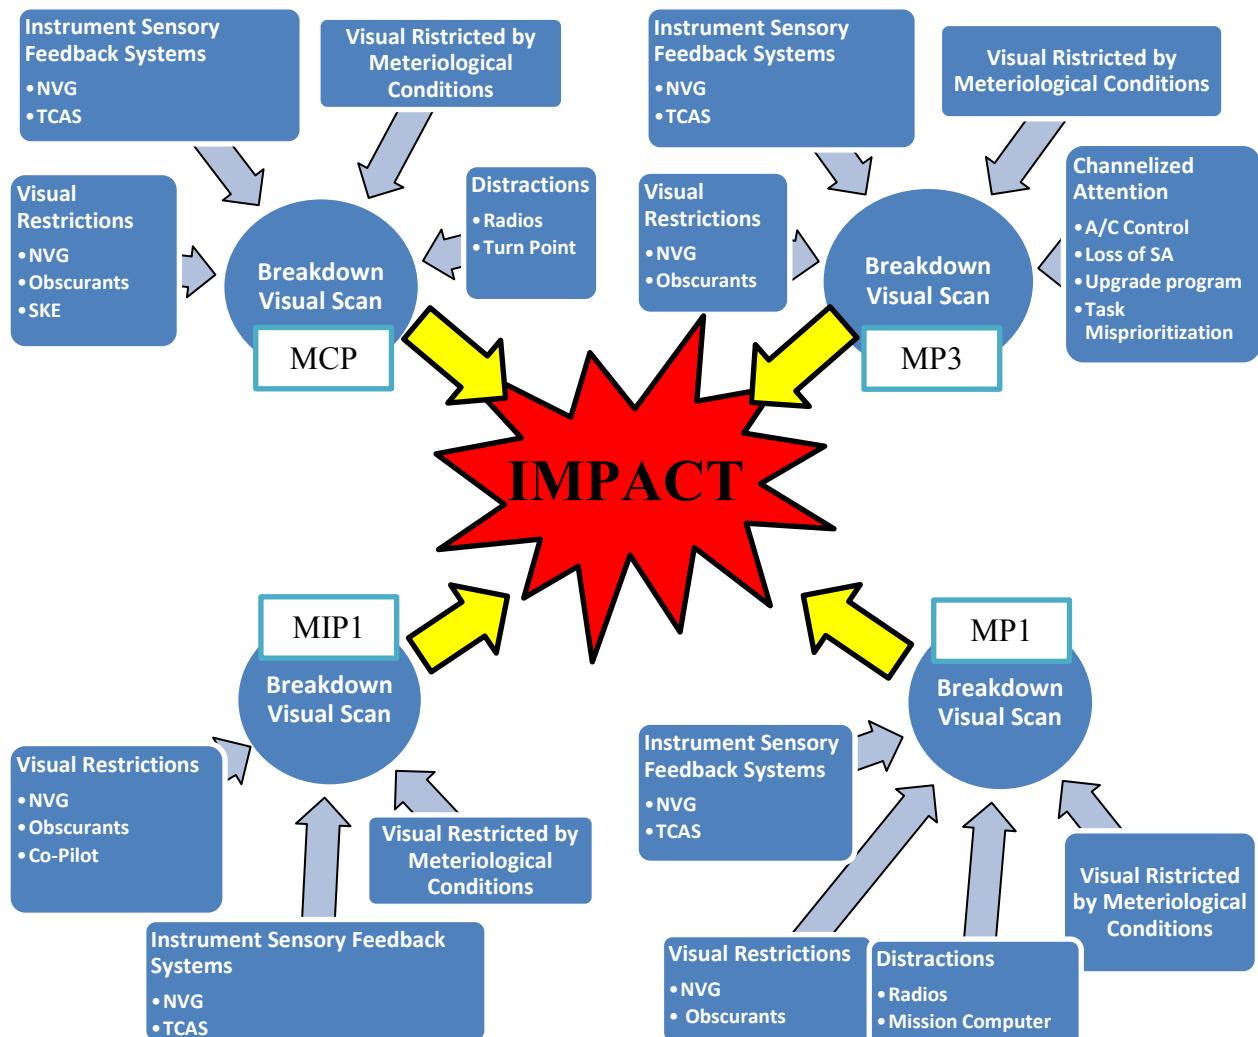
**Figure 13. Human Factors Contributing to Breakdown of Visual Scan**

MCP exchanged control of the aircraft to MP3 shortly after the mishap C-130 crew completed the completion of airdrop checklist (Tab V-4.15). MN gave navigation guidance and briefed the upcoming turn point and heading change (Tab V-6.13). MP3 lost situational awareness and channelized his attention on maintaining aircraft control, leveling the aircraft at 1,500' MSL (Tabs V-3.21 to V-3.22; DD-35). This caused a breakdown of his scan to the left, preventing him from seeing the mishap C-27 prior to the mishap.

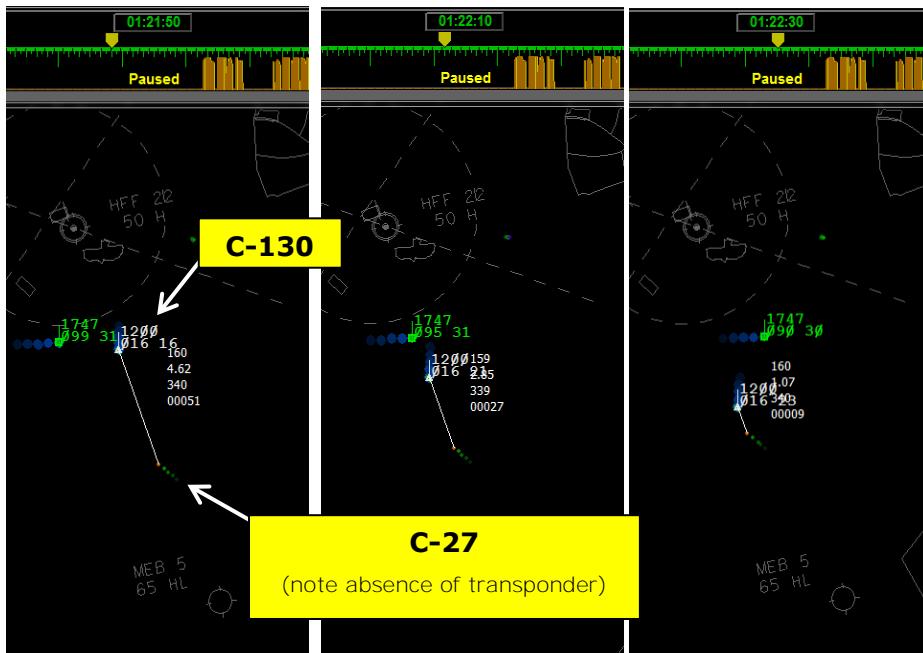
The aircraft closed on a flight path that remained at a nearly constant bearing, resulting in no relative movement on either windscreen.

Radar data depicting relative bearing (160 & 159) prior to impact (times in Zulu)
