# Preventing Main Landing Gear Shimmy Events

Main landing gear (MLG) shimmy is a rare event that starts at airplane touchdown and continues during rollout. Boeing has determined several causes of shimmy, particularly for the 737-200/-300/-400/-500 fleet and offers specific actions that can prevent this vibration from occurring.

By **Warren Malkowicz**, Senior Engineer, Landing Gear Structures, Service Engineering, and  
**Christopher Dubuque**, Senior Engineer, Landing Gear Systems, Service Engineering

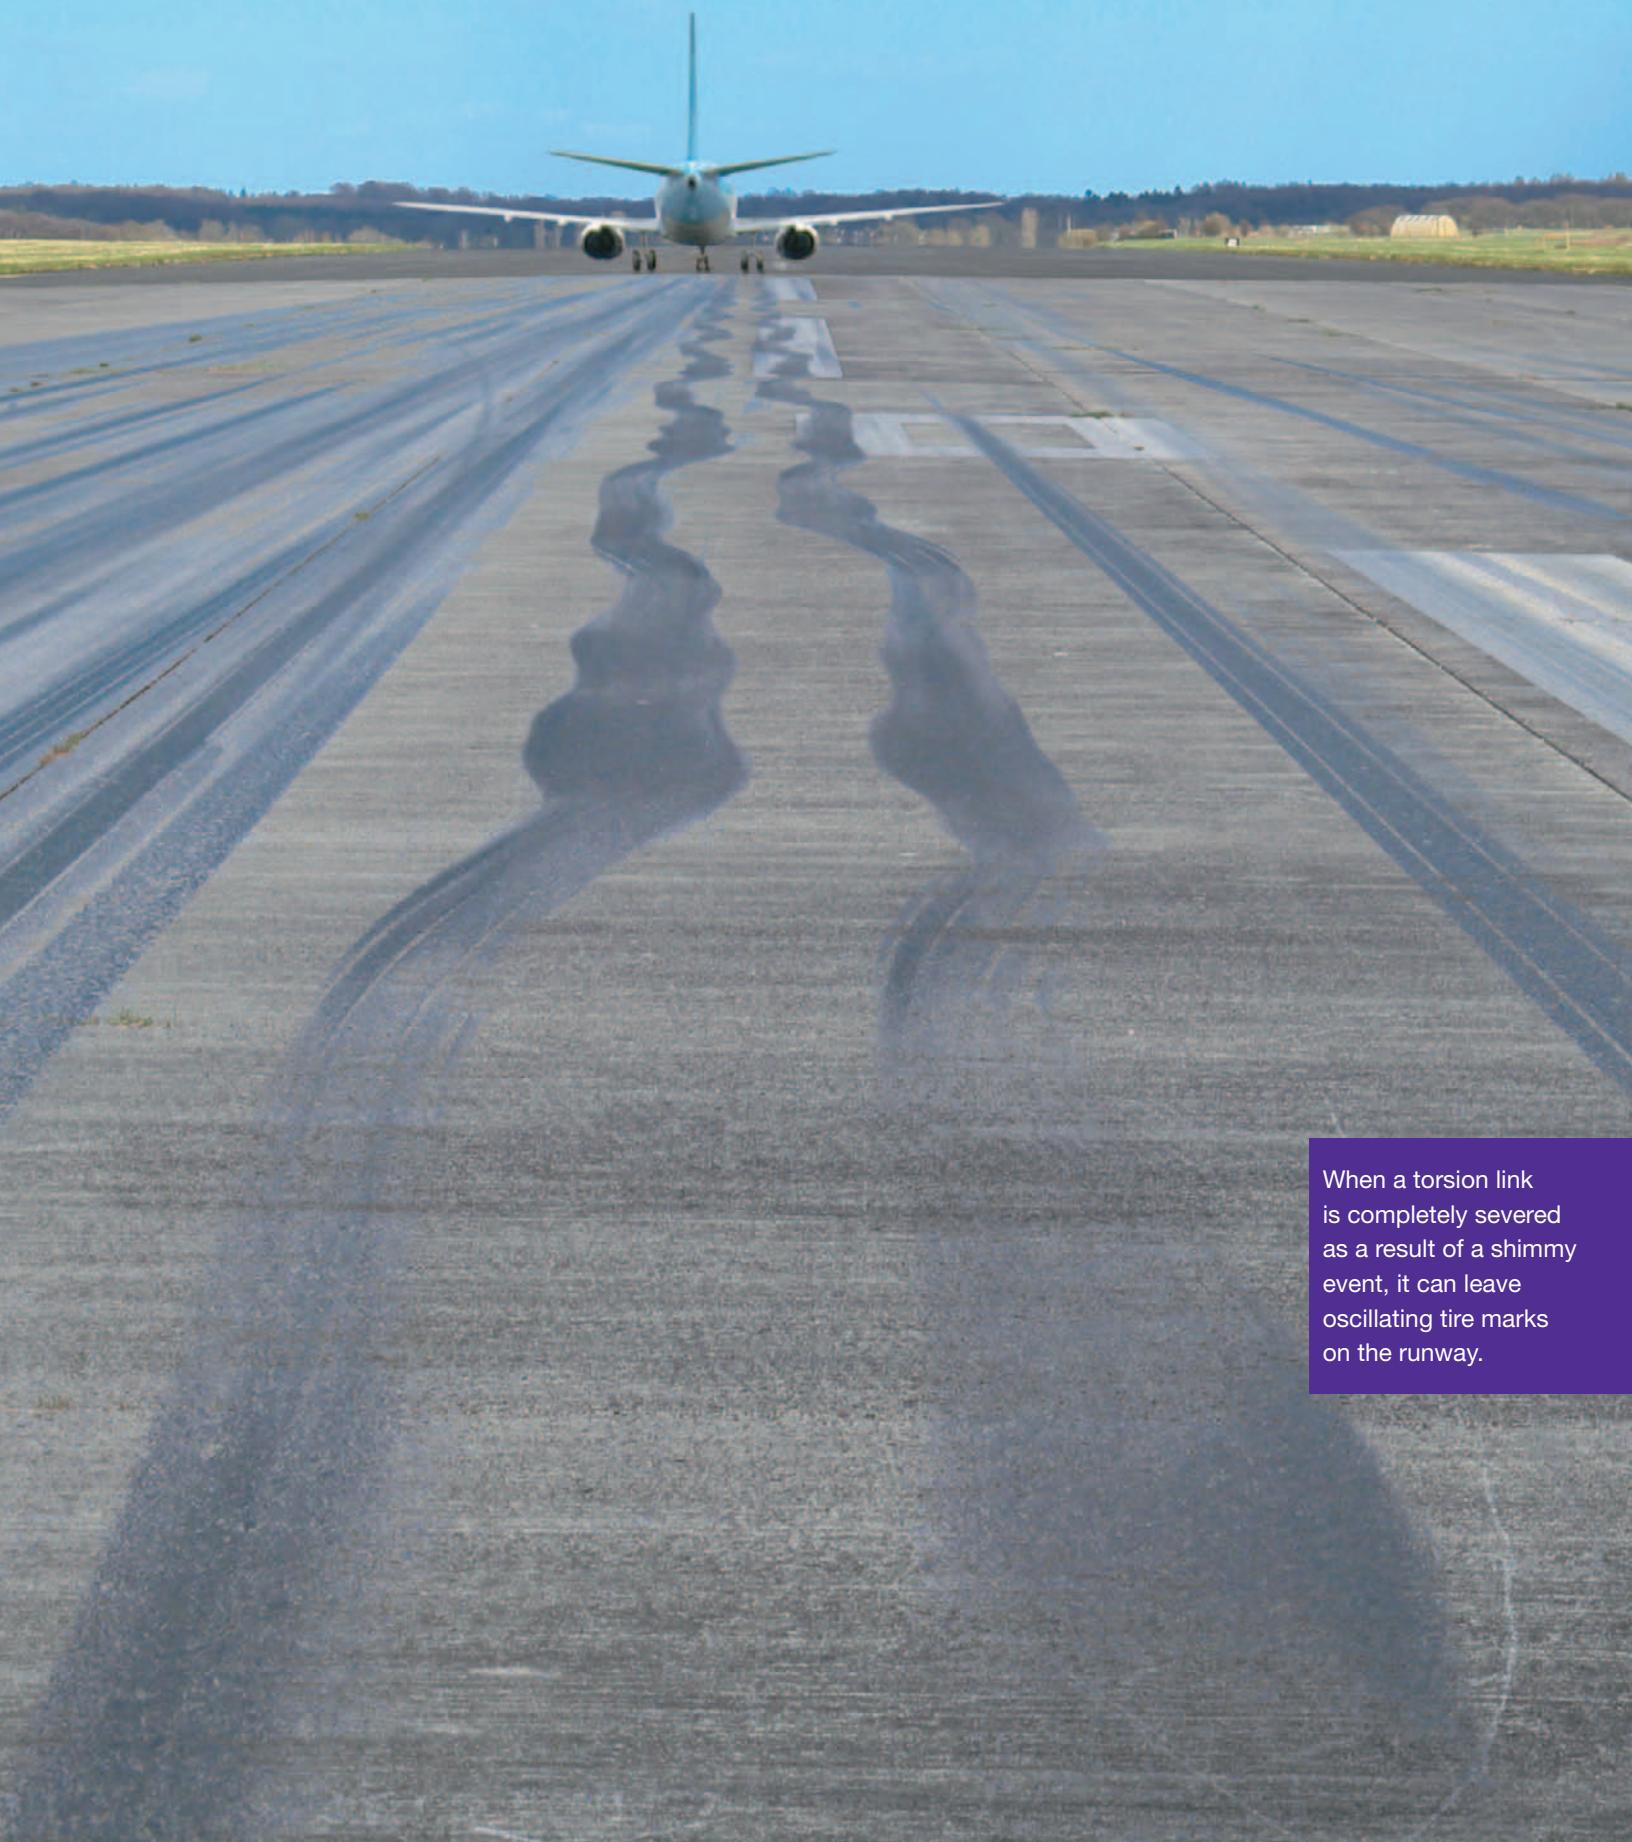
When a torsion link is completely severed as a result of a shimmy event, it can leave oscillating tire marks on the runway.

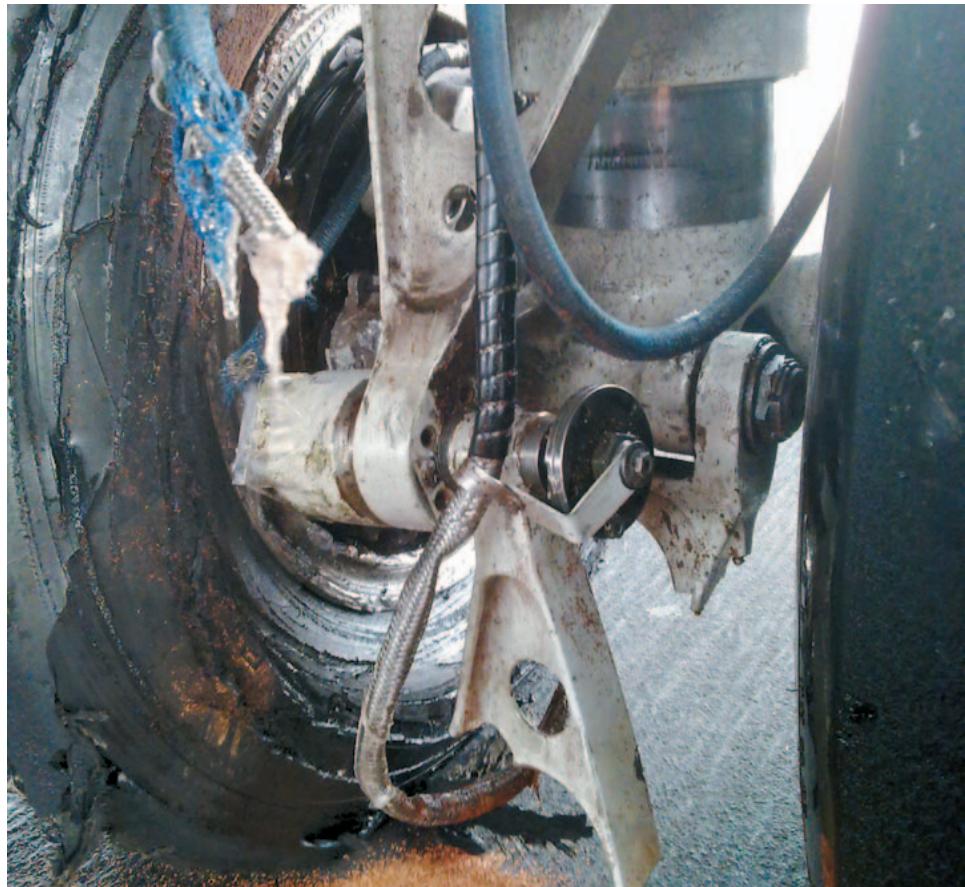
## Figure 1: Fractured torsion link

Despite the presence of shimmy damper hardware, which is attached to the apex lugs on each MLG and is designed to reduce the torsional vibration energy generated during landing, airplanes occasionally experience MLG shimmy. Shimmy events almost always result in damaged torsion links and shimmy dampers (see fig. 1). When a torsion link is completely severed, it can leave oscillating tire marks on the runway. Following a shimmy event, the airplane typically needs to be temporarily removed from revenue-generating service for inspections and repairs.

A main-landing-gear shimmy event fractured the lower torsion link and damaged the wheel, tire, and shimmy damper.
