FINAL REPORT
IG - 556/CENIPA/2018

OCCURRENCE: SERIOUS INCIDENT
AIRCRAFT: CS-TOD
MODEL: A340-312
DATE: 08DEC2011

This is the Final Report of the 8 December 2011 serious incident involving the model A340-312 aircraft, registration CS-TOD. The incident was classified as “[CTOL] Collision with obstacle(s), during take-off or landing”.

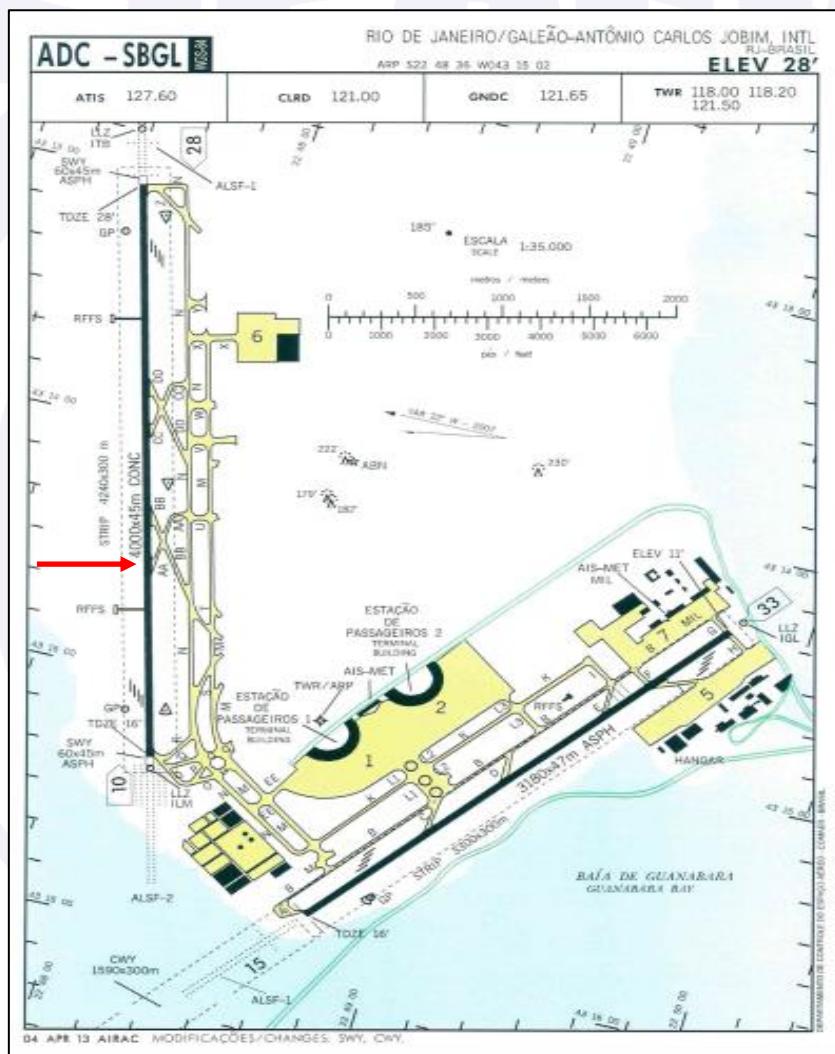
Figure 1 - SBGL Aerodrome Chart (ADC).

The *Airdrome Chart* (ADC) shows that, in order to take off from the displaced threshold of runway 10 and utilize the available 2,730 meters, the crew should use the distance between taxiways AA and BB on departure (Figure 1).

Starting the takeoff run after having joined runway 10 via taxiway BB would result in a reduction of 600 meters in the available runway length.

According to the ADC, taxiways AA and BB intersect each other at an angle of approximately 135 degrees.
