In-flight upset involving Boeing 747-438, VH-OJU

110 km SE of Hong Kong Airport | 7 April 2017

ATSB Transport Safety Report

AO-2017-044

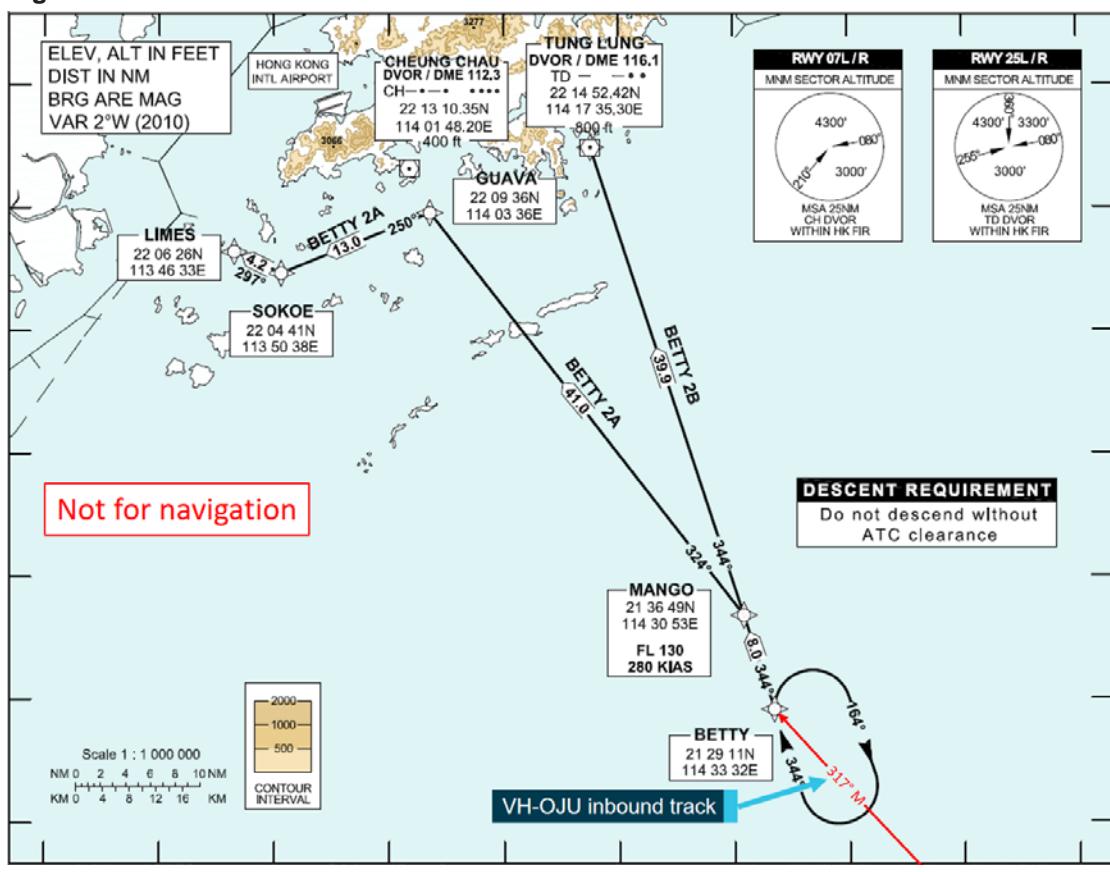
Figure 1: BETTY 2A standard arrival route chart extract

At about 1745 Hong Kong Time (HKT),² in daylight, the aircraft descended toward waypoint³ BETTY (Figure 1) with the autopilot engaged in lateral navigation (LNAV) and vertical navigation (VNAV) modes,⁴ and the autothrottle engaged. As the aircraft descended from flight level (FL) 300,⁵ the customer service manager (CSM) (following direction from the flight crew) advised the passengers to prepare for landing and fasten seatbelts, however, at this time, the fasten seatbelt sign was not illuminated.

The figure shows the position of the BETTY hold along with the inbound track of VH-OJU. Source: Hong Kong CAD, annotated by ATSB

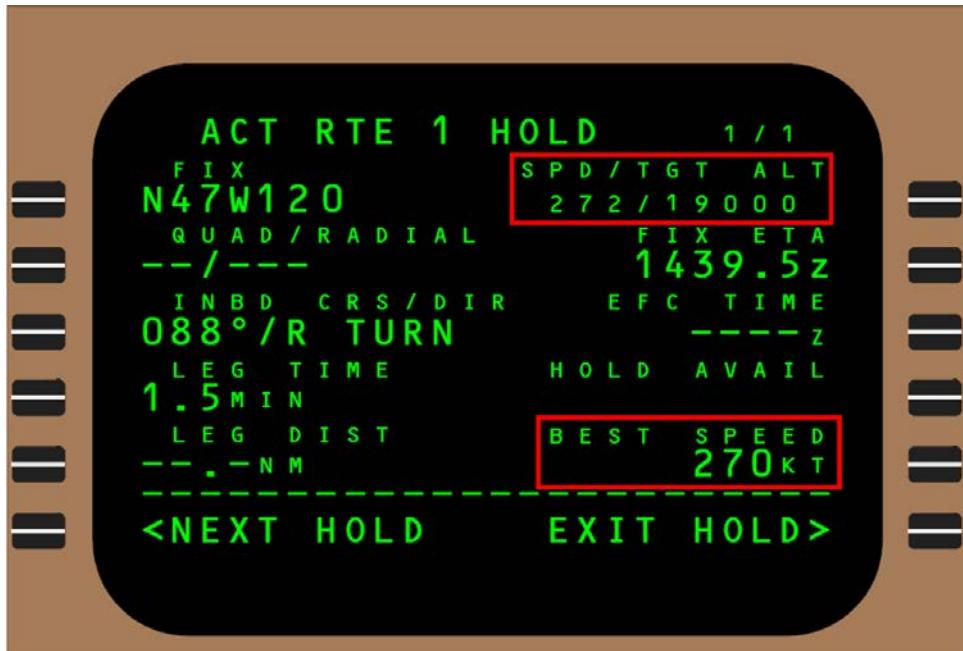
Figure 2: Example of the FMC route hold page with the target speed and the best speed highlighted

The flight crew anticipated that air traffic control (ATC) would direct them to hold at waypoint BETTY, at about FL 150 to FL 160, and they used the aircraft flight management computer (FMC) to plan for the hold. The FMC provided a calculated target hold speed (Figure 2) of 223 kt at FL156, which was the FMC-calculated crossing level at waypoint BETTY. The crew verified this calculated speed by comparing it to the flaps-up manoeuvring speed (see *Hold speed* below) using a heuristic of adding 80 kt to the flaps-30 landing reference speed of 143 kt, resulting in 223 kt.⁶ The captain asked the first officer to input 225 kt above FL 150 as the target hold speed.

The FMC route hold page, showing the best speed indication (representative and not indicating incident data).

The flight crew reported that in practice they used the flaps up manoeuvring speed and then added an arbitrary buffer when selecting a hold speed. This is contrary to the FCTM guidance, and there was no other operator or manufacturer guidance recommending this procedure or the size of the buffer to be used. The investigation found that the flight crew were not aware of the function, or use of, the best speed in the hold page of the FMC.

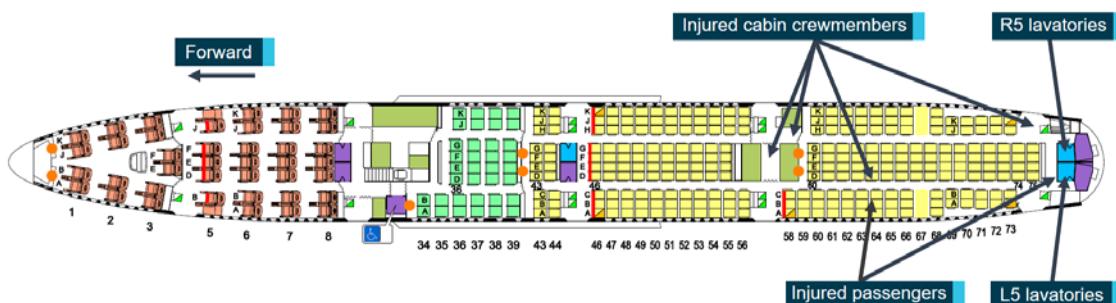
Figure 3: VH-OJU main deck layout

During the pilot-induced oscillations, the CSM, who was standing in the left aisle in the vicinity of rows 63 and 64 (Figure 3), struck the cabin ceiling before falling on a seat armrest, sustaining injuries. Five other cabin crewmembers also struck the ceiling, with three sustaining injuries. A passenger located in an L5 lavatory struck the cabin ceiling landing on the lavatory seat, resulting in minor injuries and damage to the lavatory fittings. A passenger in seat 63C who did not have her seatbelt fastened, was also injured.

The figure shows the aircraft main deck layout. The locations of the injured cabin crewmembers, injured passengers and L5 and R5 lavatories are identified. Source: Operator

The cabin crewmembers established that the smoke alarm originated at the R5 lavatories and that there was no evidence of smoke, fire or fumes. The CSM reported to the flight deck that they believed the smoke alarm to be a false alarm caused by the lavatory damage.

The recorded flight data shows that during the oscillations, the aircraft underwent significant variations in vertical acceleration. The pilot-induced oscillation occurred at a time when the fasten seat belt sign was not illuminated and cabin crewmembers were standing in the rear cabin, completing the cabin preparation for landing. The variations in vertical acceleration resulted in several cabin crewmembers and passengers impacting the cabin ceiling and furnishings, sustaining minor injuries. The impact of occupants to the cabin ceiling and furnishings resulted in damage to these furnishings, in particular an L5 lavatory. This damage resulted in the L5 and R5 lavatory smoke alarm activations.

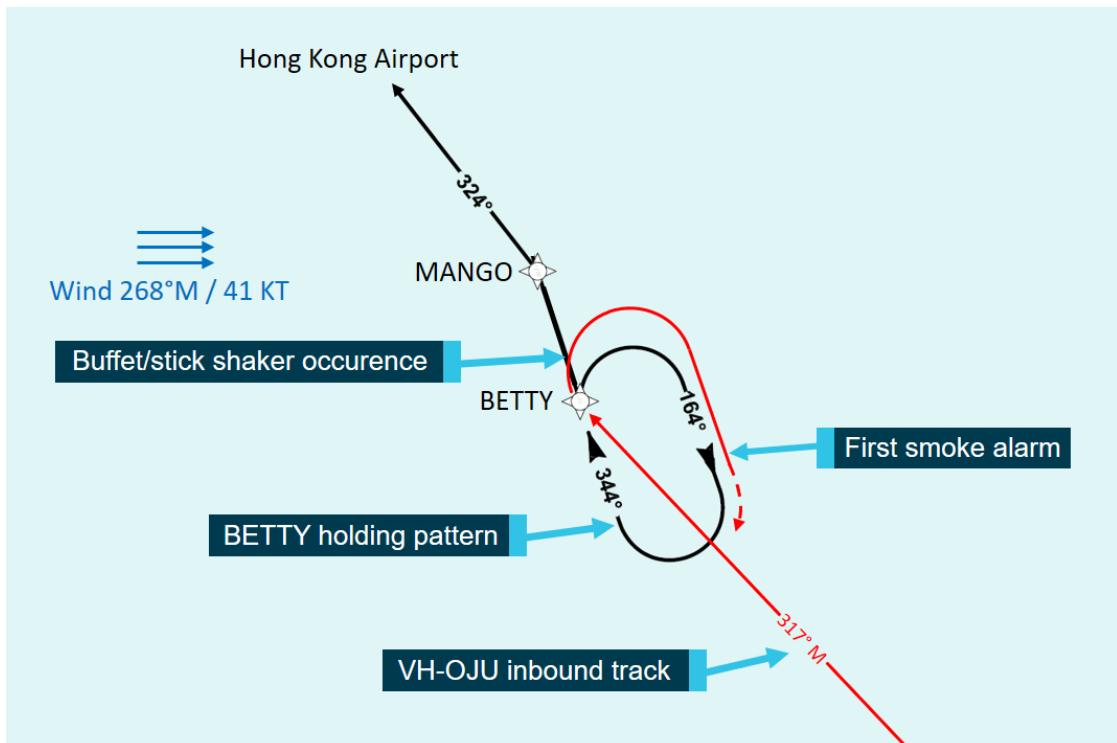
Figure 4: BETTY holding pattern

The aircraft tracked 317°M as it crossed BETTY (Figure 4) and began a right turn, through a total of 207°, to track 164°M for the outbound leg of the pattern.

As the aircraft turned, the wind direction moved to a relative position behind the aircraft, increasing the aircraft's ground speed. The increased ground speed required a greater bank angle to achieve the targeted turn radius and outbound track spacing. The first officer also later commented that when the holding entry required a turn in excess of 180°, the autopilot would initially command a bank greater than 30 degrees.

The figure shows the BETTY holding pattern along with the recorded wind conditions, the approximate track of VH-OJU as it entered the holding pattern and the locations of the buffet/stick shaker occurrence and first smoke alarm. Source: Hong Kong Civil Aviation Department, annotated by ATSB

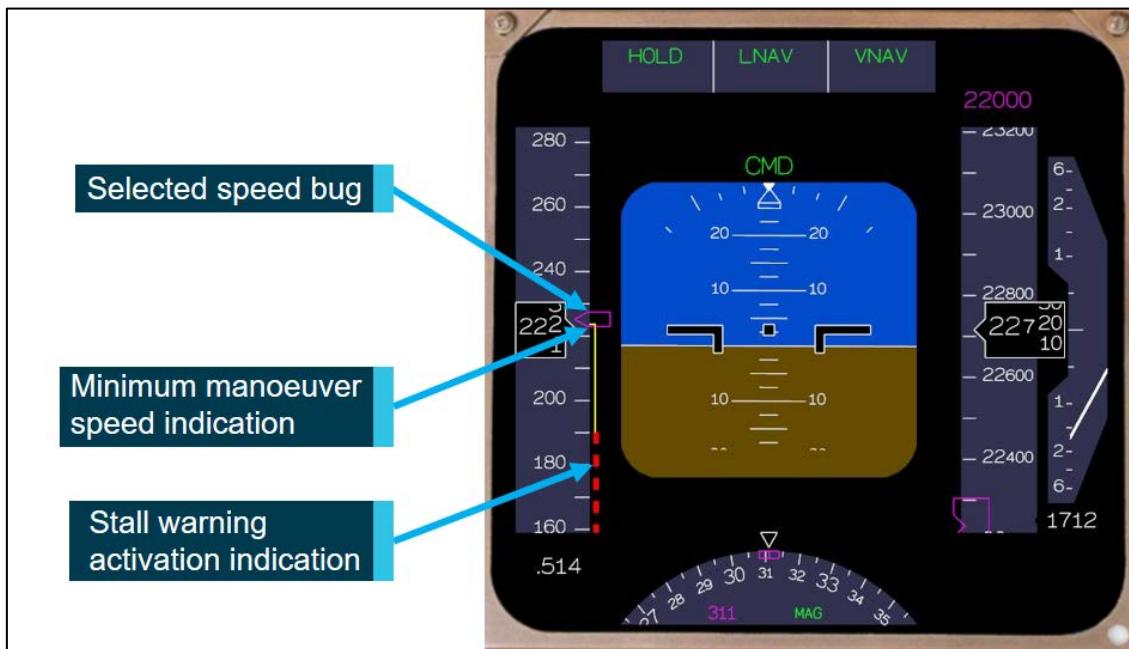
Figure 5: Representation of the primary flight display as the aircraft crossed BETTY

While descending towards BETTY, the aircraft's speed reduced below both the target speed of 225 kt and the minimum manoeuvring speed, which was indicated on the pilot's flight display (PFD) as the top of an amber band (see Figure 5 in *Operational information* below).

This figure shows a representative presentation of the primary flight display as the aircraft crossed BETTY, derived from recorded flight data. The minimum manoeuvre speed amber band and selected speed bug are annotated. Source: ATSB

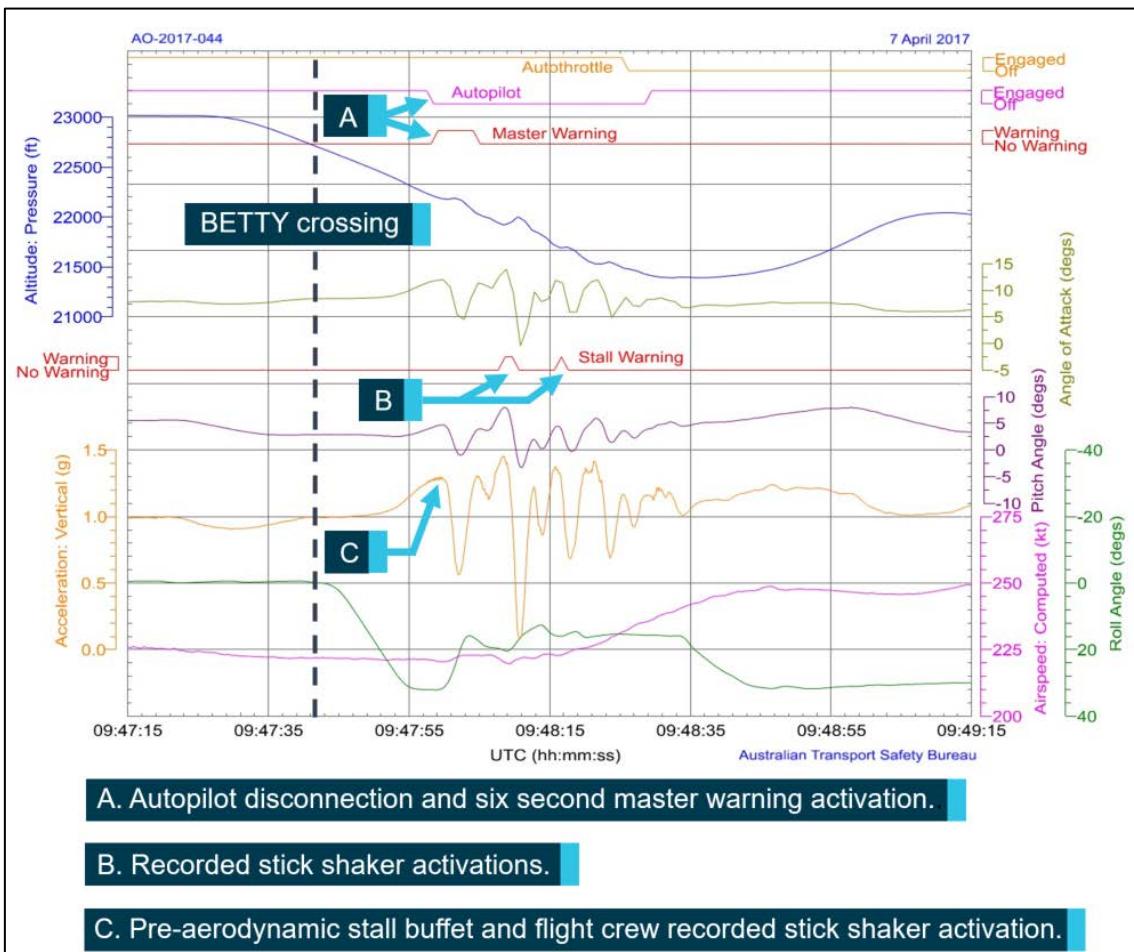
Figure 6: Graphical representation of quick access recorder data

The figure shows a graphical representation of recorded flight data from stick shaker incident significant points of the occurrence are annotated. Source: ATSB

The aircraft manufacturer reviewed the flight data and determined that during the stick shaker occurrence, the aircraft did not enter a stall. The manufacturer provided the following analysis:

For the 747-400, at the event flight condition, the estimated maximum vane angle of attack before stall is achieved would be approximately five degrees.¹⁵ During this occurrence, the highest recorded vane angle of attack was approximately -0.5 degrees, resulting in significant margin to the estimated maximum vane angle of attack when stick shaker activated.
