# Unreliable airspeed indication and stall warning involving Airbus A320, VH-FNP

near Perth, Western Australia, on 12 September 2015

**ATSB Transport Safety Report**  
Aviation Occurrence Investigation  
AO-2015-107  
Final – 4 April 2019

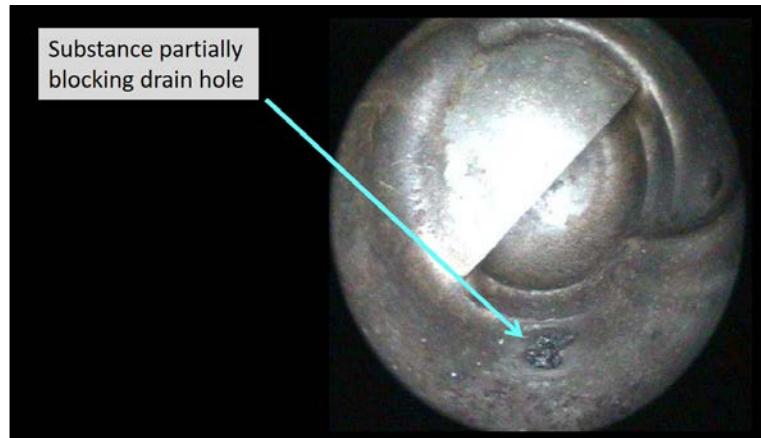
**Figure 17: Image of substance partially blocking one drain hole in the captain's pitot probe**

The ATSB found that blocked drain holes in the pitot probes prevented water from being effectively discharged, resulting in erroneous airspeed measurements in all three systems at various times during the take-off and climb. The erroneous airspeeds were not detected by the flight crew, but had been detected by the system, resulting in the autothrust and autopilot disconnecting, and the generation of multiple alerts, including a NAV ADR DISAGREE alert. That alert required the flight crew to crosscheck the three airspeed indications and the result would indicate if they had an airspeed or angle of attack disagreement. Due to the limited space in the alert message area, the NAV ADR DISAGREE alert was initially pushed off the screen by engine related alerts that were programmed to have a higher priority.

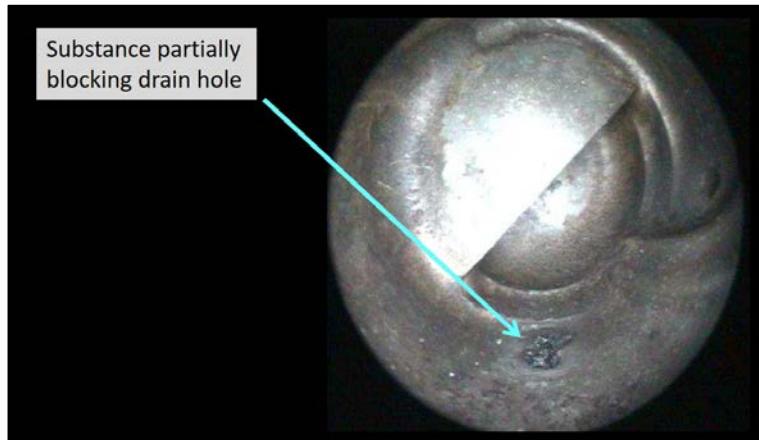
**Figure A1: Image of substance partially blocking one drain hole in the captain's pitot probe**

The captain's pitot probe failed the acceptance tests due to the blocked drain hole and the contamination by the red clay substance.

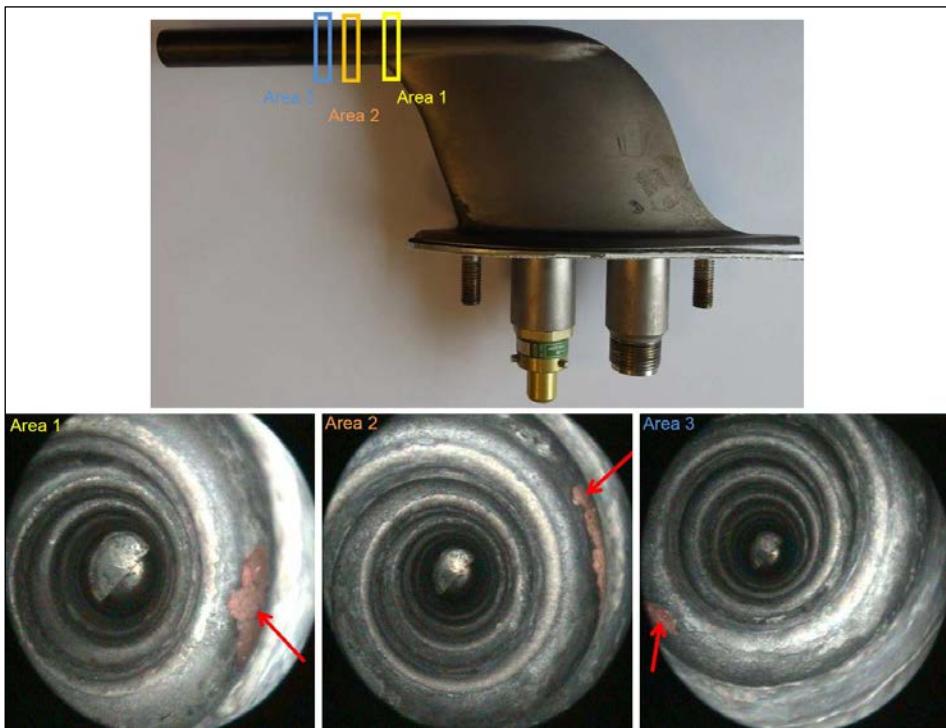
**Figure A2: Image of red contamination (red arrows) in the captain's pitot probe**

Contamination of the interior of the pitot tube by a red substance was also identified in three locations within the captain's pitot probe (Figure A2). Spectrographic examination of that substance identified that it consisted predominantly of oxygen, silicon, iron, aluminium and carbon and that it had an infrared spectrum consistent with an aluminium silicate clay.

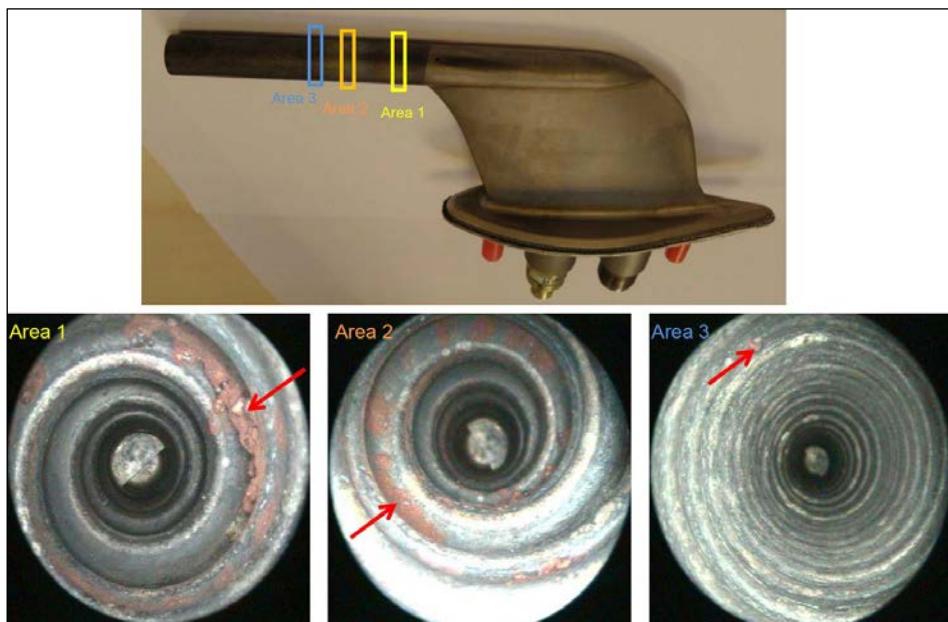
**Figure A3: Image of red contamination (red arrows) in the standby pitot probe**

The standby pitot probe failed the acceptance tests due to the contamination by the red clay substance.
