SERIOUS INCIDENT

Aircraft Type and Registration:	DHC-8-402 Dash 8, G-ECOE	
No & Type of Engines:	2 Pratt & Whitney Canada PW150A turboprop engines	
Year of Manufacture:	2008 (Serial no: 4212)	
Date & Time (UTC):	11 January 2018 at 1632 hrs	
Location:	Belfast City Airport	
Type of Flight:	Commercial Air Transport (Passenger)	
Persons on Board:	Crew - 4	Passengers - 44
Injuries:	Crew - None	Passengers - None
Nature of Damage:	None	
Commander's Licence:	Airline Transport Pilot's Licence	
Commander's Age:	60 years	
Commander's Flying Experience:	14,122 hours (of which 464 were on type) Last 90 days - 91 hours Last 28 days - 39 hours	
Information Source:	AAIB Field Investigation

Synopsis

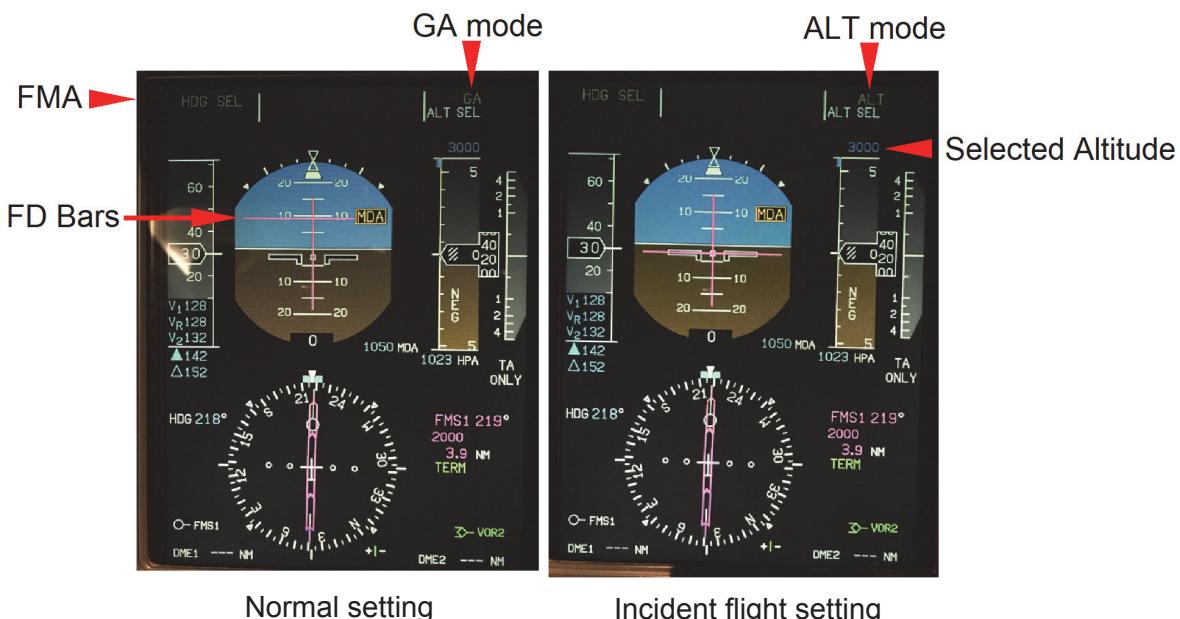
If the HDG, ALT SEL and ALT modes are selected on the ground, subsequently as the aircraft climbs after takeoff above the target altitude, the FD vertical guidance bar will progressively move to a nose-down pitch attitude. Upon engagement of the autopilot, the aircraft will pitch down to follow the FD vertical guidance bar to descend to the target altitude. For this incident this target altitude would have been set to about 0 ft amsl.

Figure 2 shows the FMA and FD vertical bar positions displayed on the PFD when the FD modes are selected in accordance with the operator's procedures prior to takeoff (GA, HDG and ALT SEL) and those selected during the incident takeoff (HDG, ALT SEL and ALT). Other than the FMA indicating that the ALT mode has been armed on the ground, there are no other indications to identify that the target altitude has been set to the airfield elevation amsl.

PFD indications when GA, HDG and ALT SEL (left PFD) and HDG, ALT SEL and ALT (right PFD) are selected for takeoff

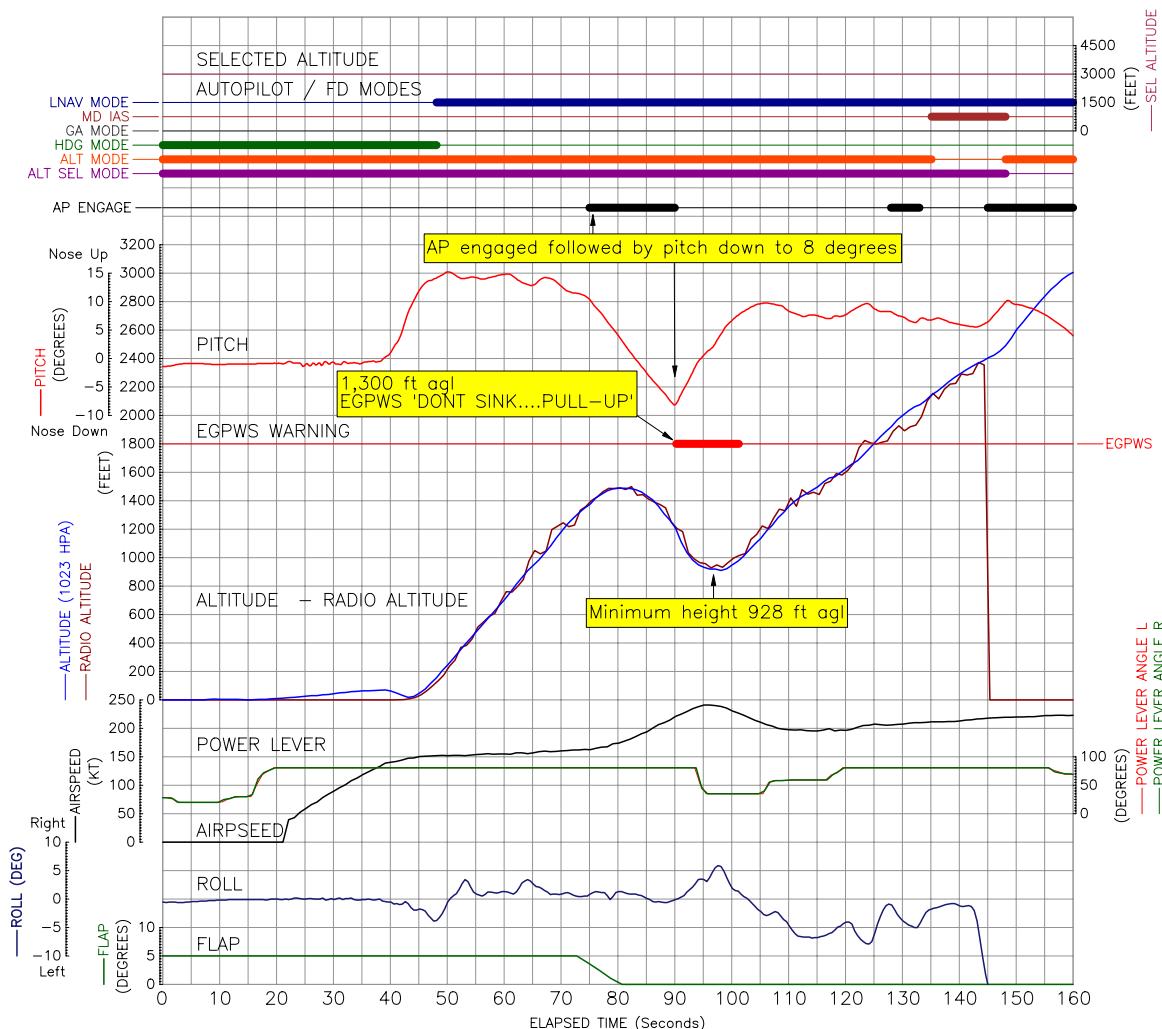
After reaching the acceleration altitude (1,000 ft aal) the flaps were retracted, which was shortly followed by the autopilot being engaged. The aircraft was now in IMC and at a height of 1,350 ft agl and its airspeed was 163 KIAS. Following the autopilot engagement the aircraft started to gradually pitch nose-down at a rate of about 1.2° per second from a height of 1,500 ft agl. During the next 15 seconds, whilst the crew were completing the 'after takeoff' checklist, the aircraft descended at an increasing rate with the pitch attitude reducing from about 10° nose-up, to 8° nose-down.

At a height of about 1,300 ft agl, an EGPWS Mode² "DON'T SINK" caution was activated. The commander responded almost immediately, disconnected the autopilot and applied nose-up pitch to arrest the rate of descent, which had reached a maximum of 4,300 ft/min. Engine power was also simultaneously reduced, with the airspeed having increased to 235 KIAS. The aircraft continued to descend for a few more seconds, during which a EGPWS "PULL UP" warning was triggered. The aircraft then transitioned to a climb, having reached a minimum height of 928 ft agl and a maximum airspeed of 241 KIAS (V_{MO} ³ below 8,000 ft amsl is 245 KIAS); the crew subsequently reported that they had become visual with the ground during the recovery.

Figure 3
Descent following autopilot engagement
