FINAL REPORT
A - 158/CENIPA/2013

OCCURRENCE:	ACCIDENT
AIRCRAFT:	PT-MVL
MODEL:	A330-203
DATE:	02SEPT2013

This is the Final Report of the 02SEPT2013 accident with the A330-203 aircraft, registration PT-MVL. The accident was classified as "Caused by Meteorological Phenomenon in Flight".

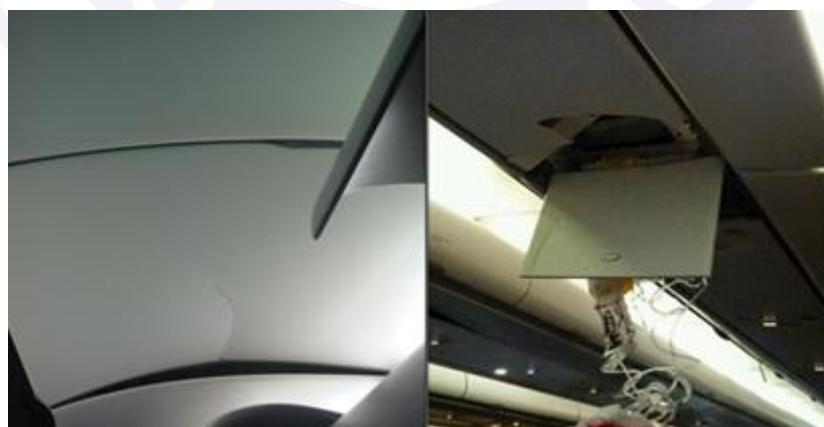
There were minor damage inside the aircraft, due to the impact of passengers against the top of the passengers cabin (Figure 1).

Figure 1- Damage inside the aircraft.

There were minor damage to the aircraft due to the impact of passengers on the top of the cabin (Figure 1).

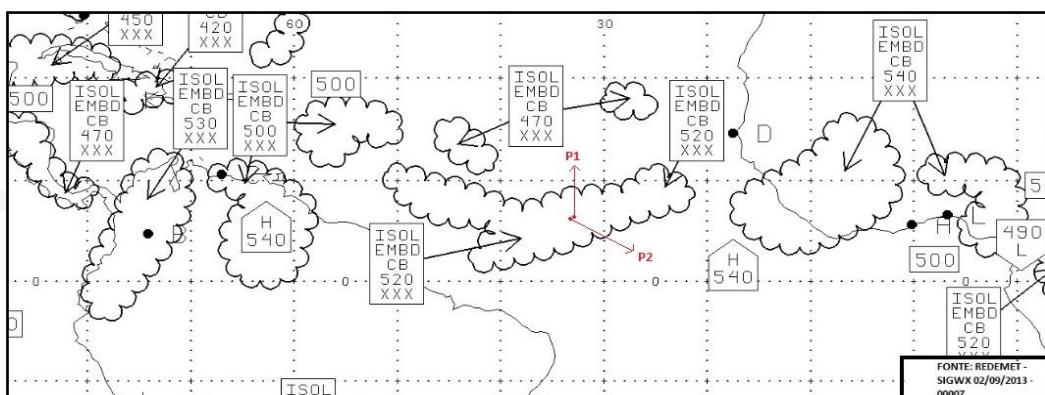
According to the Significant Time Forecast Chart (SIGWX) of 0000 UTC (UTC) on 02SEPT2013, with validity from 0900 pm (UTC) from 01SEPT2013 to 0300 am (UTC) on 02SEPT2013, ranging from FL250 (25,000 feet) to FL630 (63,000 feet), an abnormal condition with cumulonimbus clouds (CB), topped in FL520 (52,000 feet) was predicted for

Figure 2 - SIGWX chart of 02SEPT2013, at 00h00min (UTC), where the positions P1 and P2 define the starting and ending sections of the turbulence.

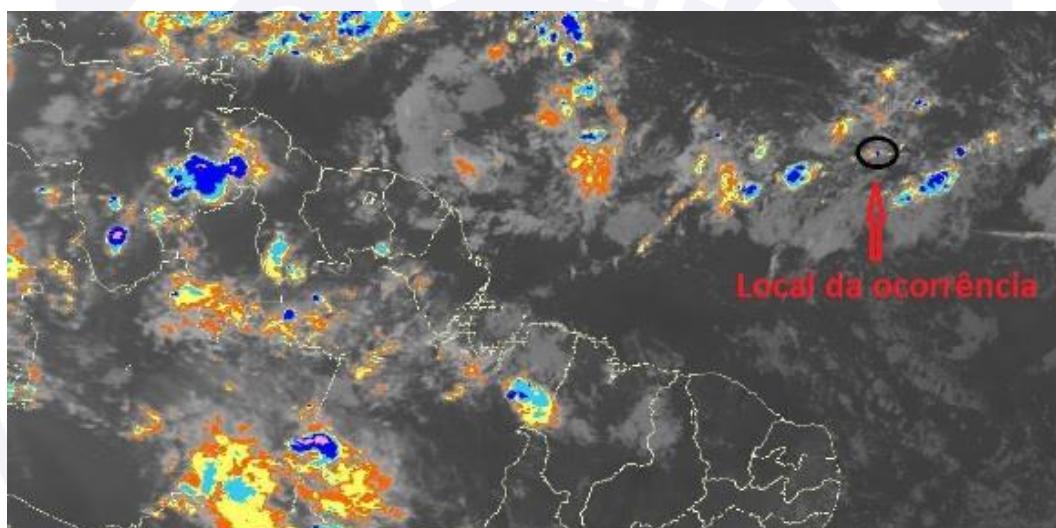
The satellite image of 02SEPT2013, at 0300min (UTC), provided by the Center for Weather Forecasting and Climate Studies (CPTEC) website showed that on the route of the aircraft there were agglomerations and isolated cells of CB, appearing in the vicinity of the abnormal condition region (Figure 3).

Figure 3 - Satellite image of 02SEPT13, at 0300 (UTC), highlighting the place of the occurrence.

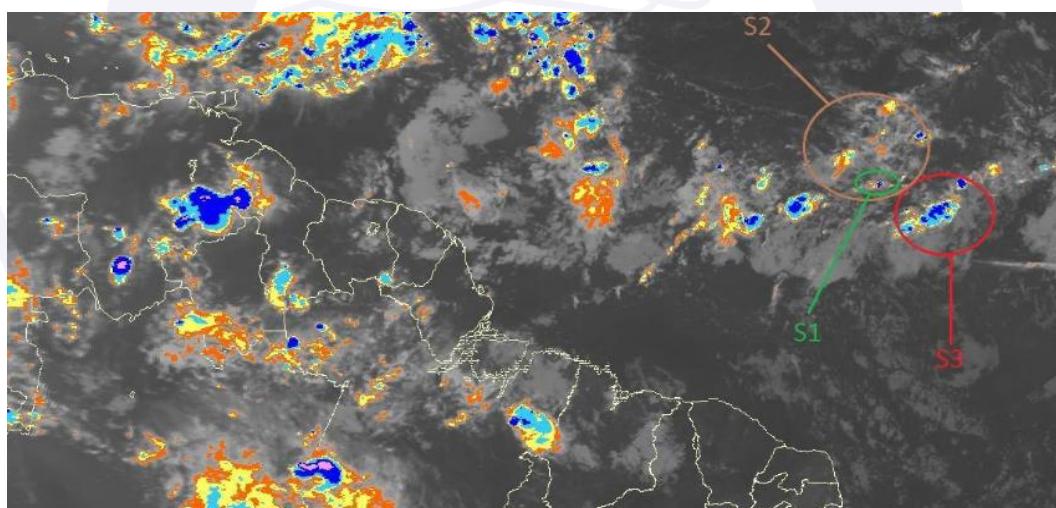
- plotted area S1 - an isolated CB cell in full development below the route traced by the aircraft, with tops at 0245 am (UTC), around the FL370, which probably contributed most to the occurrence of severe turbulence through intense ascending currents.
- plotted area S2 - isolated CB cells in development and dissipation in the vicinity of the abnormal condition area; and
- plotted area S3 - well developed CB agglomerations with tops around FL450 - 45,000 feet (they were west of the route but not contiguous to points P1 and P2).

The "S1" area showed considerable development between 0245 (UTC) and 0300 (UTC), that is, it was in the stage of full development, which indicated an area of intense confluence of winds.

Figure 7 - Satellite Image Chart of 02SEPT2013, at 0300 am (UTC), focused on the reporting positions (S1) and adjacent sectors with CB formations (S2 and S3).

Thus, probably at the time of the reporting, the aircraft was under indirect influence of the systems marked by the areas "S2" and "S3" of Figure 7 and under direct influence of the developing CB cell below the region of the abnormal condition, which evidenced the presence of upward currents, predominant in the route of the aircraft. It is also inferred that the top of the CB could be very close to the level of flight of the aircraft when it suffered the turbulence.

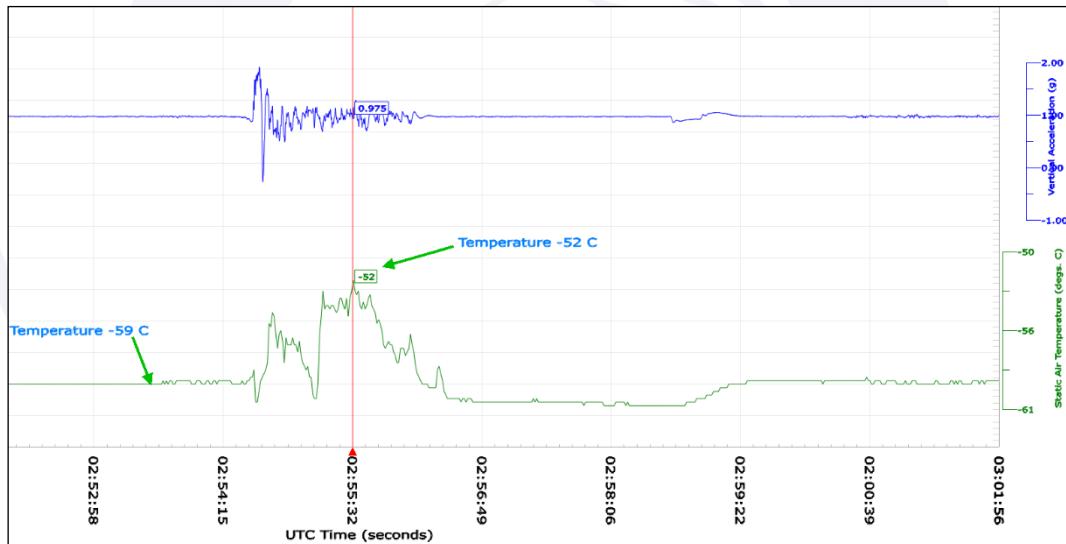
The data obtained by the recorder of the aircraft corroborate to the fact that the aircraft has been subjected to a rising current of air, coming from the convective movements of a CB in formation just below it. As it can be seen in Figure 9, the external temperature recorded by the aircraft, which was -59°C , rose suddenly to an average of -52°C .

Figure 9 – Graphic of the FDR of temperature variation during turbulence.

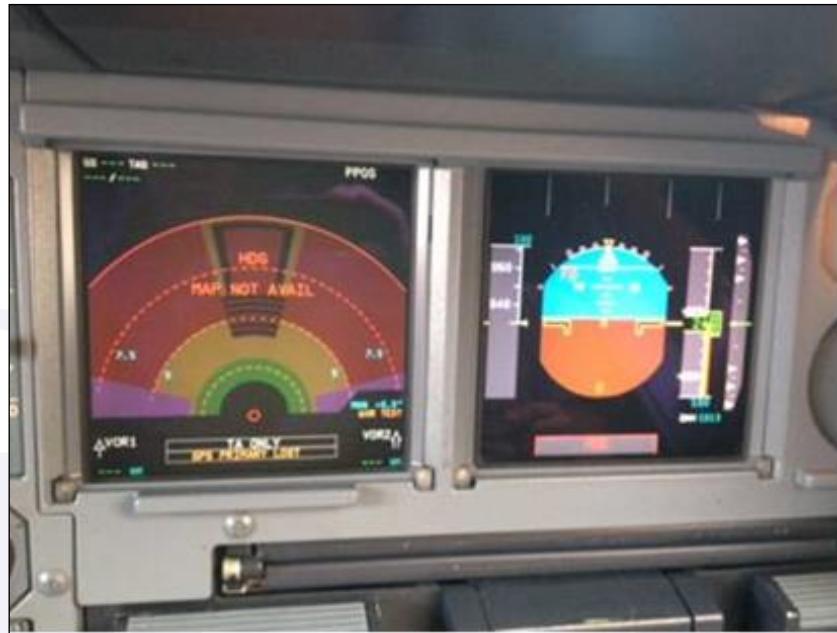
On the day after the event, the antenna and the meteorological radar system of the aircraft were submitted to bench tests, and no discrepancy was observed (Figure 10).

Figure 10-Weather radar antenna scanning operational test.

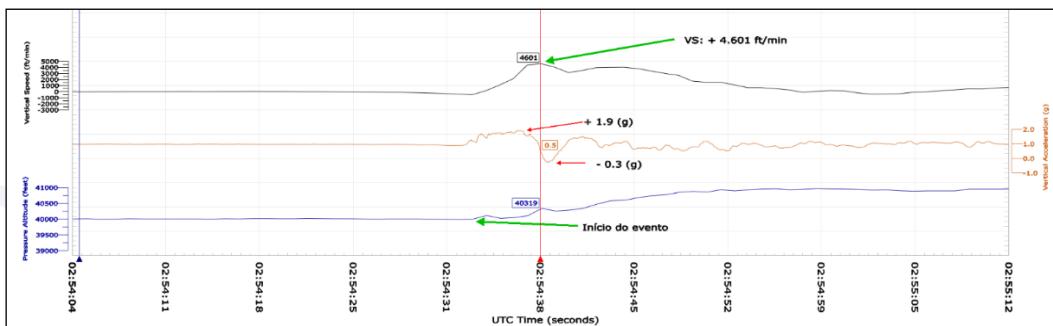
In the analysis of the FDR flight data, it was possible to verify that the aircraft faced a region of turbulence, being recorded that, in a certain moment, it was submitted to a load factor that varied between +1.9 G and -0.3 G, corresponding to a variation of 2.2 G in two seconds. During this same time, an intense variation in the ascent rate of up to + 4.601 ft. / min could be observed, causing the aircraft to release FL 400 and reach FL 409 (Table 1).

The FDR revealed that the turbulence lasted approximately 1 minute and 37 seconds, with a maximum intensity of 15 seconds (Figure 17).

Figure 17 - Variation of the vertical acceleration, load limit, and speed during the event.

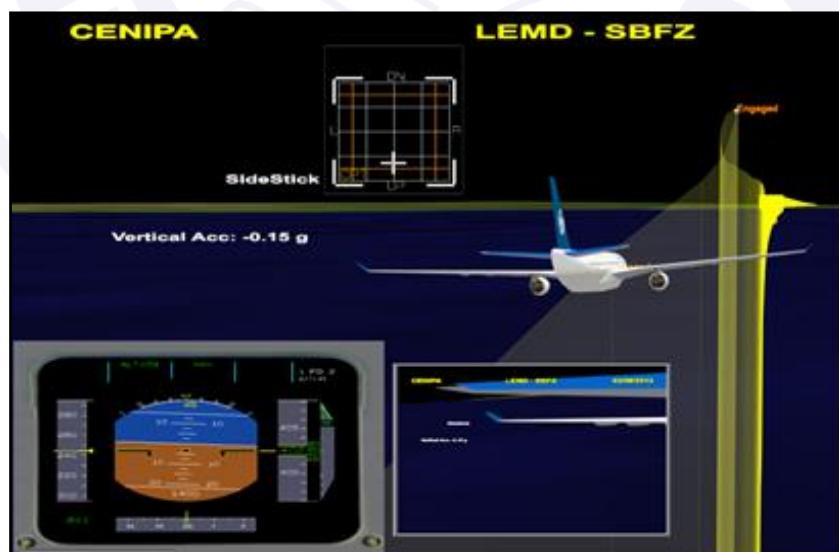
Figure 18 - Sidestick down with the aircraft pitching down.

The limits of the device entry and the Attack Protection Angle have been exceeded, causing the autopilot to disengage. According to FDR data, the pilot attempted to counteract the effects of the turbulence, with Sidestick applications opposed to the aircraft's attitude changes, which may have contributed to increase the effects caused by turbulence.

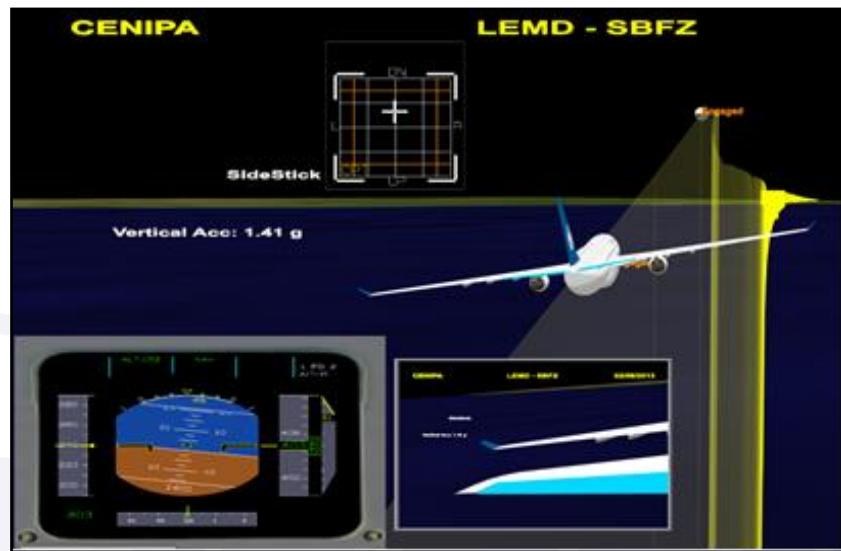
Figure 19 - Sidestick up with the aircraft pitching up.
