**ACCIDENT**

| <b>Aircraft Type and Registration:</b> | EMB-145EP, G-CKAG | |
| <b>Date &amp; Time (UTC):</b> | 22 December 2017 at 1137 hrs | |
| <b>Location:</b> | Runway 27 at Bristol Airport | |

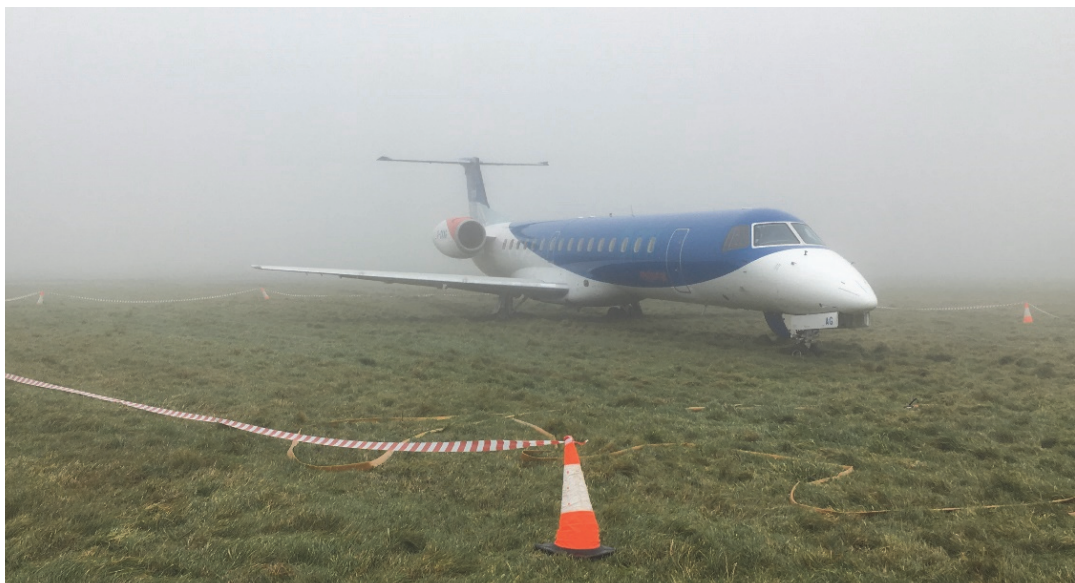
**Figure 4**  
G-CKAG off the runway

Figure 4 shows the aircraft where it had come to rest and the poor visibility shortly after the time of the accident. Marks and rubber fragments on the runway defined the touchdown point, approximately 468 m from the threshold, and showed the aircraft initially tracking on the runway centreline before drifting first slightly to the right of the centreline and then veering left over 280 m. Overheated fragments of vulcanised rubber were found at various points along the runway, with a cluster of larger fragments approximately 400 m from the touchdown point over an area of approximately 40 m by 3 m. After this point there were faint but reasonably clear lines left on the runway surface made by the wheel rims up to the point where the aircraft left the runway and continued onto the grass.

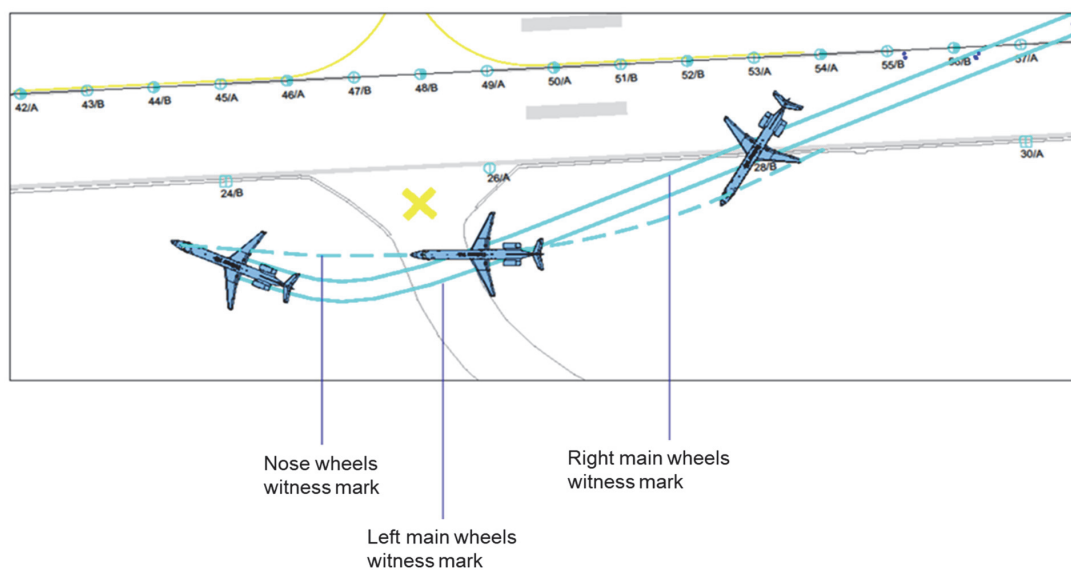
**Figure 5**

Once on the grass the aircraft left deep furrows in the top soil up to where it traversed a disused taxiway with further deep furrows beyond leading to its final position. The distance from where the aircraft left the main runway until coming to stop was approximately 120 m. Marks showed that it had 'fishtailed' from right to left whilst on the grass. The path of the aircraft from the runway is shown in Figure 5.

The aircraft's path leaving the runway

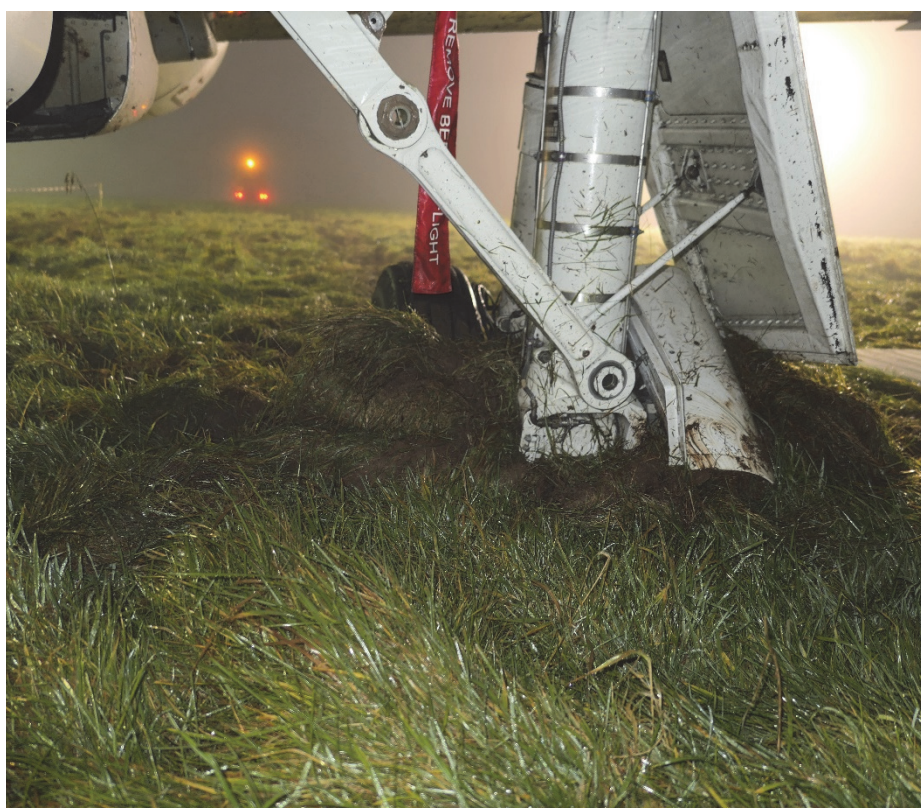
**Figure 6**

The aircraft stopped on a heading of 296°(M) and all four main wheels were buried up to their axles. The components attached to the front of the left and right main landing gear were clogged with soil and turf. Apart from the detached and loose lower fairing mounting strut on the left landing gear, there appeared to be no other damage. The nose landing gear, fuselage, wings and engines were undamaged although the left wing leading edge had soil residue along its length. Figure 6 shows the extent that aircraft main wheels and landing gear had dug in.

The extent of the entrapment of the main wheels and landing gear  
(left side shown, the right side was similar)

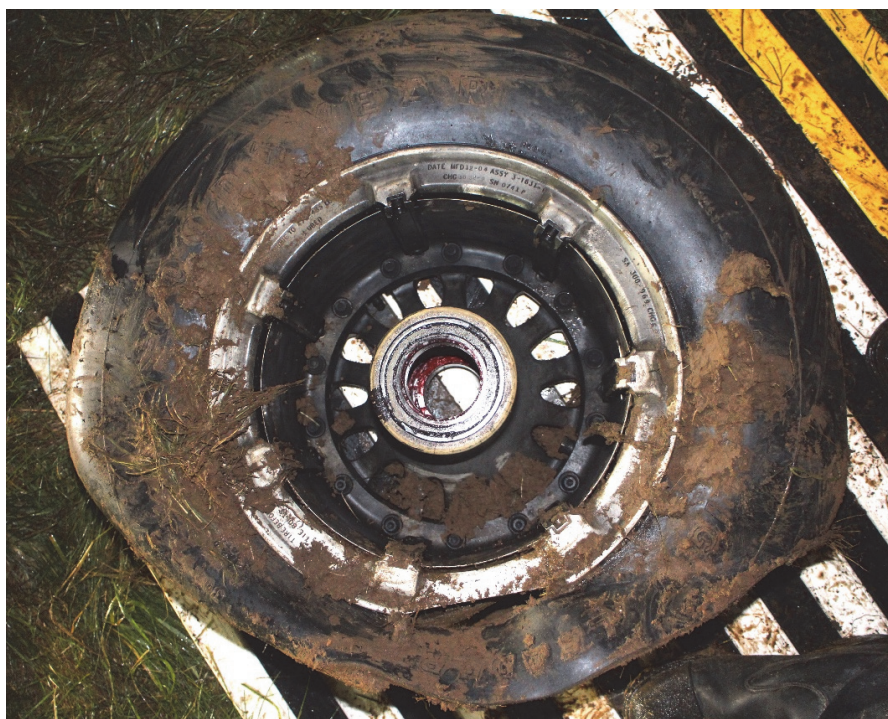
**Figure 7**

The wear pattern on the tyres showed the tread surface abraded through leaving ragged edges and missing material. Abrasion then carried on symmetrically though the sidewalls over an approximately 140° arc down to the wheel rims. There was also abrasion of some of the wheel rims where they had contacted the runway surface. None of the tyre beads de-seated and the fusible plugs and valves were not affected. Figure 7 shows the damage to one of the main wheel and tyre assemblies. The other main wheels and tyres exhibited the same extent of damage.

Main wheel and tyre damage

The material evidence supported the conclusion that the aircraft landed with all the main wheel brakes locked on which did not allow any rotation of the main wheels.

The crew noted a more rapid than normal de-rotation on touchdown consistent with the effect of higher drag loads imparted by the tyres as they contacted the runway surface. The small overheated tyre material 'rubbings' suggested the tyres did not immediately burst or deflate on touchdown. However, the cluster of larger fragments and ply material approximately 400 m from touchdown suggested that all the tyres burst either simultaneously or in very quick succession at that point. This left the sidewalls to take the weight and abrade uniformly down to the wheel rims, evidenced by the marks left on the runway, until the aircraft traversed on to the grass.

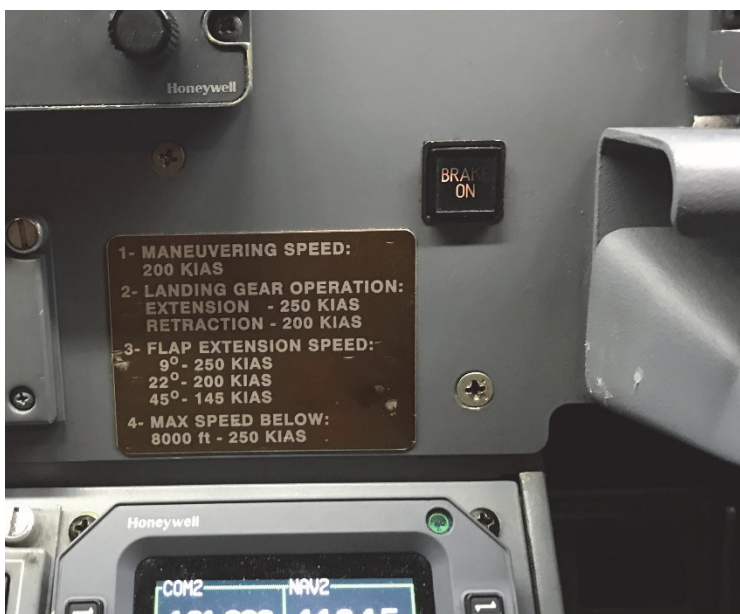
**Figure 8**

The aircraft had been shut down and made safe by the crew with the parking brake left in the OFF position. During examination of the aircraft, the parking brake was operated and, with aircraft electrical power on, the parking brake indicator on the centre panel illuminated. However, the nomenclature on the light did not appear to be as well defined as would be expected, consistent with one of its filaments having failed. Figure 8 shows the parking brake indicator.

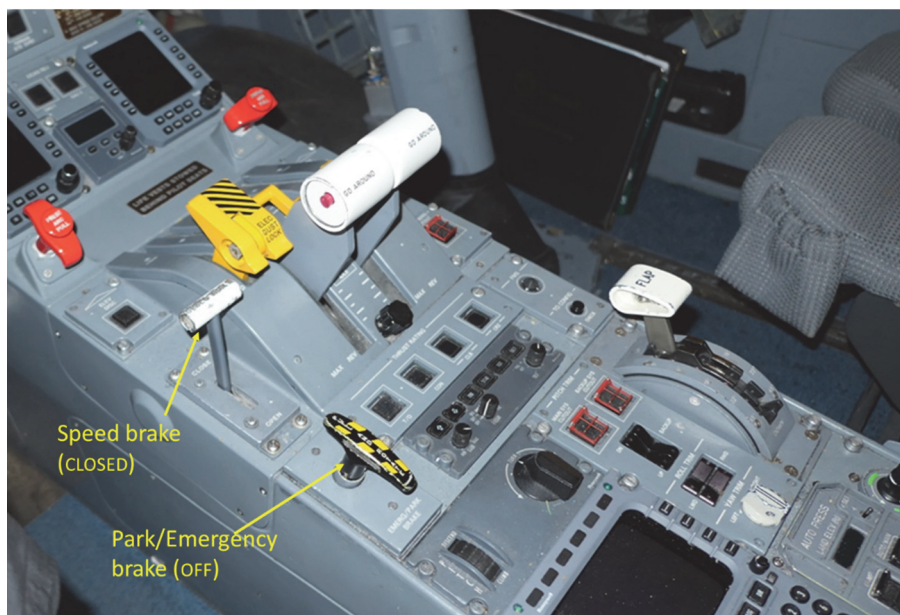
**Figure 9**

The speed brake function is electrically controlled by a small lever next to the power levers on the left side of the centre console (Figure 9). A green 'OPN' caption is displayed on the lower right area of the central Engine Indication and Crew Alerting System<sup>2</sup> (EICAS) screen when any of the surfaces are open.

The accident arose as a result of the inadvertent selection of the Emergency/Parking brake instead of the speed brake. The levers are of similar shape and sited close to each other but with a different appearance and mode of action. There is also a BRAKE ON indicator light. These risk controls proved ineffective in preventing the inadvertent selection of the Emergency/parking brake both on this occasion and on at least two previous occasions. Once the parking brake had been set there were opportunities to detect and correct the error, but a busy flight deck environment together with a high workload contributed to it going unnoticed.

The operator introduced a revision to the Landing Checklist in the Operations Manual which requires the handling pilot to confirm the parking brake is OFF.

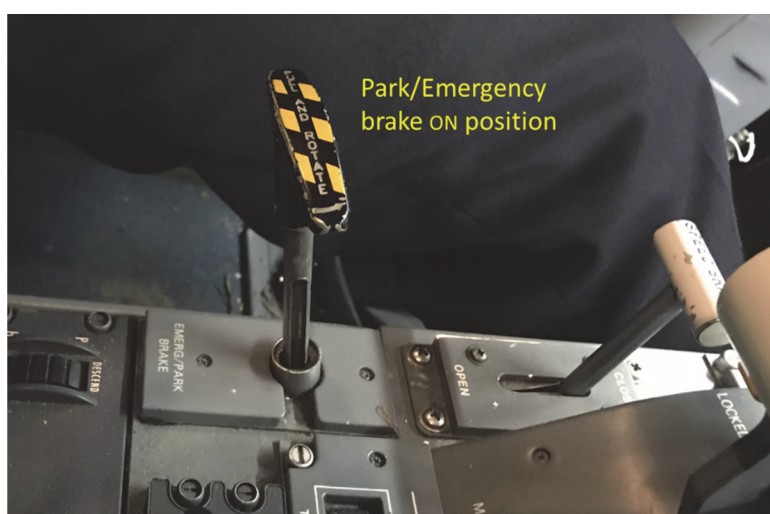
**Figure 10**

Apart from the extended position of the parking brake handle when the parking brake is applied, the only other brake condition indication is on a small illuminated indicator on the instrument panel marked BRAKE ON. Figure 9 shows the location of the controls on the centre console and Figure 10 shows the parking brake in the ON condition.

Figure 10 shows the left seat in its rearwards position. When the seat is towards its fully forward position the parking brake handle is out of the seat occupant's direct line of sight and is likely to be operated by 'feel'. When the aircraft is on the ground with the parking brake set to ON there is a warning feature built into the system which displays an EICAS caution NO TAKEOFF CONFIG if the power levers are advanced to 60%. This system does not apply when the aircraft is airborne.

Once the parking brake has been inadvertently set, the extended position of the handle and the BRAKE ON indication light may alert crews to the condition. In this event, however, neither the extended handle nor the partially lit BRAKE ON light were noticed.

On G-CKAG, the BRAKE ON light is situated out of the normal field of view of a pilot in the right seat. For some other variants of the type it is situated higher on the centre panel, next to the landing gear selector lever and closer to the normal field of view, thereby providing an additional opportunity to notice that the light is on when lowering the landing gear. Although this is likely to be a more effective position, the aircraft in one of the two previous events recorded had this configuration. Thus, there was insufficient evidence to draw conclusions about the effectiveness of the different panel layouts in preventing this type of accident.
