Investigation Report

Type of Occurrence:	Serious Incident
Date:	3 November 2011
Location:	Munich
Aircraft:	Transport aircraft
Manufacturer / Model:	Boeing / B 777-300 ER
Injuries to Persons:	None
Damage:	None
Other Damage:	Crop damage
State File Number:	BFU EX010-11

Synopsis

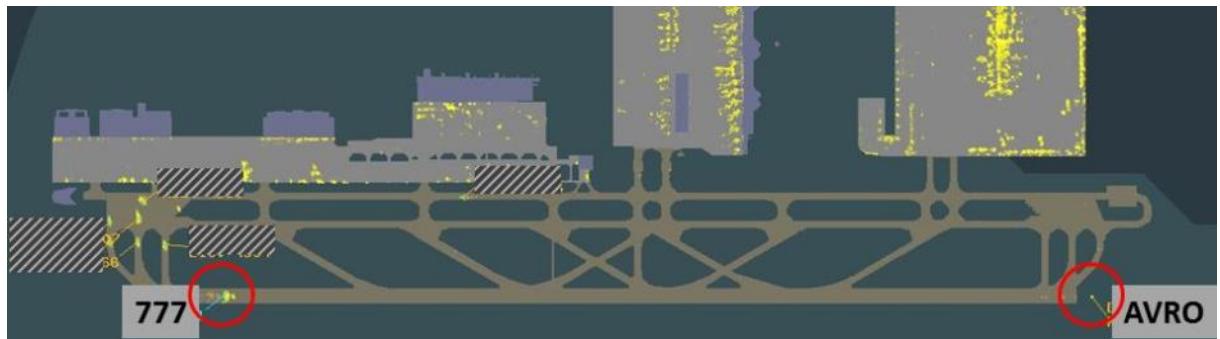
Position of the BAE 146-RJ85 at the time the B 777 touched down

At 1207:53 hrs as the B 777 was about 2.9 NM ahead of the threshold of runway 08R, one aircraft each was at the CAT II/III holding position of taxiways B1, B2 and B3 and two aircraft were farther north of them. An additional airplane taxied west on taxiway S. At the same time a BAE 146-RJ85 taxied over the high speed taxiway B4 onto runway 08R and started the take-off run about 20 seconds later. At that time the B 777 was about 2.1 NM prior to the runway threshold in an altitude of about 700 ft AMSL. At 1209:09 hrs the B 777 crossed the threshold of runway 08R in an altitude of 50 ft. Six seconds later the BAE 146-RJ85 overflew the end of the runway in about 380 ft. At 1209:29 hrs the BAE 146-RJ85 overflew the ILS localizer antenna of runway 08R in 740 ft.

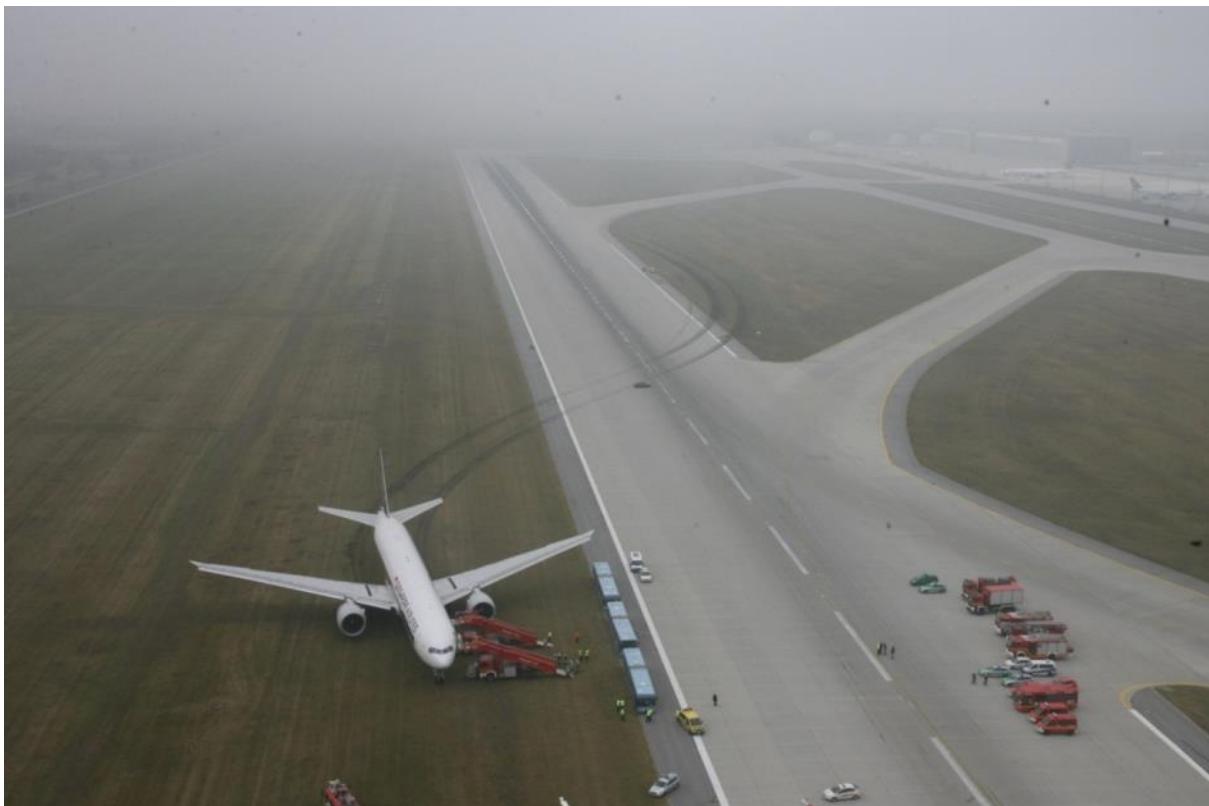
Aircraft position after complete stop

The autopilot was still engaged as the airplane moved toward the left runway edge and veered off the runway with a speed of 123 kt (KIAS) about 944 m beyond the threshold in the area of taxiway B4. For about 400 m the airplane rolled through the grass north of runway 08R in a slightly curved right hand turn. The largest lateral deviation from the runway was reached at about 1,242 m beyond the threshold; speed was 109 kt KIAS. Because of the system design the autopilot disengaged due to crew inputs via the rudder pedals. The airplane turned right by about 40°, re-entered the runway close to the intersection with taxiway B6, about 1,566 m beyond the threshold. The aircraft crossed the runway with a heading of about 120°. Speed was still 71 kt KIAS. The airplane veered off the runway again, turned left by about 40°, and came to a stop in the grass south of and parallel to runway 08R. At 1209:09 hrs the airplane crossed the threshold; at 1209:51 hrs it came to a stop.

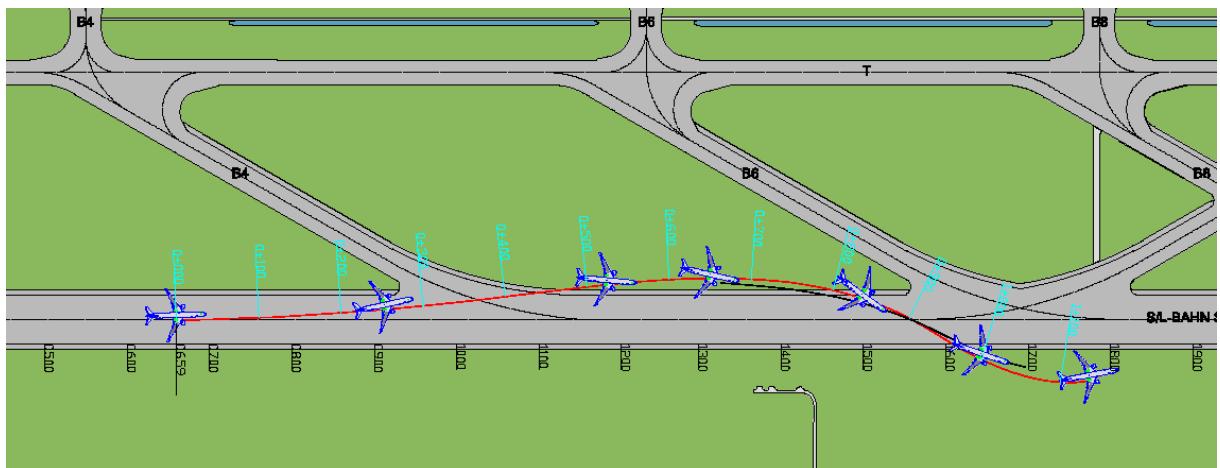
Rolling traces of the airplane

The first visible traces were determined about 659 m after the beginning of runway 08R. The main landing gears and the nose wheel landing gear left distinct tyre marks from the moment the airplane veered off the runway at taxiway B4, to the crossing of the runway, until it came to rest on the south side of the runway. After about 1,242 m the airplane reached, with about 40 m, the largest lateral deviation to the north of the runway centre line. At 1,740 m the largest lateral deviation to the south was about 60 m. The tyre tracks were up to 15 cm deep. After about 1,780 m beyond the threshold of runway 08R the airplane came to a stop on the grass.

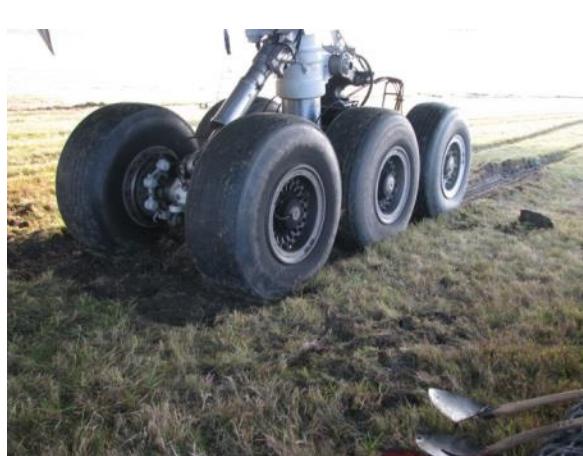
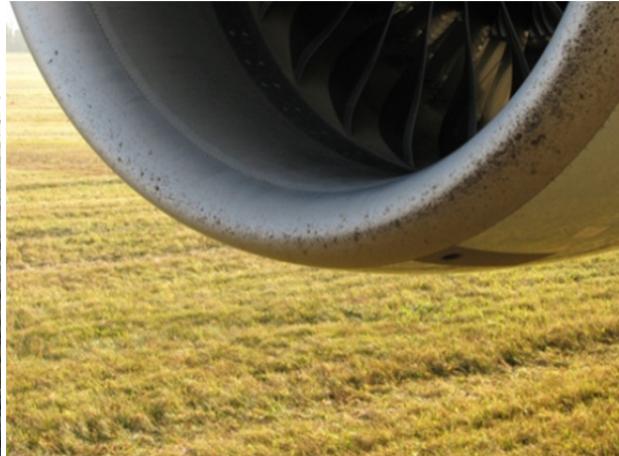
Right main landing gear and contamination on the right engine

There were no damages on the airplane safe for some grass and dirt on the right engine and the landing gear.

Because the shoulders of the runway had been paved with macadam and it had not rained in quite some time, the wheels of the airplane did not sink in too much and the landing gear was not damaged.
