Serious incident

to Dornier 328

registered **HB-AEO** and operated by SkyWork
and to Embraer 190

registered **PH-EXB** and operated by KLM Cityhopper
on 7 March 2016
at Bâle-Mulhouse

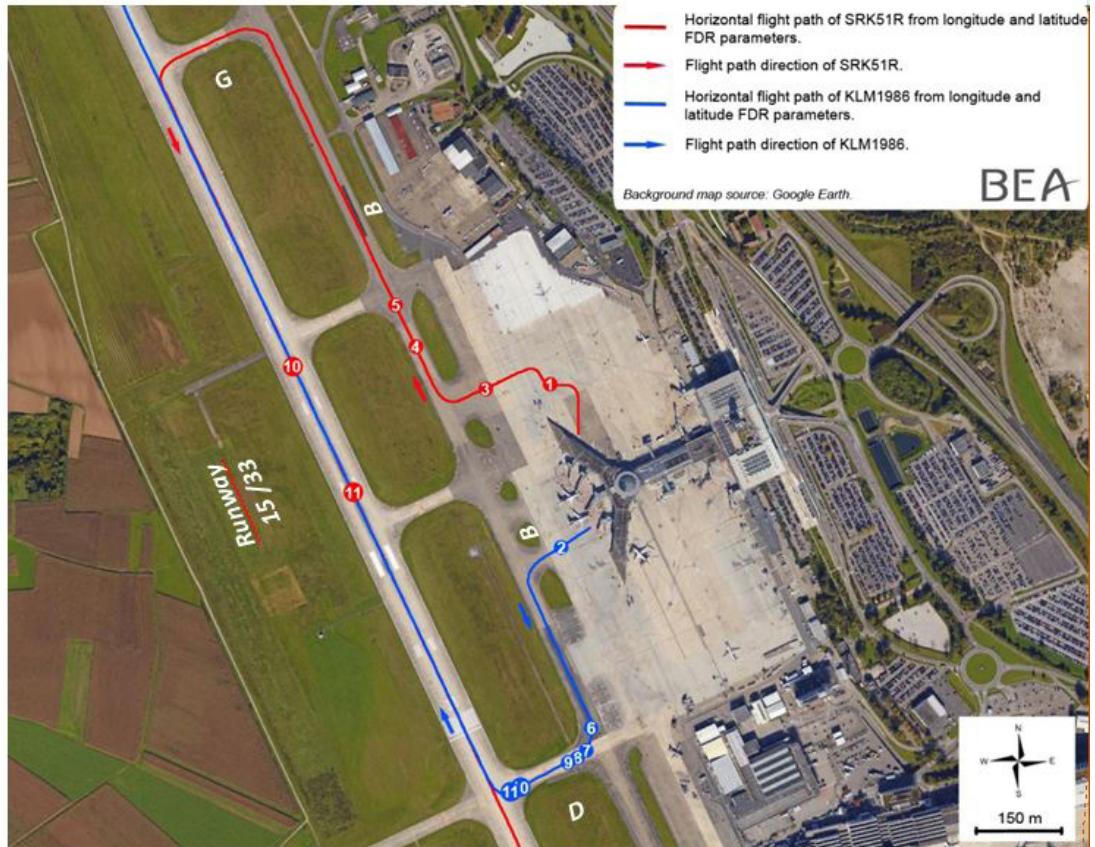
Figure 1: Horizontal flight paths of SRK51R and KLM1986

⁽⁵⁾Points 1 to 11 are shown in Fig. 1 below.

The vertical separation between the two aircraft was 380 ft at the time of crossing.

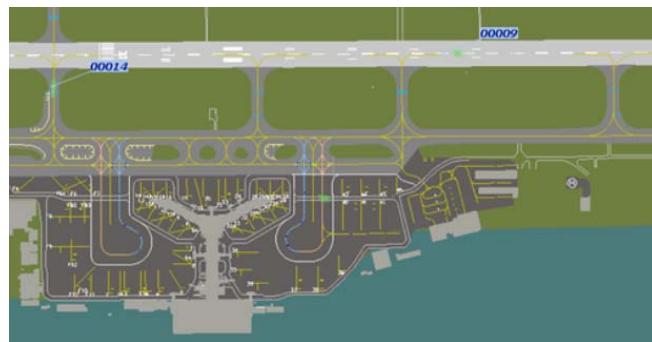
Figure 3: Excerpt from replay of event: SRK51R (00009) is taxiing on runway 15 and KLM1986 (00014) is on the DELTA taxiway
