**SERIOUS INCIDENT**

| <b>Aircraft Type and Registration:</b> | Boeing 787-9, G-CKWC | |
| <b>Location:</b> | London Gatwick Airport | |

**Synopsis**

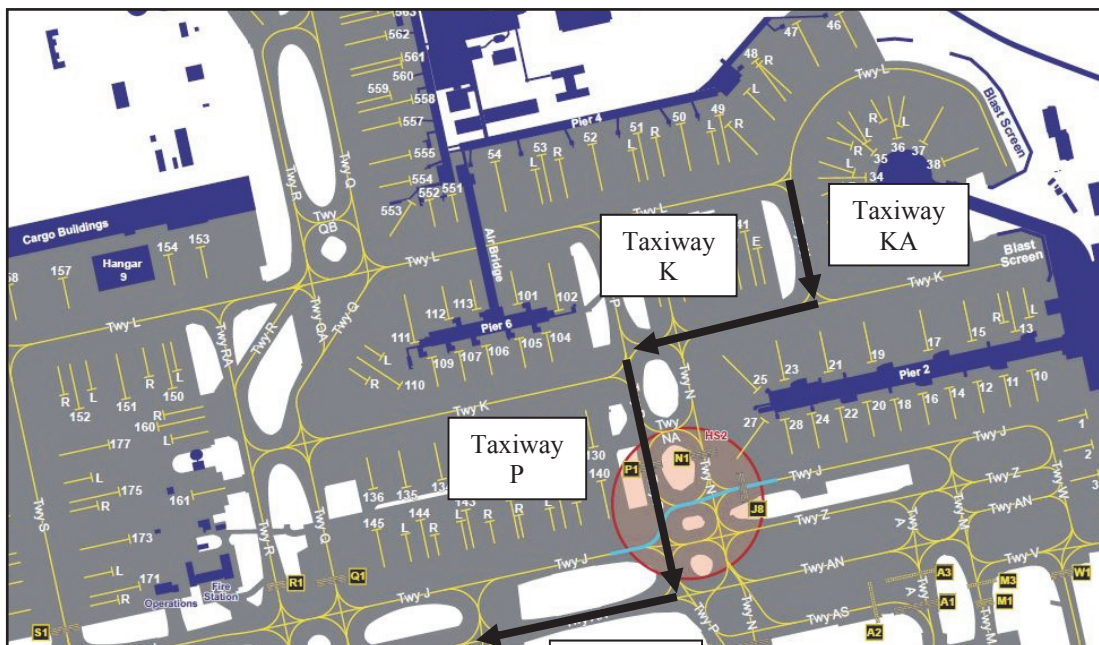
**Figure 1**  
G-CKWC taxiway routing at LGW

At 2137 hrs, the aircraft pushed back from its stand at LGW. The aircraft taxied out for Runway 26R via Taxiways KA, K to hold at Holding Point P1. At 2156 hrs, the aircraft was given a conditional clearance to line up on Runway 26R after a landing A320. At 2158 hrs the aircraft crossed the holding point at P1 and taxied via P and AN to the runway. Whilst on Taxiway AN, before entering the runway, the crew received their takeoff clearance. Figure 1 shows the taxi routing taken by G-CKWC.

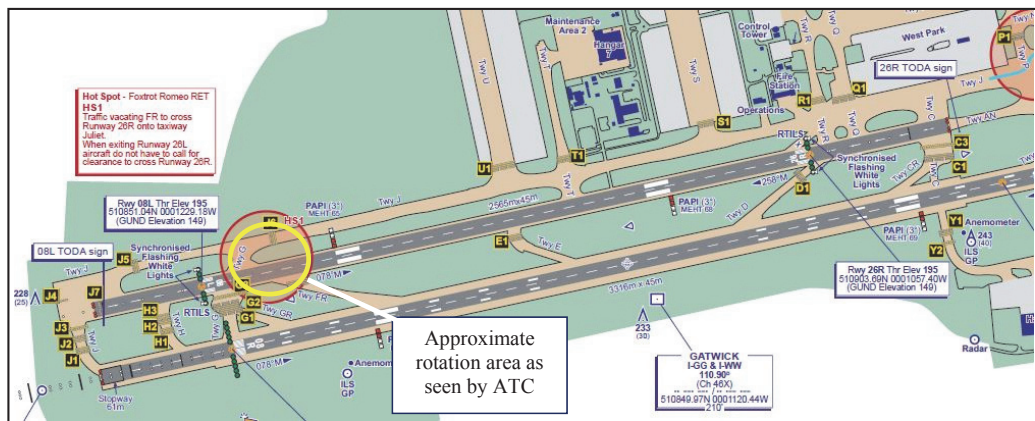
Figure 2

The crew elected to perform a rolling takeoff. The tower controller noted that the aircraft did not appear to put on power or accelerate until at the Runway 26R landing threshold. The controller also saw that the aircraft did not appear to rotate until approximately abeam Taxiway FR as shown in Figure 2. The crew later recalled that there was not much runway remaining at lift-off.

Full length of Runway 26R

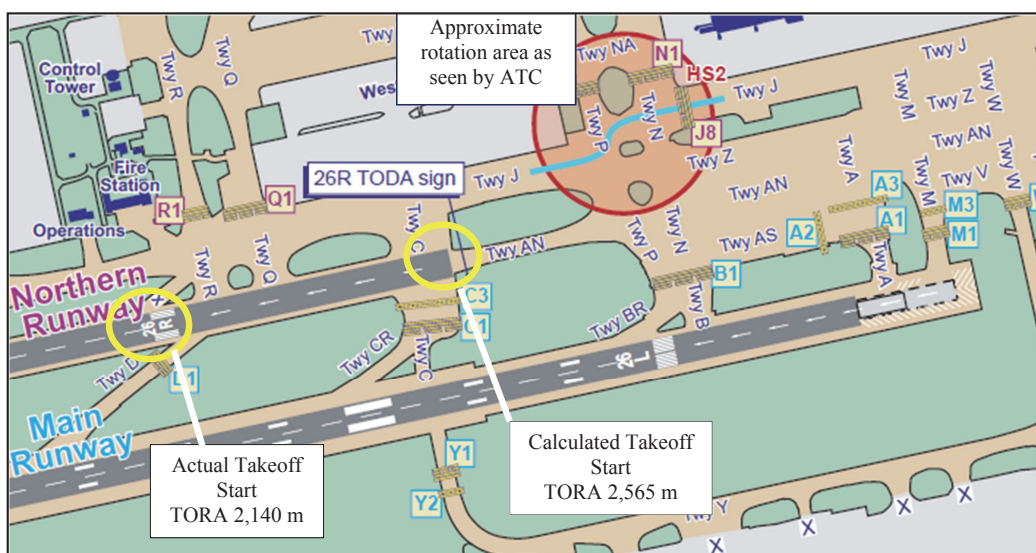
Figure 3 shows where the aircraft takeoff performance was calculated from (TORA<sup>1</sup> 2,565 m) and where the takeoff actually commenced (TORA 2,140 m).

The calculated and actual takeoff start points

From the position of the displaced landing threshold, the ASDA is 2,156 m. Had the aircraft suffered an engine failure just before  $V_1$  and had the crew decided to stop, a runway overrun could have occurred. A calculation by the operator indicated that the aircraft was around 12,000 kg too heavy for the distance available. The airfield boundary fence is 2,250 m from the landing threshold of Runway 26R where the aircraft began its takeoff roll.

The operator also completed an analysis of the performance in the case of an engine failure at  $V_1$ , followed by a continued takeoff. This showed that the accelerate-go<sup>6</sup> distance was 2,354 m. From the displaced threshold of Runway 26R, the TODA is 2,295 m. The aircraft would have failed to meet the regulated takeoff performance criteria in both cases.

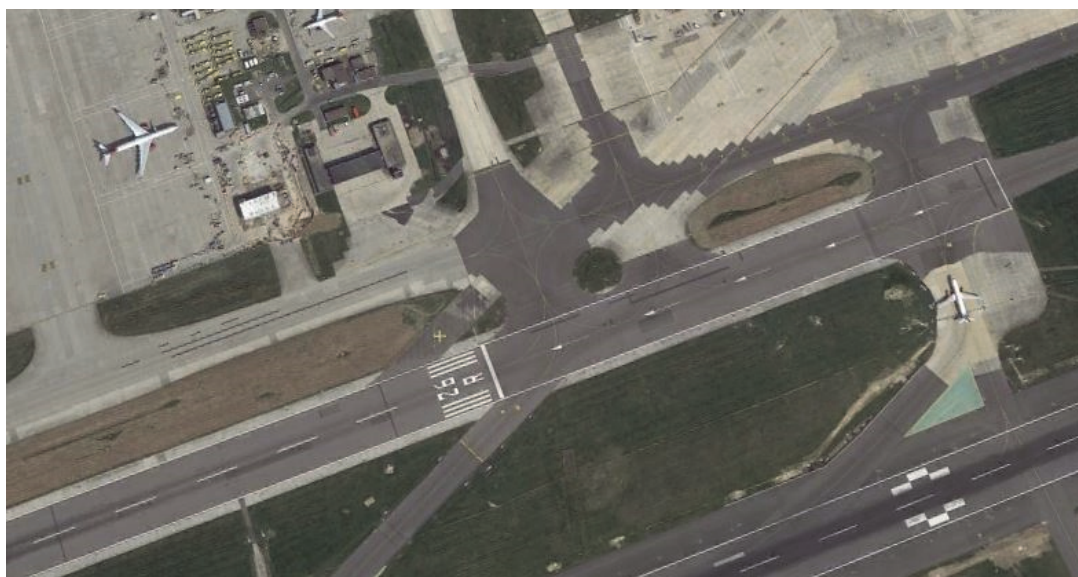
**Figure 4**

The Runway 26R landing threshold is displaced by 417 m from the start of the TORA due to obstacle clearance requirements for the approach. Takeoffs should be commenced from the beginning of the runway which is indicated by a white line. The start of the runway also has large centreline arrows showing the presence of a displaced landing threshold. The runway markings are shown at Figure 4.

Image showing the runway markings © Google Earth

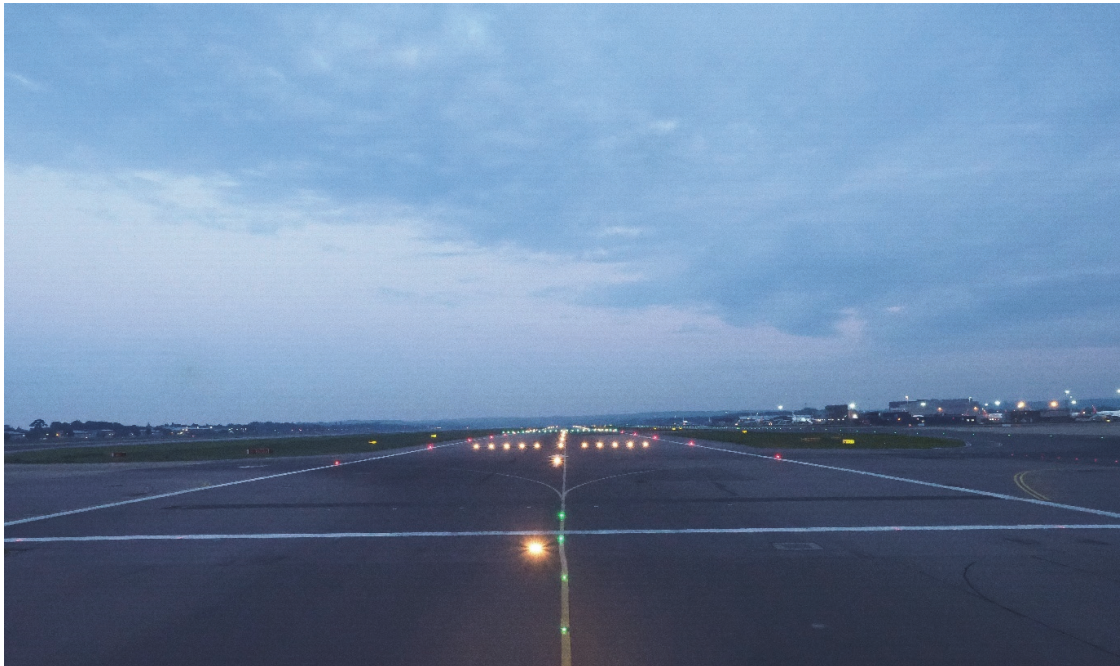
**Figure 5**

Runway 26R/08L has red edge lighting for the part of the runway before the displaced landing threshold and no centreline lights. This configuration is compliant with relevant regulations. The edge lights revert to white once past the displaced landing threshold. The area between the beginning of Runway 26R and the displaced threshold contains one bar and some centre lights of the approach lighting system. The displaced threshold has green threshold lights as well as a set of Runway Threshold Identification Lights (RTILS). RTILS consist of two synchronised white flashing lights, one at each end of the green threshold bar. The RTILS are angled for landing traffic and should not be visible to aircraft on the ground

at the beginning of the runway. Figure 5 shows the markings and lighting on Runway 26R shown from before the beginning of the runway.

View of the markings and lighting Runway 26R  
(Photo courtesy of Gatwick Airport Limited)

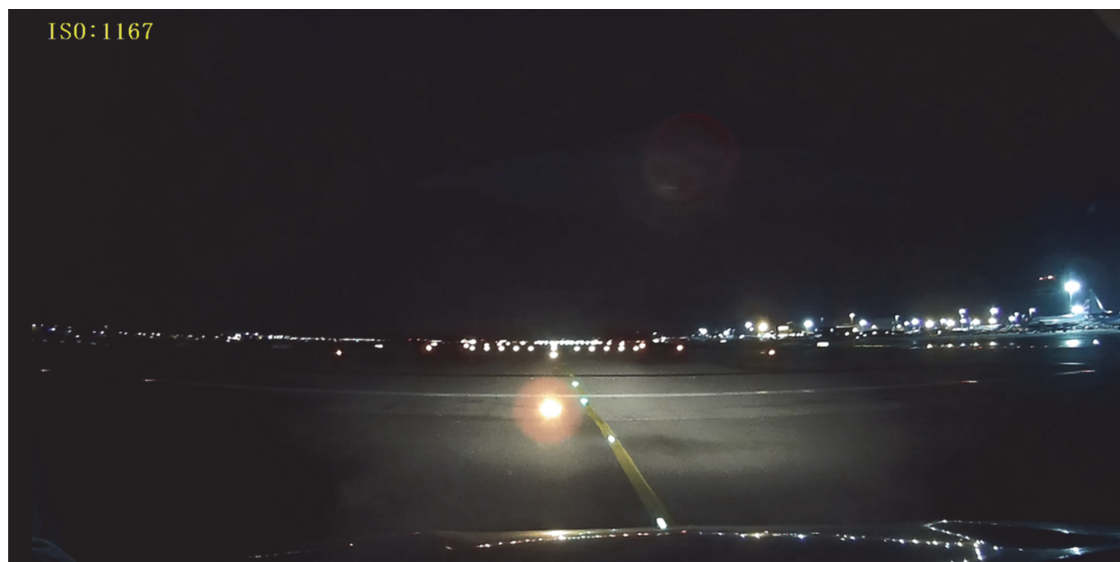
**Figure 6**

Figure 6 shows the same view in darkness.

Start of Runway 26R at night  
(Photo courtesy of Gatwick Airport Limited)

When asked specifically about what they saw at the beginning of Runway 26R the commander said that neither of the pilots could recall seeing anything that indicated they were in the wrong place nor did they see the TODA sign. The routing along Taxiway AN was dark and “the runway looked pitch black and the only thing we saw was the green lights”. He agreed that the crew were aware of the displaced threshold on Runway 26R but did not see the markings indicating the beginning of the runway.

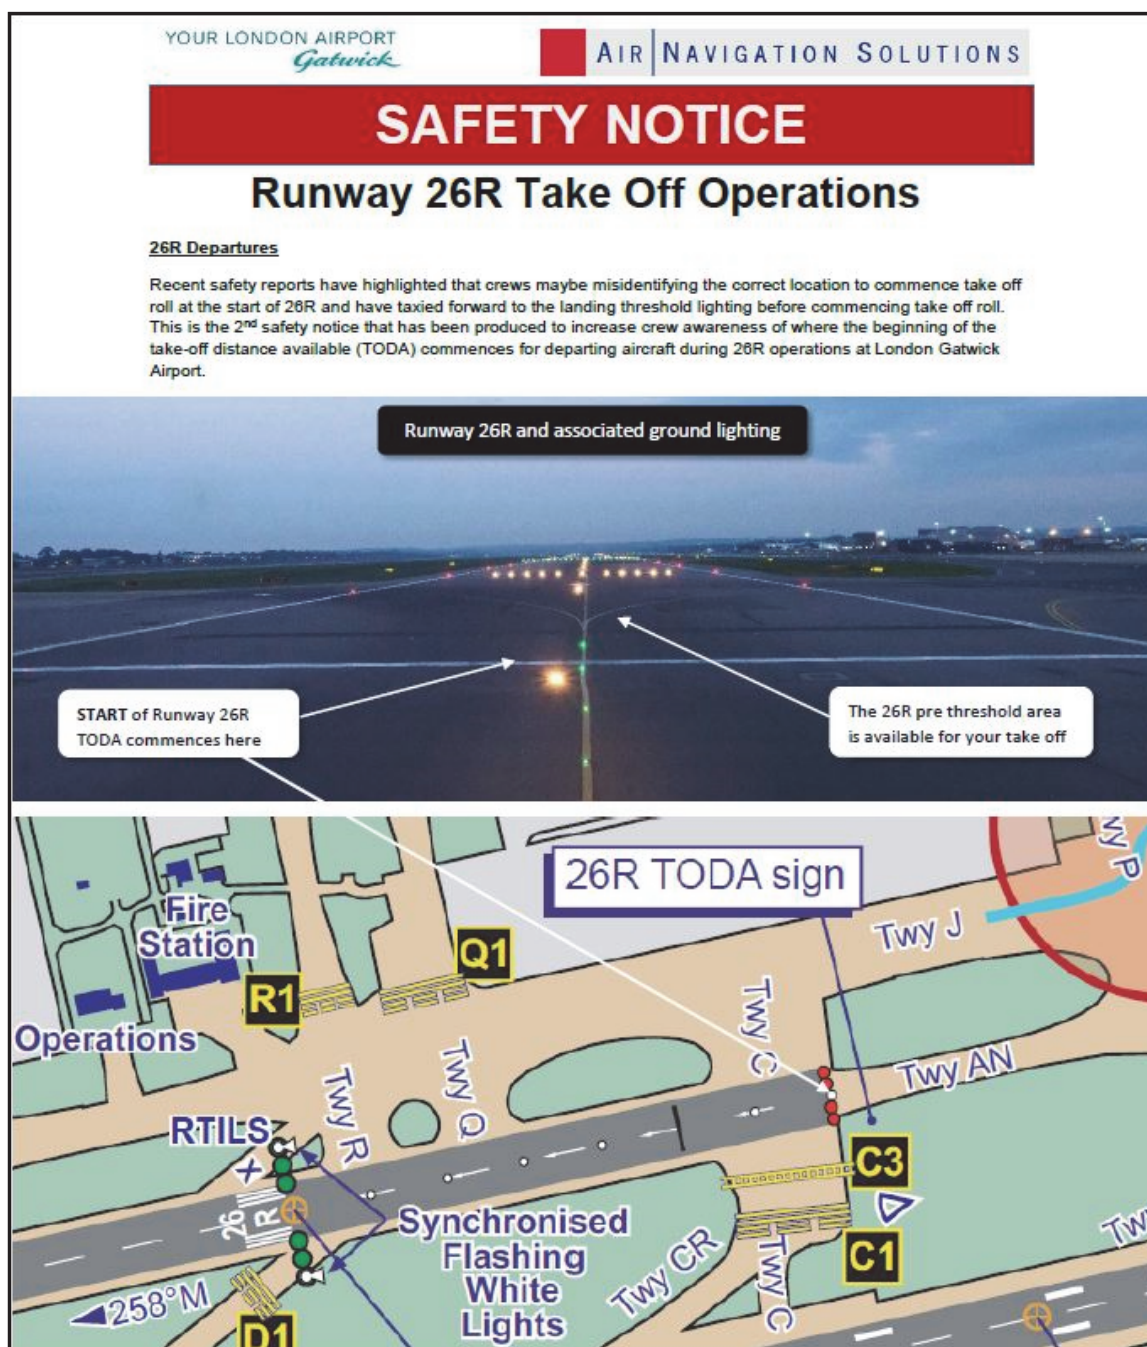
Figure 7

Safety Notice issued by Gatwick and the ANSP

- A Safety Notice was published on 13 April 2018 to provide further information for pilots on the location on Runway 26R from where they can commence their takeoff. This Safety Notice was subsequently amended and reissued to include a photograph with the airfield lighting illuminated. This amended notice is shown at Figure 7.

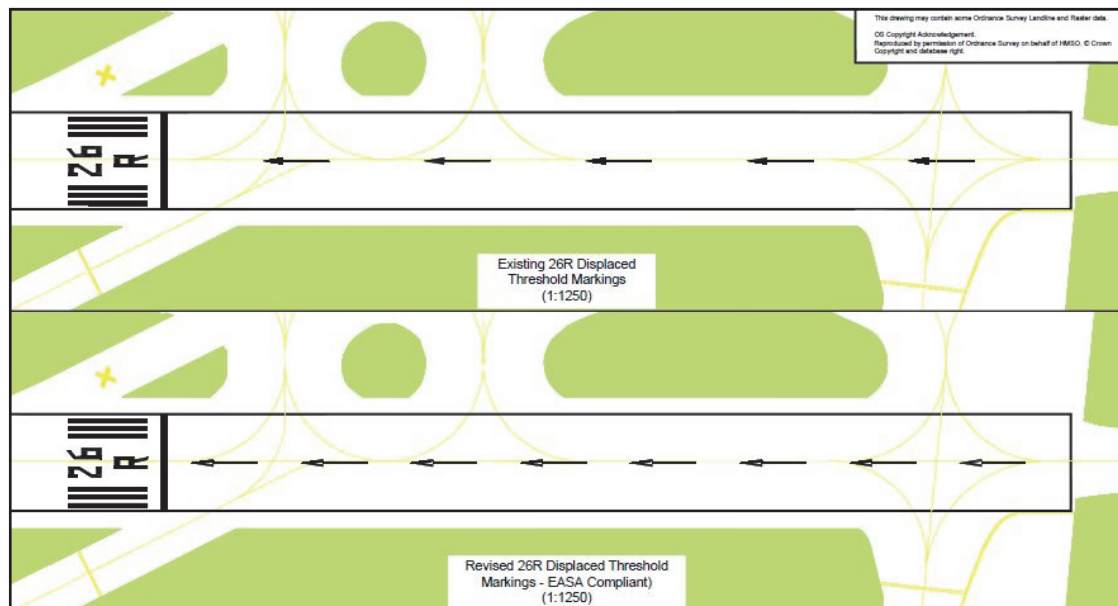
**Figure 8**

Revised markings Runway 26R

- A review was undertaken of the markings on the standby runway before the displaced landing threshold on both 08L and 26R which revealed that they were not EASA compliant. The airport planned remedial work for September 2018 which would increase the number of arrows painted on the centreline before the displaced threshold as shown at Figure 8.
