**KOMITE NASIONAL KESELAMATAN TRANSPORTASI  
REPUBLIC OF INDONESIA**

### **Aircraft Accident Investigation Report**

**Wings Abadi Airlines**

**ATR 72-212A (600 version); PK-WGK**

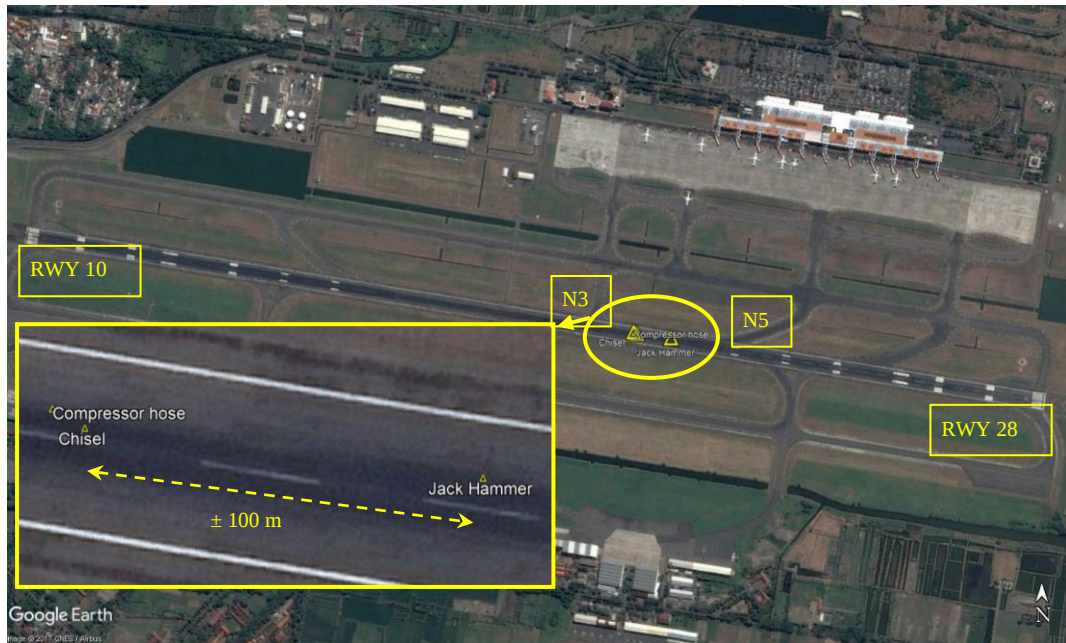
**Figure 1: Estimated location of the objects on the runway**

The estimated location of the compressor hose, chisel and jack hammer on the runway is shown in the figure below.

15. ARFF personnel entered the runway and found objects around the runway centerline on the intersection with taxiway N5. The objects consisted of compressor hose (about 10 meters long), jack hammer (about 60 cm long) and chisel (about 4.5 kg).

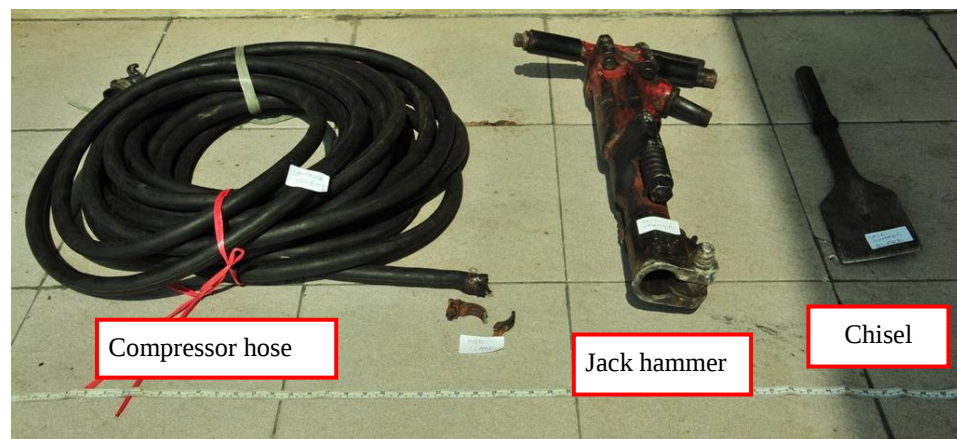
**Figure 2: Objects found on the runway**

At 0623 LT, the controller decided to close the runway operation and instructed the ARFF personnel to enter and inspect the runway. The ARFF personnel found compressor hose (about 10 meters long), jack hammer (about 60 cm long) and chisel (about 4.5 kg) on the runway.

The objects found on the runway were on dark color and found on dark surface which was runway asphalt that also covered by rubber deposit. These conditions had made the objects with significant size, were not clearly visible during the dark time. Without proper procedure or system to ensure all equipment had been used were completely collected, might have made the equipment had left on the runway.

The investigation did not find procedure for runway inspection following runway maintenance or construction work on movement area including the checklist of tool and equipment completeness before and after the runway maintenance. KNKT recommend to develop procedure of inspection following runway maintenance or construction work on movement area.

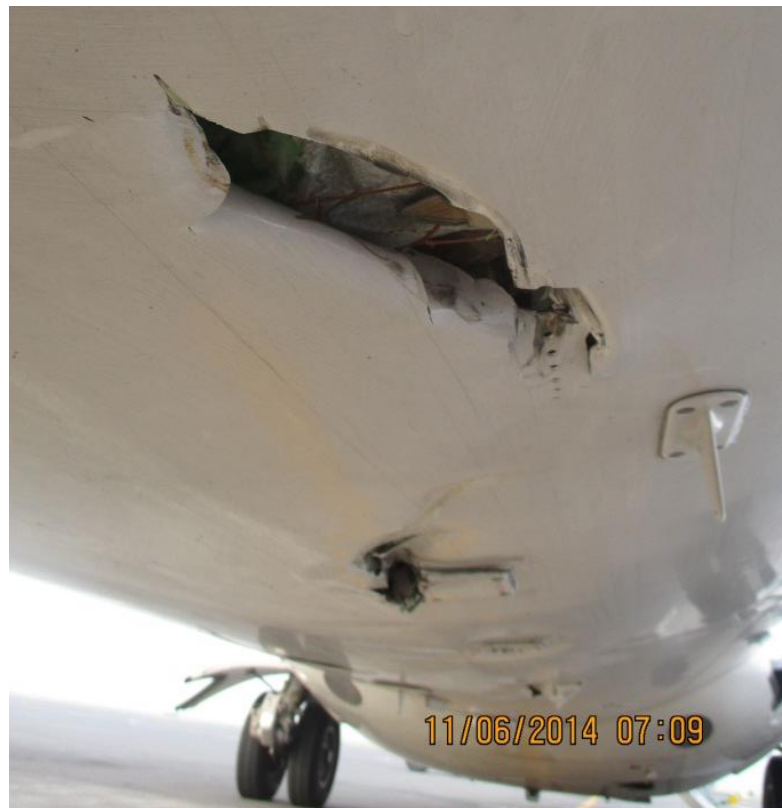
**Figure 3: Damages found on the lower fuselage**

After the IW 1861 aircraft parked on the apron, the aircraft engineer performed walk around inspection and found eight holes at the aircraft lower fuselage between the nose wheel and the main wheel bay. The aircraft grounded for further inspection and repair. No one injured in this accident.

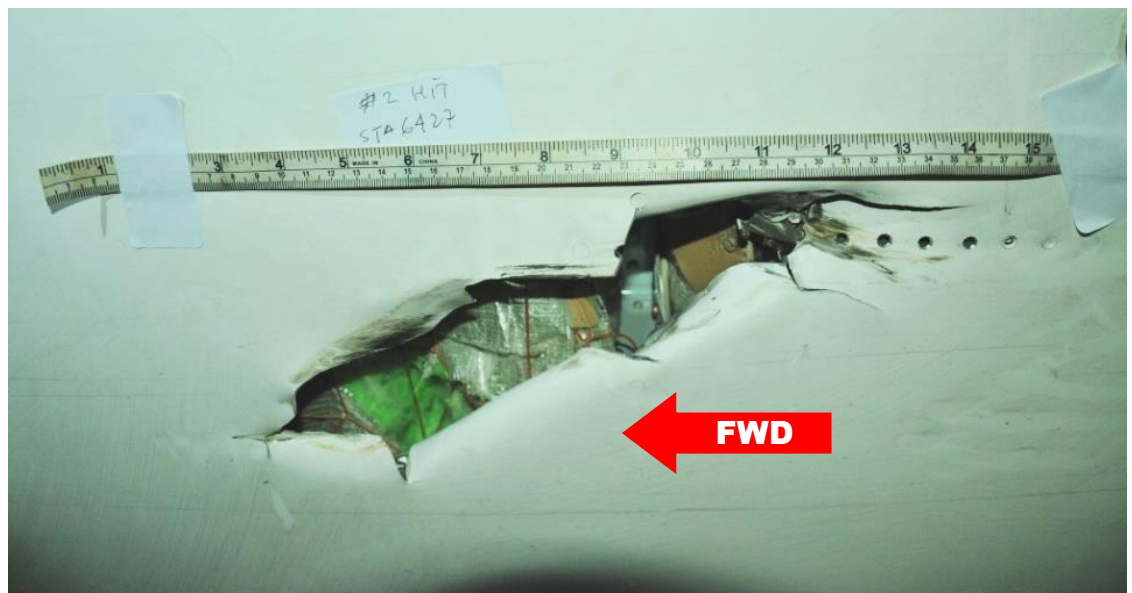
**Figure 4: The hole on STA 6427**

1. at body station (STA)<sup>4</sup> 6427, a hole with dimension of 33 cm x 15 cm,
2. at STA 6888, a hole with dimension of 44 cm x 19 cm,
3. at STA 7684, a hole with dimension of 29 cm x 15 cm,
4. at STA 9020, a hole with dimension of 49 cm x 15 cm,
5. at STA 10604, a hole with dimension of 53 cm x 22 cm,
6. at STA 12268, a hole with dimension of 26 cm x 14 cm, honeycomb panel and gondola support structure damage,
7. at STA 13322, a hole with dimension of 30 cm x 40 cm, honeycomb panel, gondola support structure, refrigeration condenser and pipe damage,
8. at STA 15589, a hole with dimension of 34 cm x 50 cm, honeycomb panel and wheel well structure damage.
