Air Accident Investigation Unit

SYNOPTIC REPORT

SERIOUS INCIDENT

ATR 72-212A, EI-FCY

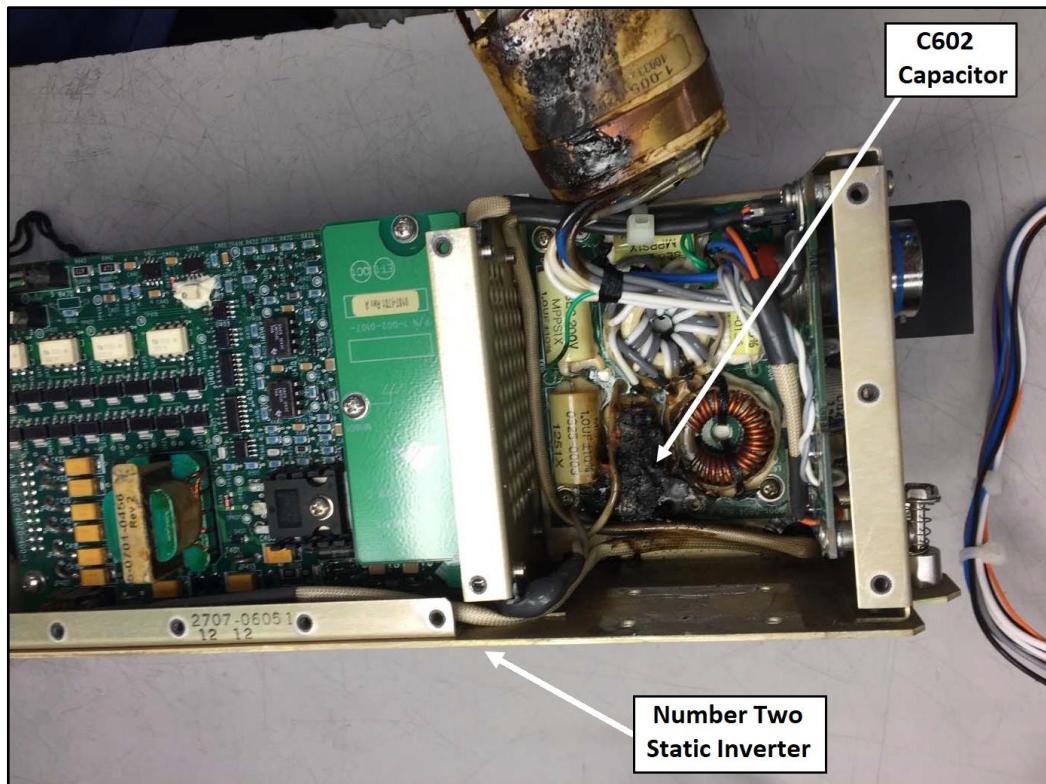
The OEM conducted an engineering examination of the failed static inverter. The OEM produced a Failure Analysis Report which found that the failure of the number two static inverter and associated smoke and odour was caused by a failure of the C602 (1-001-0306-0136) capacitor within the number two static inverter (**Photo No. 1**).

Photo No. 1: Static Inverter showing location of failed capacitor (C602).

Workshop examination of the number 2 static inverter showed that a C602 capacitor within the unit had failed in a manner that resulted in electrical smoke being emitted from the unit.

Failure of the C602 (1-001-0306-0136) capacitor within the number two static inverter.

'Product improvement to the Static Inverter upgrades the unit from "MOD E" to "MOD F" which replaces capacitors C601 through C605 with new capacitors that have had additional quality screening (i.e. burn-in)'.
