# Air Accident Investigation Sector

### - Final Report -

AAIS Case N°: AIFN/0011/2016

# Nose Gear Tire Tread Separation and Number 1 Engine Failure

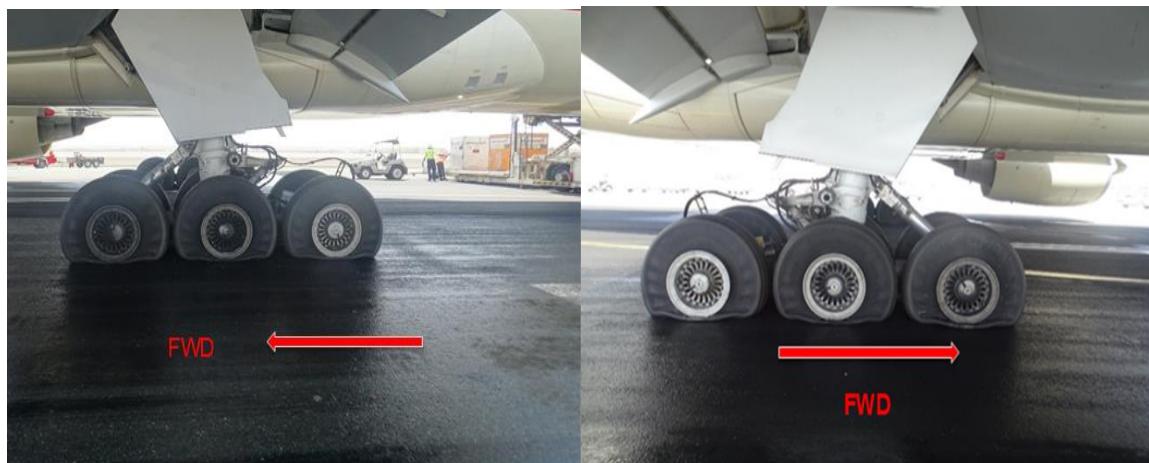
Figure 3. MLG wheels (LH & RH) deflated

As the Aircraft was overweight, the rollout after landing was prolonged causing high brake temperatures. The Aircraft main landing gear (MLG) thermal fuses melted due to the high brake temperatures, and all of the MLG tires deflated (figure 3). Due to the deflated MLG tires, the Aircraft remained stationary on the runway. Both nose gear tires maintained their pressure. The No.1 nose wheel tire had shed its tread. (Figure 4).

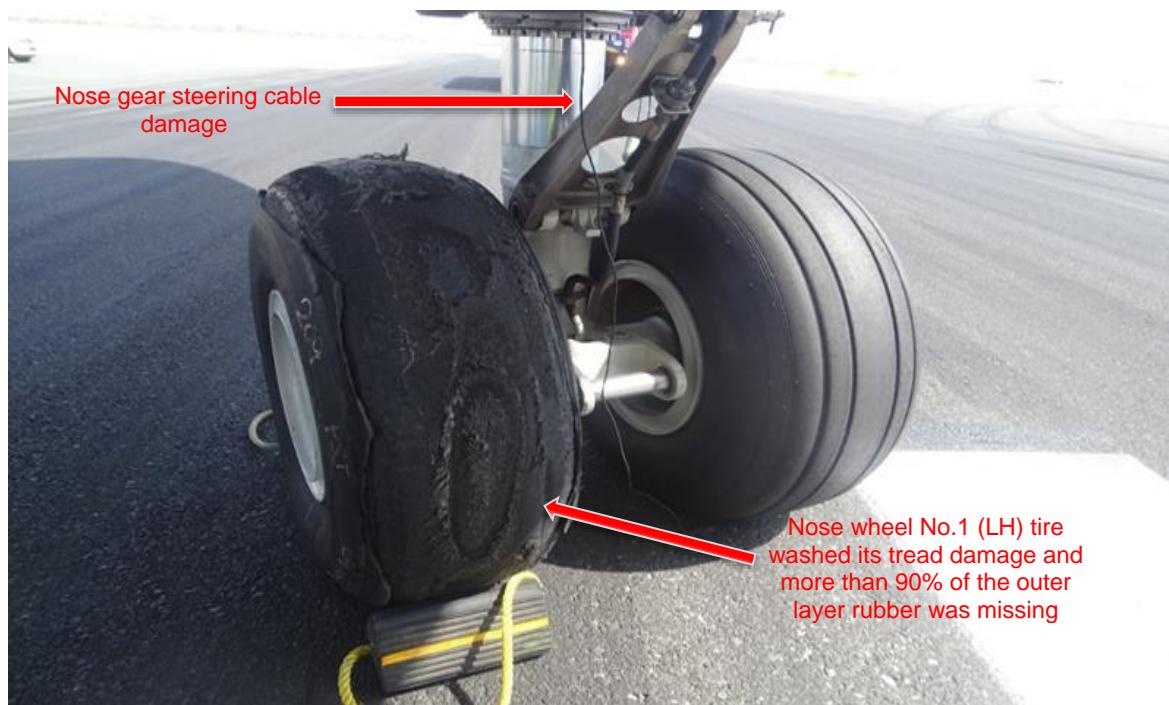
Figure 4. No.1 nose wheel tire and steering cable damage

More than 90% of the outer layer of the No.1 nose wheel tire tread had separated and disintegrated (figure 4). Following the landing, all of the main gear tires were found to be deflated (figures 3). The nose wheel tires remained inflated. There was no damage to the main gear wheel hubs.

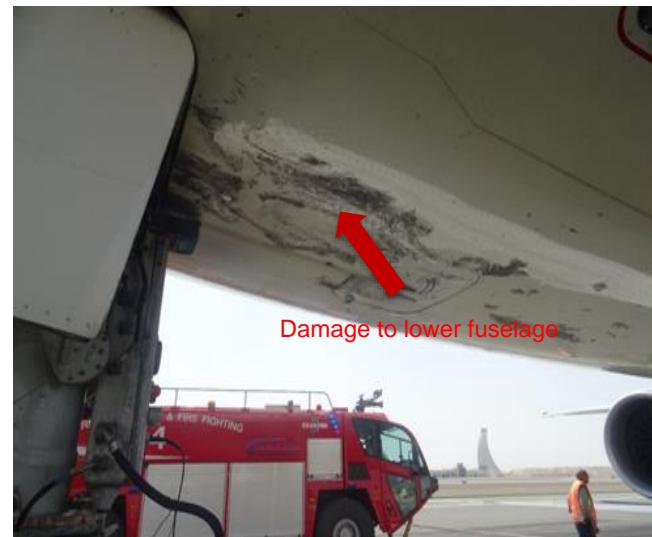
Figure 5. Damage to lower fuselage aft of the NLG bay

The Aircraft suffered damage to the lower fuselage, aft of the NLG bay (figure 5). The No.1 engine fan blades and engine inlet sustained damage (figure 6) and the nose gear steering cable was damaged (figure 4). In addition, there was evidence of tire debris impact on the inboard fan cowling of the No.2 engine.

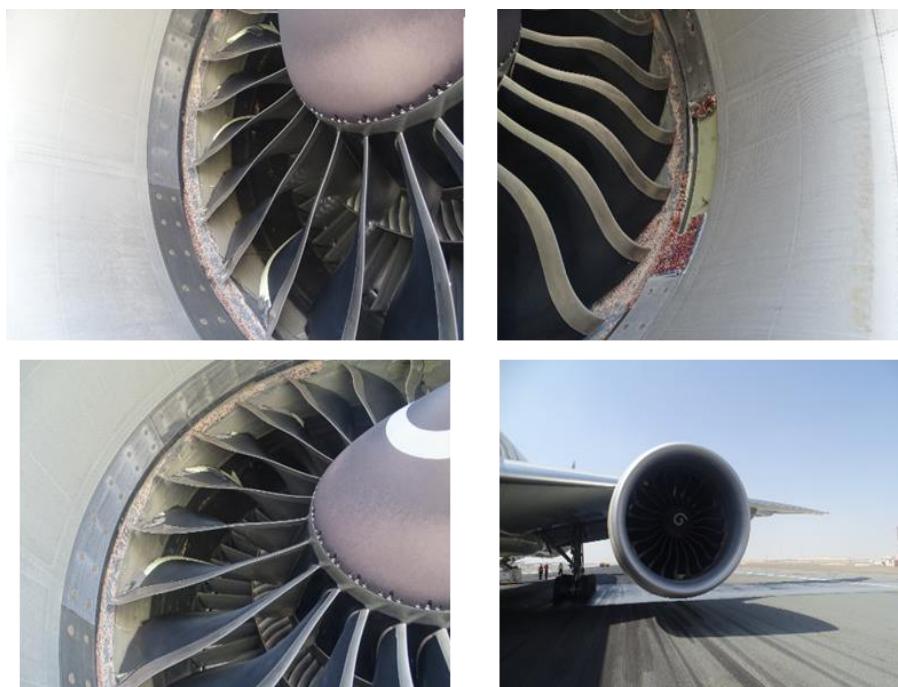
Figure 6. LH engine fan blades and Inlet damage

The No.1 engine suffered foreign object damage (FOD), following ingestion of liberated tread which subsequently caused an uncommanded in-flight shutdown (IFSD) shortly after takeoff.

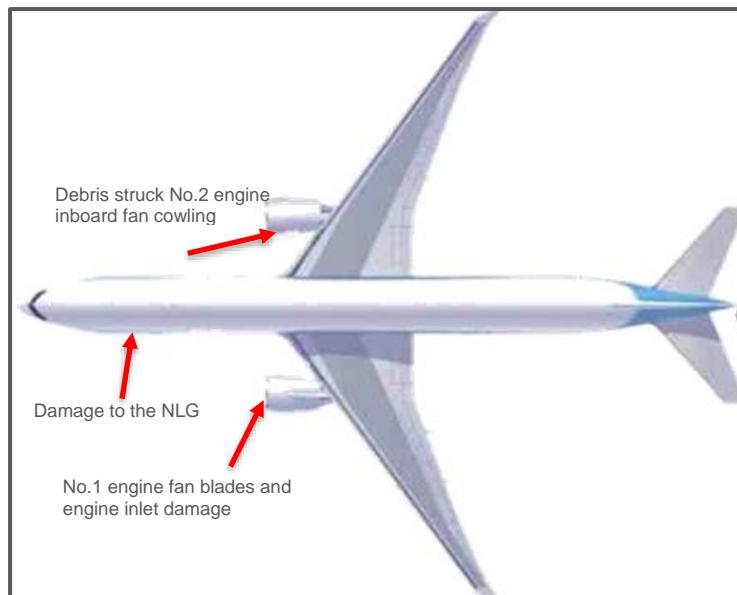
**Figure 7.** Locations of damages resulting from the No.1 nose wheel tire tread separation

On separation of the No.1 nose wheel tire tread, the tread broke up and pieces impacted several areas of the Aircraft. Tire debris struck the lower fuselage aft of the NLG bay, the No.1 engine, and the inboard fan cowling of the No.2 engine (figure 7).

The No.2 engine inboard fan cowling was struck by tire debris, but the cowling was not damaged. No tire debris was ingested by the No.2 engine.

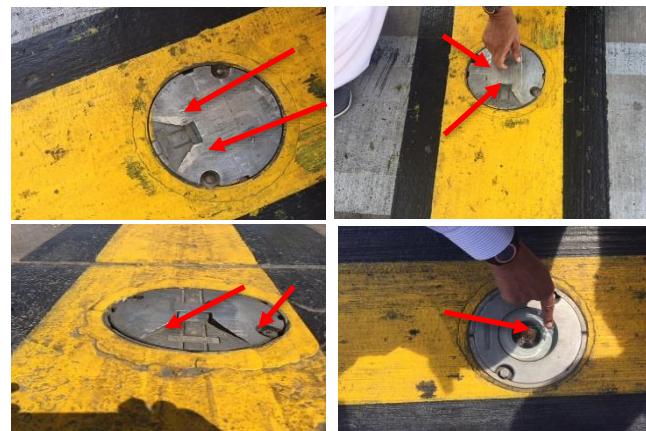
Figure 8. Types of lights in the parking bays (OMAA)  
[Arrows indicate sharp edges]

The Investigation found some of these lights with sharp edges (figure 8) which had the potential to cause damage to aircraft tires.

A post-Incident inspection performed by AAIS noted that many stand centerline lights had sharp edges.

- (a) The reason for the sharp edges to the lights near the stands was investigated. It was identified that the towbarless tugs, while disengaging from aircraft, caused damage to the lights.
- (b) Once the main reason for the sharp edges was identified, training to the tug operators was undertaken to educate them about the subject, and advise them not to disengage the tugs near the lights.

conduct regular inspections and audits on the airport ground lights fittings to ensure that they remain free of sharp edges or loose bolts that could have the potential to cause damage to aircraft tires.

implement mitigations to prevent damage to airport ground lights caused by towbarless tugs.

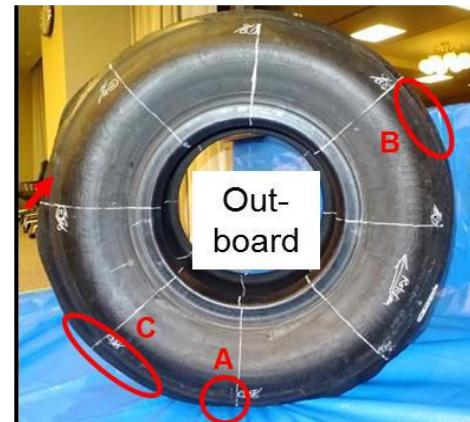
For the purpose of testing, the manufacturer identified three relevant areas of the damaged tire; A, B and C (figure 9).

Figure 9. Locations of zones A, B and C

Striation in the shoulder area of the tire casing was observed in three areas; zones A, B and C. Also, characteristic damage due to contact with a sharp object was observed in the crown area (figures 9, 10 and 11).

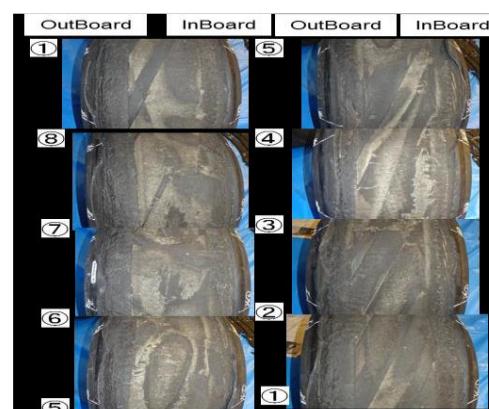
- All of the tread ribs, cut-protector and part casing belt cords were detached from the tire casing (figure 10).
- About 80% of the total tread debris was collected for examination purposes (figure 11).
- Inner liner, both sidewalls and both bead areas were in a normal condition (figure 12 is showing the wheel structure).

Figure 10. No.1 nose wheel tire casing surface

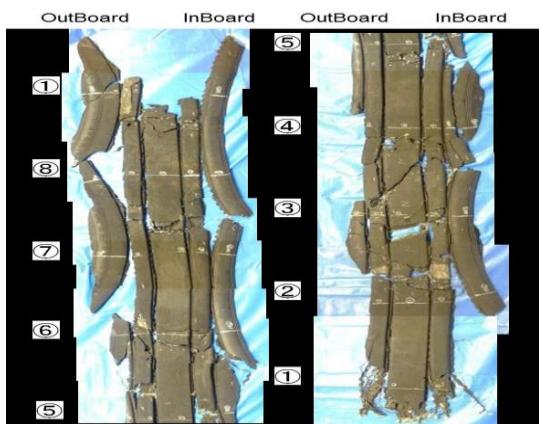
Figure 11. Collected detached tread pieces from No. 1 NLG tire

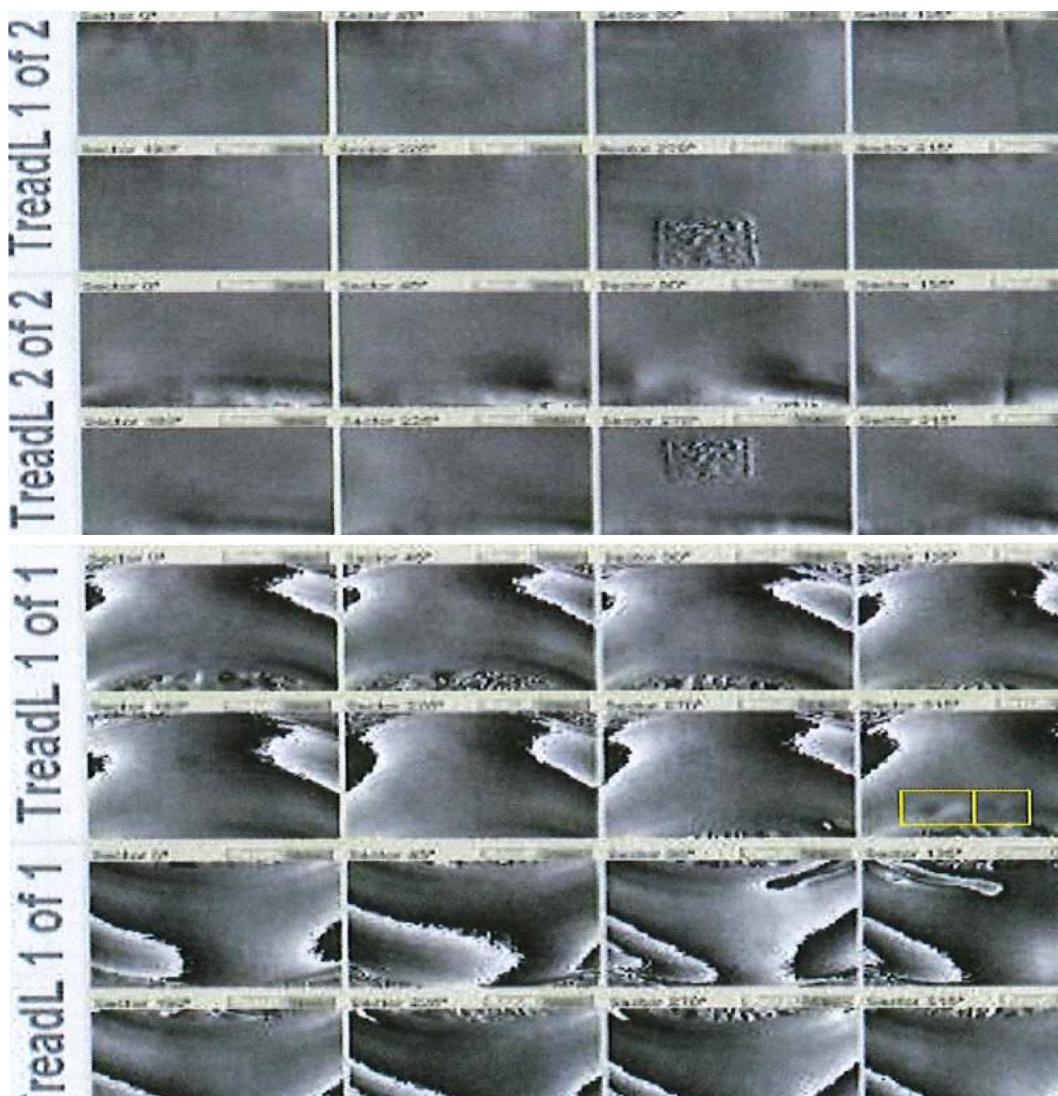
Shearography inspection report of the damage casing indicated that there was no anomaly in the crown area of the casing where the tread rubber detached, and there were two small areas of trapped air in the bead area of the Inboard side, which had no connection to the tread detachment (figure 13).

Figure 13. Shearography test

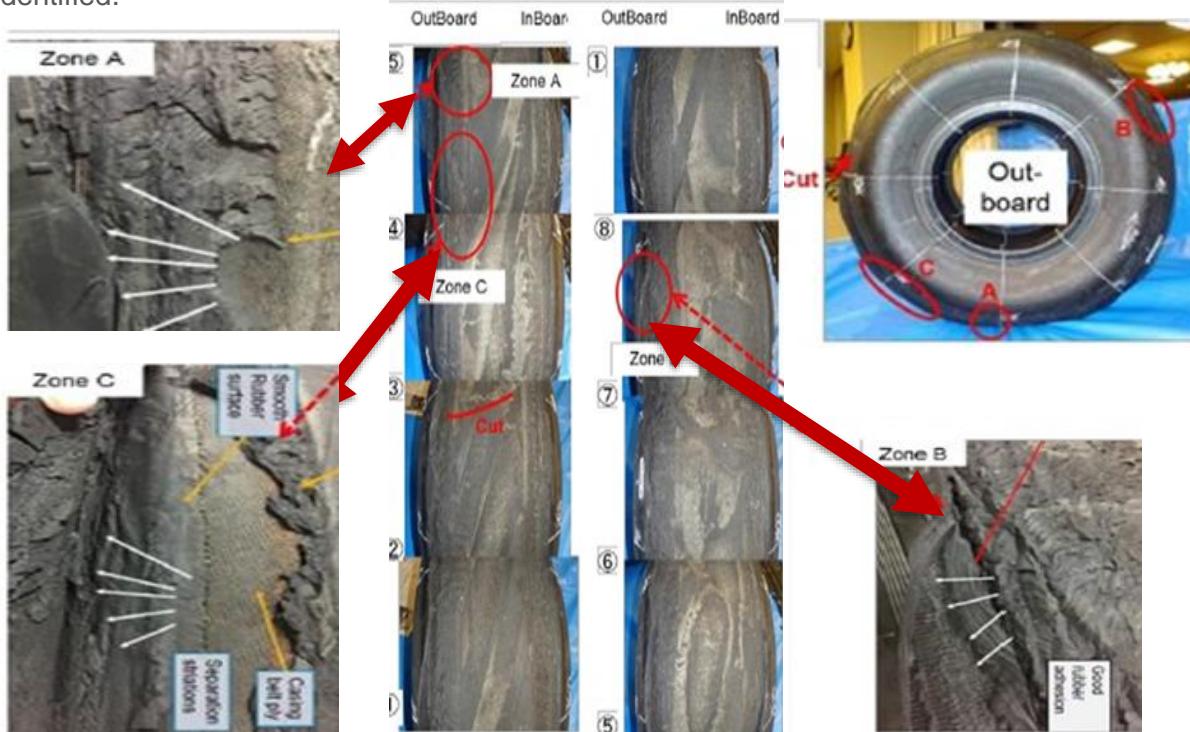
Striation in shoulder area on casing was observed at Zones A, B and C locating individually (figure 14). Also characteristic damage consisting of a sharp cut was observed on the crown area.

A series of striation marks were observed coming from the inside of the shoulder rib. No striation marks had progressed to the center and second rib. Chevrons and discolored rubber was observed on the shoulder pieces, but not the second rib pieces. Also, an area of skidding located under the second rib pieces beside the chevrons and discolored rubber was identified.

Figure 14. Possible initial foreign object damage

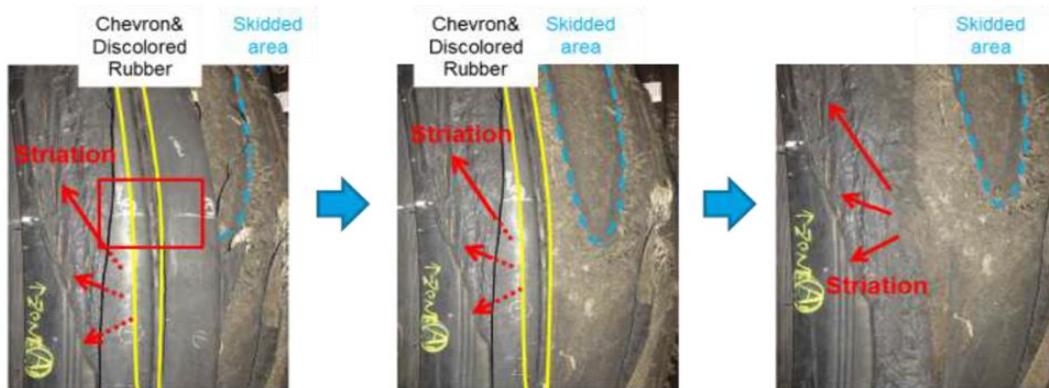
Based on these facts, it was estimated that the second rib detached before the occurrence of the chevrons, discolored rubber and skid indication above the casing. After the second rib detached, the surface of the casing, the outer edge of the second rib and the shoulder groove area contacted on the runway at touchdown (figure 15).

Figure 15. Tire damage, zone A

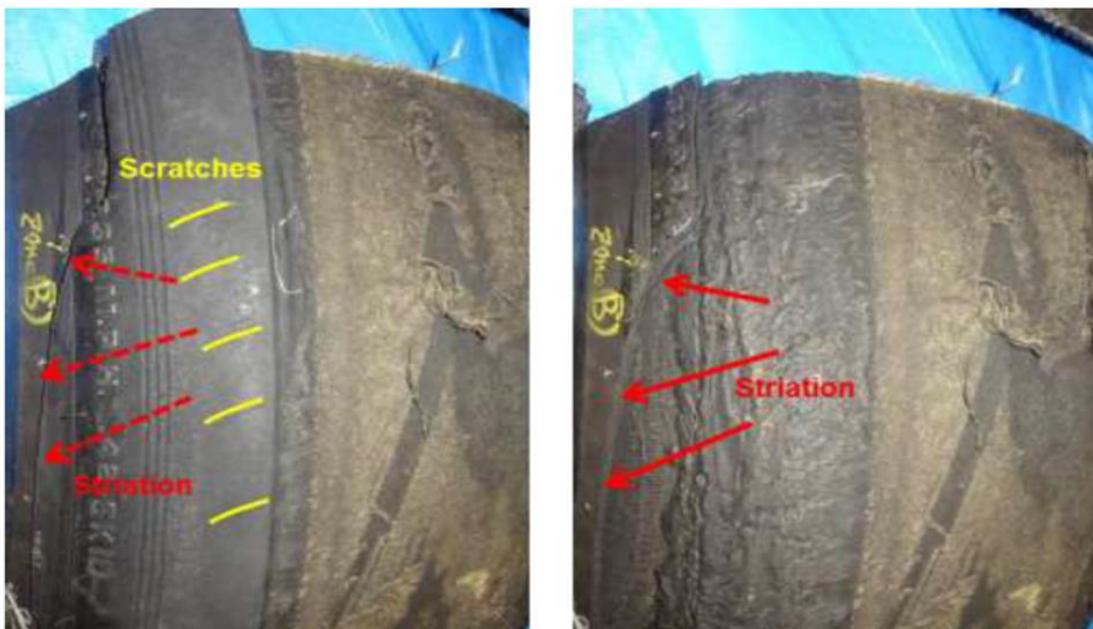
Lateral scratches with 1 – 4 cm length were observed on the surface of the detached shoulder rib (figure 16).

Figure 16. Damaged tire, zone B

A series of striation marks were observed from the inside of the shoulder rib to the outer side of the shoulder rib (figure 16). There was no striation which progressed to the center and 2<sup>nd</sup> rib. Chevrons and discolored rubber was observed on the shoulder piece, beside the chevrons and discolored rubber. Based on these facts, it is estimated that the 2<sup>nd</sup> rib detached before occurrence of chevron, discolored rubber and the skid above the casing, the outer edge of the 2<sup>nd</sup> rib and shoulder groove area contacted on runway at touch down. After that, the shoulder rib detached due to severe striation caused by tire loading and centrifugal force during tire rotation after touch down.

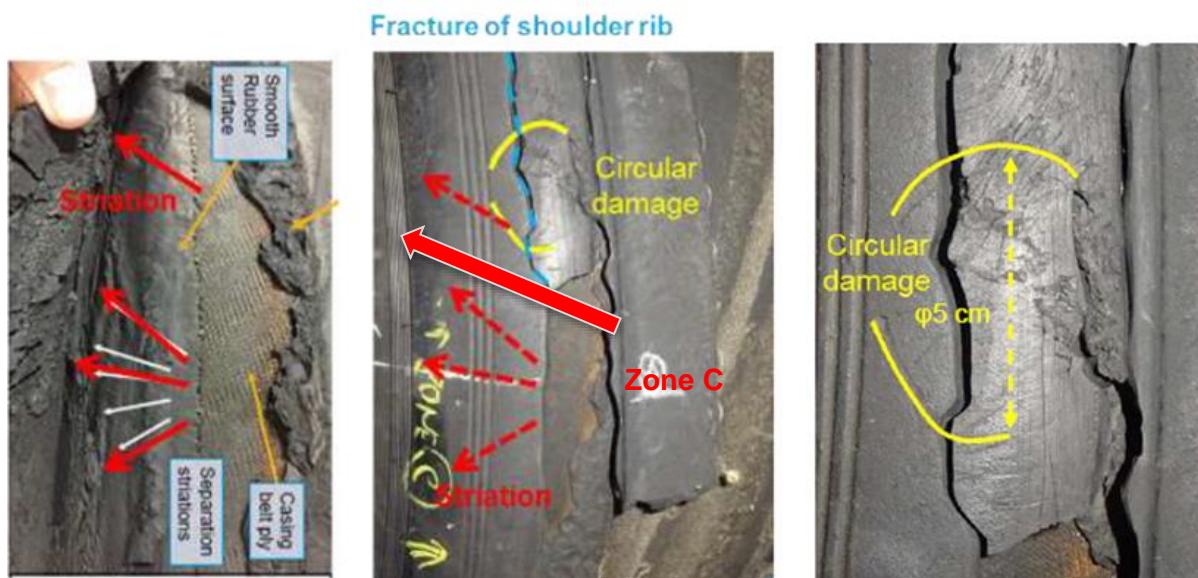
Fracture damage was observed in zone c (figure 17).

Figure 17. Damaged tire, zone C

Additionally, zone C sustained circular shaped foreign object damage at an unknown time and location. Tread separation in zone C occurred at almost the same time as tread separation in zones A and B.

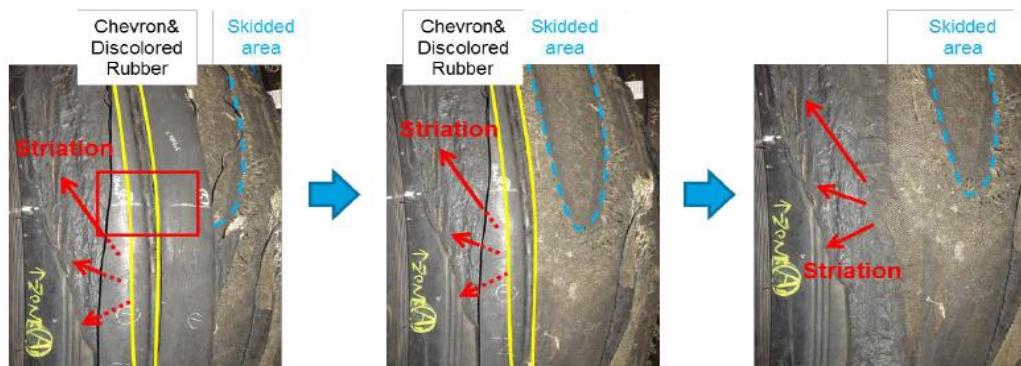
The crown tread area suffered damage due to contacting a sharp foreign object. Sometime later tread separation occurred in zones A and B. It is not known when the tire sustained the FOD damage. The damage event may have occurred during a previous flight at a different airport.

Figure 18. No.1 nose wheel tire damage characteristics
