***CONTINGENCY PLANNING of AIR NAVIGATION SERVICES***

**Real Case**

**Incompleteness of Contingency procedures**

**( Malfunction of No-Break Generator in ACC)**

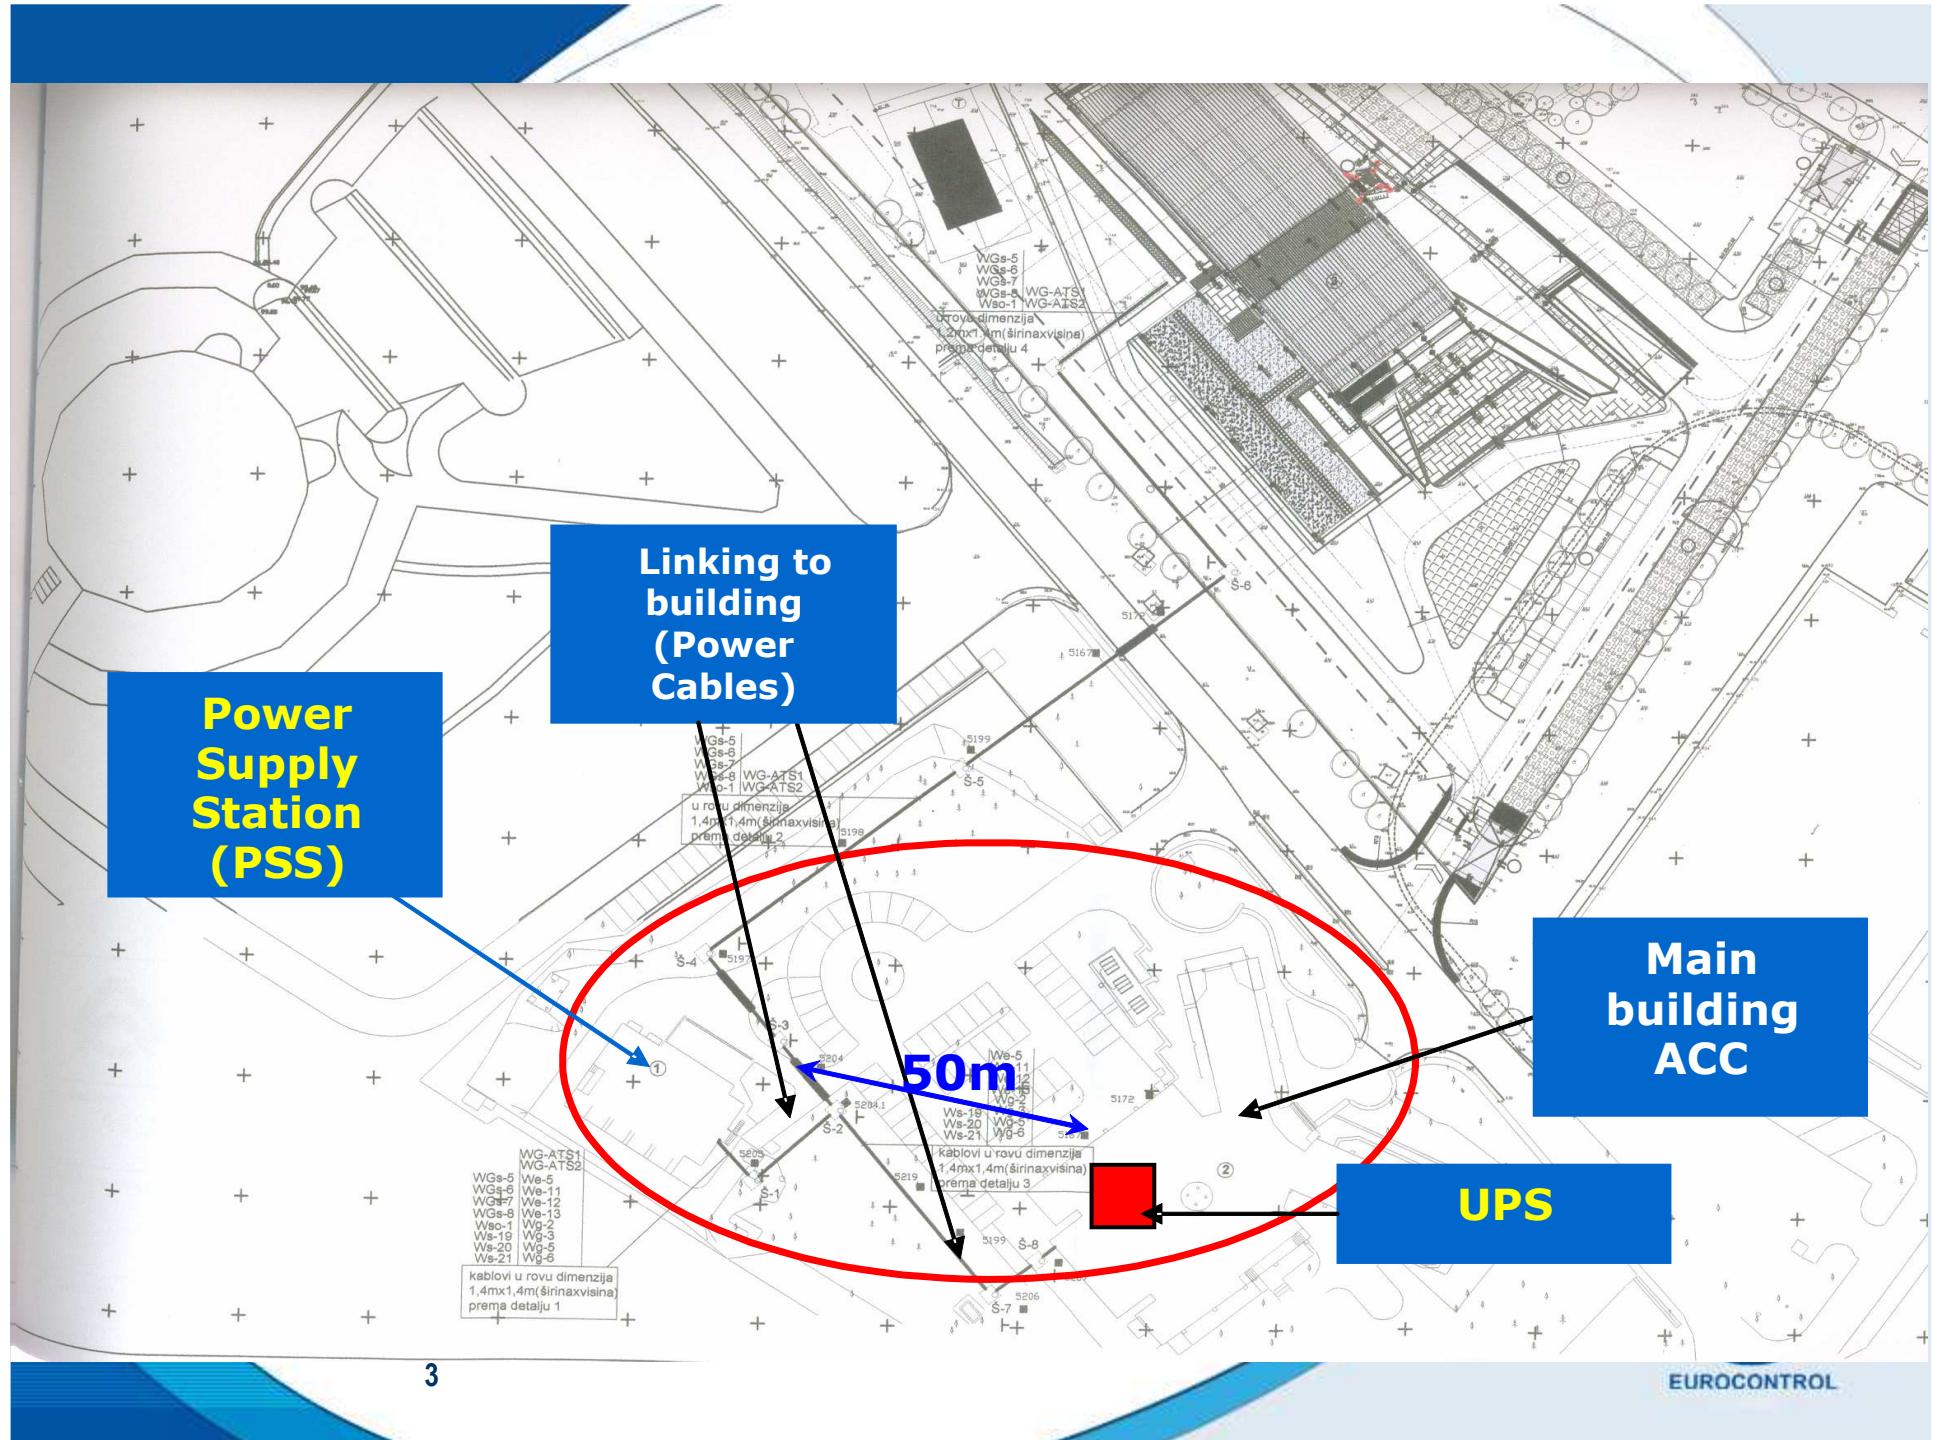
Power Supply Station is located near the ACC building and consists of :

- Transformer station and
- Generator station including
  - automatic generator and
  - two no-break generators.

The system was installed in 1974.

Switching boxes of PS Station supplies in ACC building:

- Main switching locker and
- UPS ( 2 pcs).
