REPORT

HCL 47/03 - 510-000319

Date / Time (UTC):	September 8 th , 2003, at 0744 hours	
Position:	Copenhagen Airport, Kastrup (EKCH) Taxiway V2/Runway 04R	
Airspace Classification:	Maneuvering Area	
Aircraft:	A	B
Registration:	C-GIIW	OY-GRN
Type of Aircraft:	C340	A330-200
Altitude (→ ↗ ↘):	On ground	On ground
Flight Rules	IFR	IFR
Civil or Air Force:	Civil	Civil
Weather conditions:	CAVOK	
Light and visibility:	Daylight – unlimited	
ATS units:	Kastrup Ground (121,90 MHz) & Kastrup Tower (118,57 MHz)	
Source of Information:	Air Traffic Safety Report (ATSR), Air Traffic Incident Report (A), Communication Data, Radar Data and AAIB investigation	
Classification of the Air Traffic Incident:	B) Safety not assured

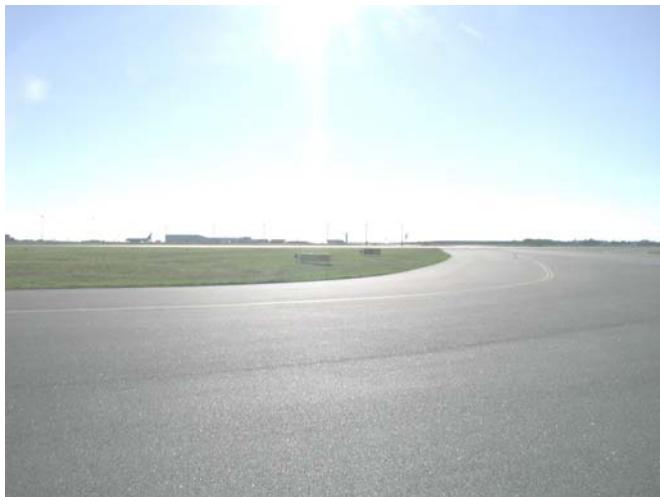
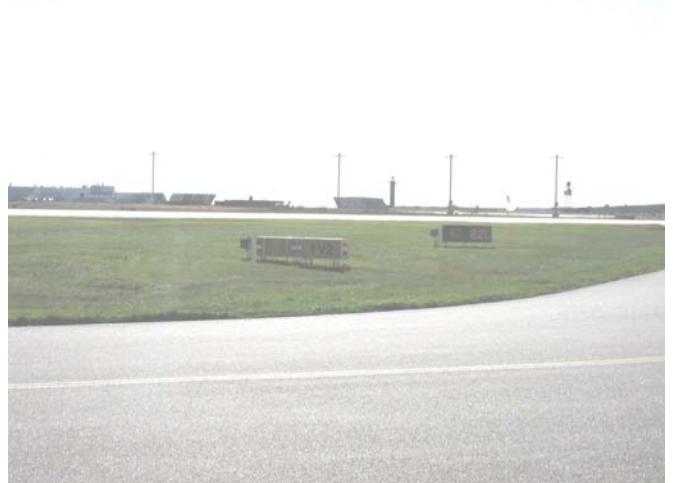
The taxiways T, V1, V2 and V were 4 separate taxiways. Taxiway V1 and V2 were not segments of taxiway V but unique and separate taxiways. (See the two photos below. The photos are taken on taxiway T in the direction of V2.).

It is the opinion of the Danish AAIB that the design and the use of certain taxiway designators at EKCH could lead to confusion and mistakes during taxiing. Flight crew might expect that the taxiways V1 and V2 would be segments of taxiway V, which could lead to misinterpretations of taxi instructions. It might be difficult during taxiing, especially for single pilot operations and/or at low visibility conditions, to be fully focused on the outside area (taxiways V, V1, V2 and T) and the taxi-chart at the same time. For that reason, the Danish AAIB finds the designators V, V1 and V2 inexpedient and latent hazard to flight safety.

The Danish Aircraft Accident Board recommends that the Danish Civil Aviation Administration should consider more suitable taxiway designators and more clear taxiways signs. (**REK-06-2006**).
