# **Final Report No. 1958**

concerning the serious incident  
involving the A330-243 Airbus aircraft, registration A6-EKU  
operated by Emirates under flight number UAE 87  
and  
the AVRO 146-RJ100 aircraft, registration HB-IXU  
operated by Swiss International Air Lines Ltd.  
under flight number SWR 162C  
on 31 October 2004  
at Zurich Airport

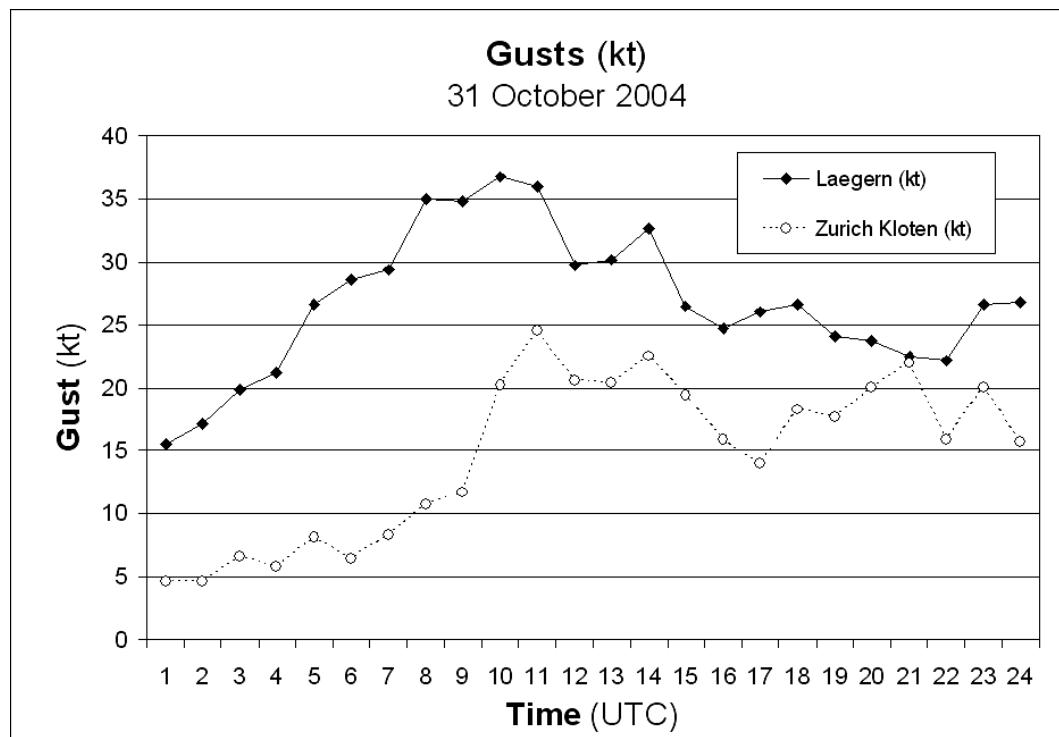
1.7.5 Record of gusts at Zurich airport and Lägern throughout the day (hill west of the airport, 2779 ft AMSL)

At the time of the serious incident, the following wind was recorded at the Lägern measurement station:

030 degrees 19 kt, gusting to 30 kt

At the Lägern measurement station, which is located on a hill to the west of the airport, gusts of max. 37 kt were recorded between 09:00 UTC and 12:00 UTC. With such peak wind values, moderate turbulence at least must be expected on approach to runway 14. The wind in the surface layer of the atmosphere is characterised by major fluctuations, making approach and landing on this runway a challenge. Under such conditions, the probability of a go-around is increased.

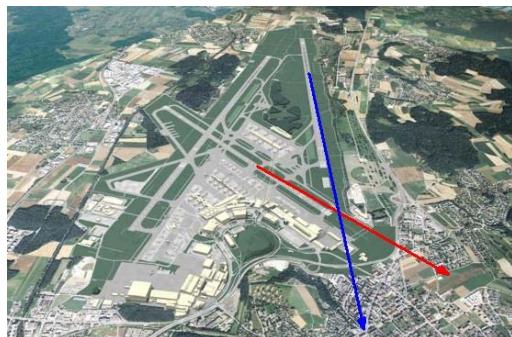
**1.10.3 Standard procedure for departures from runway 10 and missed approaches on runway 14**

Blue: Begin missed approach runway 14  
Red: Begin departure route runway 10

- Difficult to apply, because from the aerodrome control location it is only possible to determine imprecisely whether the approaching aircraft has flown over the threshold of runway 14. The case in question proves this, because the air traffic controller cleared SWR 162C for take-off when UAE 87 was still 0.6 NM before the runway 14 threshold.
- Incomplete because it does not take into consideration the fact that an approaching aircraft may initiate a go-around even after having passed the runway threshold. Particularly in weather conditions with a north-easterly wind, for the above-mentioned reasons the probability of a go-around on approach to runway 14 is increased. Under these wind conditions, simultaneous take-offs from runway 10 take place.
- Also incomplete because the type of aircraft approaching runway 14 is not taken into consideration in the procedures.
