National Transportation Safety Board

Aviation Incident Final Report

Location:	Mt. Wilson, CA	Incident Number:	OPS17IA010
Date & Time:	12/16/2016, 0125 PST	Registration:	
Aircraft:	BOEING 777	Aircraft Damage:	None
Defining Event:	Air traffic event	Injuries:	N/A
Flight Conducted Under:

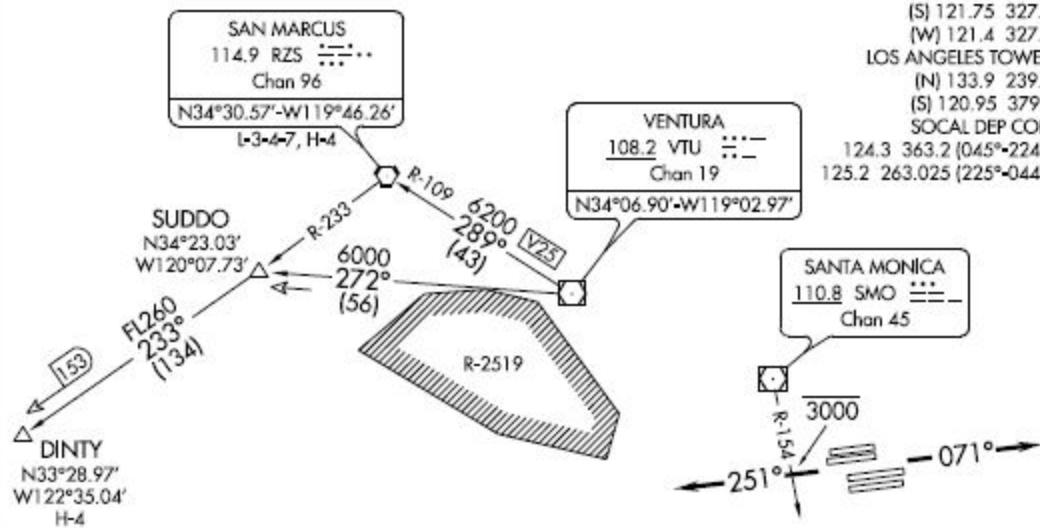
Figure 1 - Ventura Seven Standard Instrument Departure

TAKEOFF RUNWAYS 6L/R, 7L/R: Climb on heading 071° for RADAR vectors to VTU VOR/DME, thence. . . .

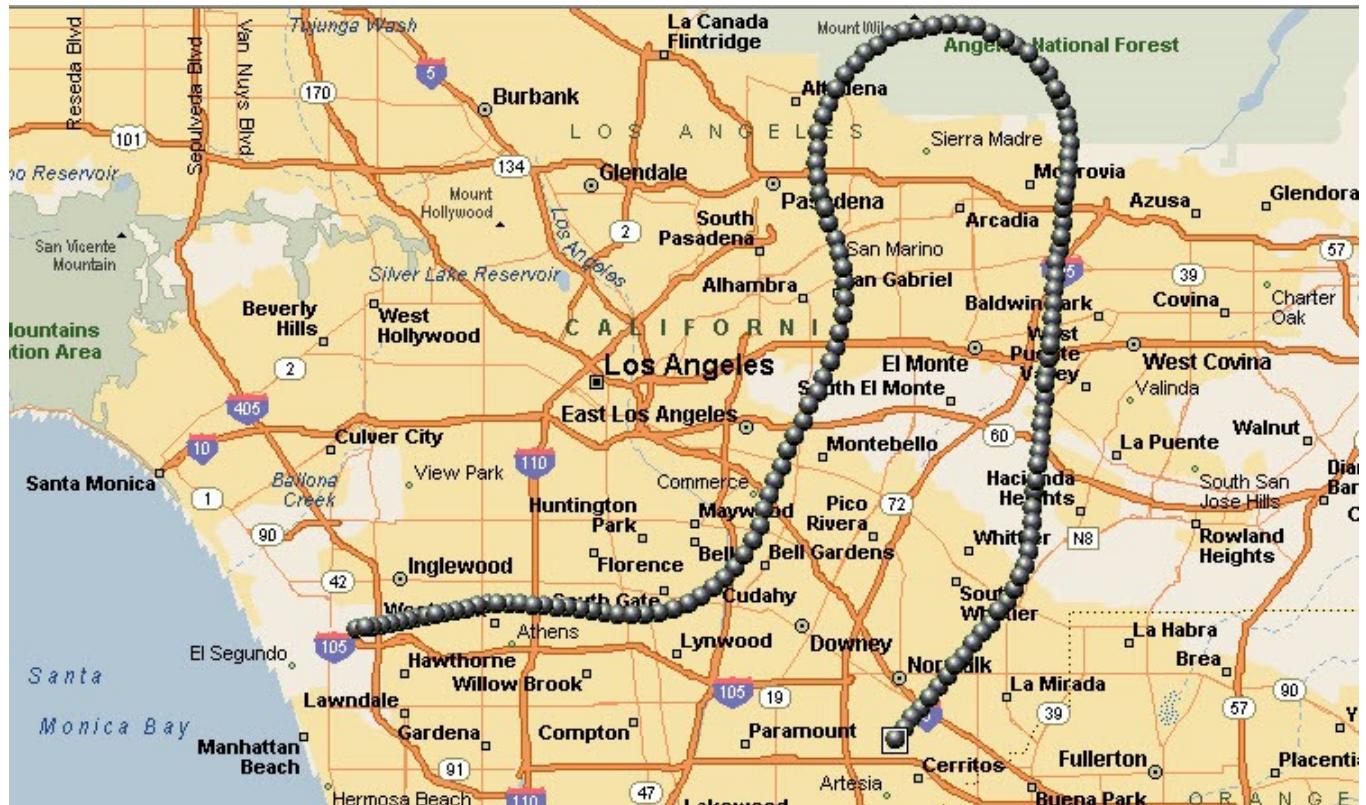
Figure 2 - Radar data showing EVA015 departing LAX and being turned northbound toward Mount Wilson.

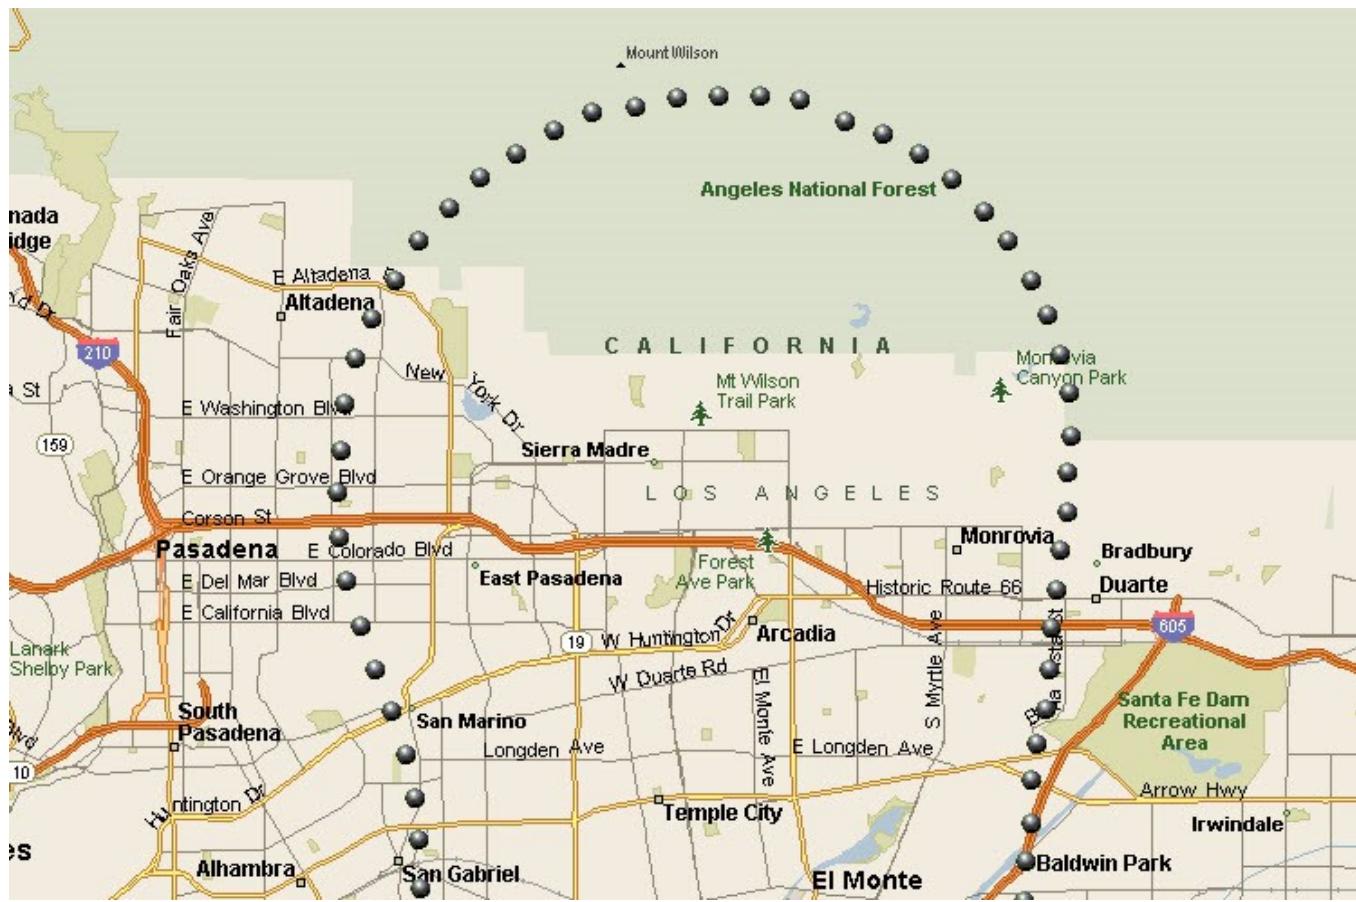
Figure 3 - Radar data showing EVA015 making a right turn just south of Mount Wilson.
