Accident Report

25th December 2013

Hewanorra International Airport, St Lucia (TLPL)

Airbus A330-343

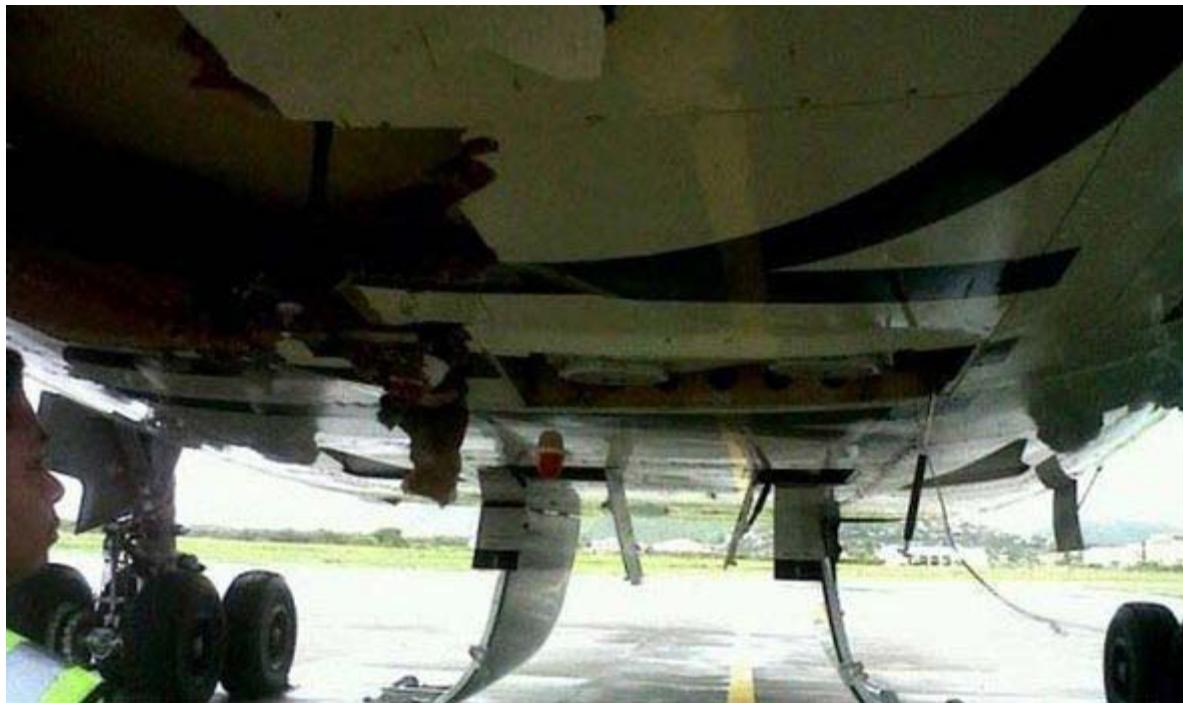
Fig. 1

From the initial inspection, it was evident that the damage was predominately to the belly panels from frames 37 to 40, 6 panels having significant damage and there was extensive damage to the belly panel supporting structure. Due to the panels being pushed upwards, significant damage had occurred to the cross bleed system ducting, pack ducting and potentially the packs themselves. There was also some damage to several brake units, 2 minor scratches to the fuselage, and a dent to right hand #2 Flap fairing. There was also some damage noted to the undercarriage.

The nature of the damage to the belly panels in the vicinity of the Pack Bay area indicates that the aircraft had come into contact with a significant amount of water at high speed. There was no evidence that the aircraft was struck by any other object.

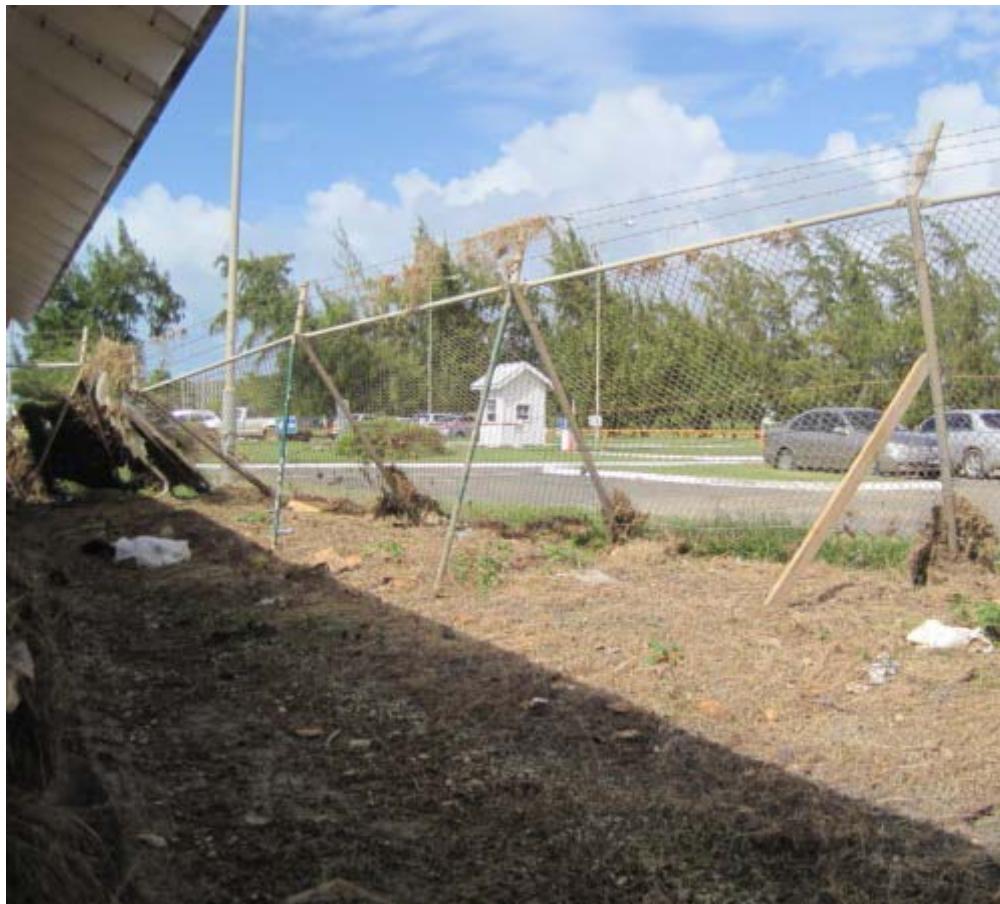
Fig. 2

Several sections of the airport security perimeter fence were damaged during the flooding

In viewing the condition of the perimeter fencing, there is evidence to suggest that the rate of flowing water was significant, as the concrete footings for the posts were seen to be ripped out of the ground. The debris caught within the fencing was approximately 3 foot high.

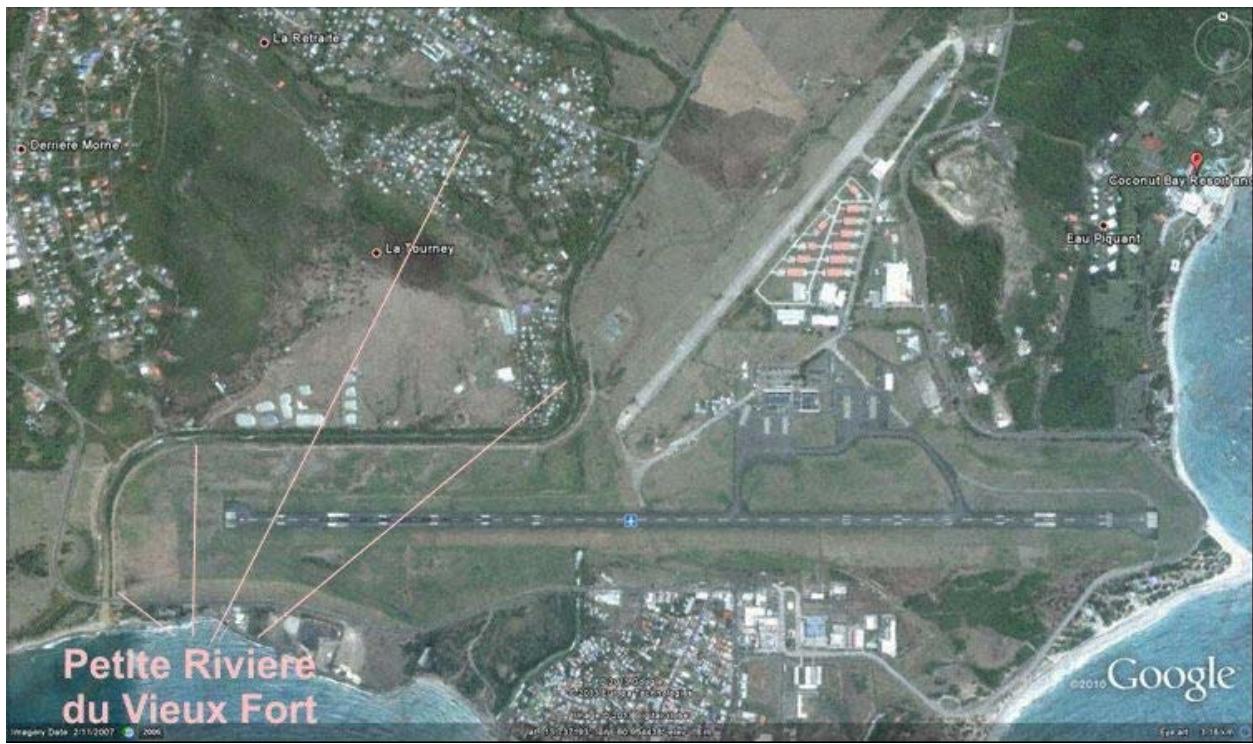
Fig. 4

The investigation revealed that the original course of the river to the north of the runway had been diverted to allow for runway construction. The evidence indicates that as a result of the extreme weather and heavy rain that existed at the airport that night, the river burst its banks at the point where the original course of the river had been diverted 90 degrees to the west. This resulted in the touchdown area of the runway being flooded.

The river burst its banks at the point where it makes a 90 degree turn to the west prior to paralleling the runway, thereby flooding the touchdown area of the runway.

2. The St Lucia Authorities should install physical 'high level' indicators to warn of rising water levels in the adjacent river to the North of the Hewanorra International Airport.

3. The St Lucia Authorities should install flood defences in order to prevent future runway contamination at the Hewanorra International Airport should the river burst its banks.

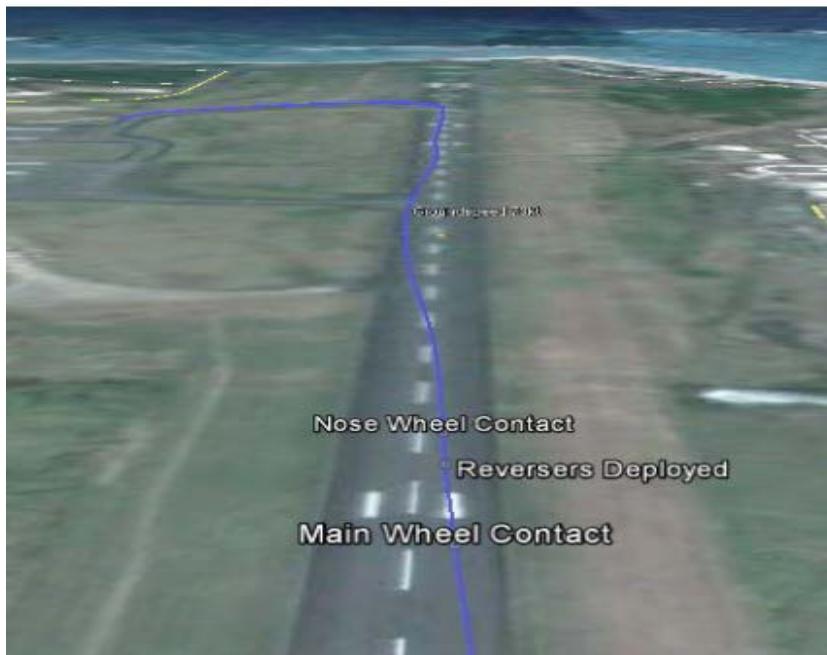
Fig. 5

At 00:15:05 UTC, GS=106kt, right rudder pedal was applied up to -31.5° (max rudder pedal deflection) to counter a left departure (LATG increased up to $+0.2G$), then heading increased from 99° up to 108° (QFU=104°).

It confirmed the deviation left to the runway without lateral excursion. The aircraft was brought back towards the centreline with rudder.

There is no evidence that the aircraft struck any objects. The data shows that the aircraft came within 6 metres of the left hand edge of the runway

Track of the aircraft after touchdown.
