Lessons learned from Belgocontrol Power Failure

Author: Alain Du Bois
Function: Safety Advisor
Location: Brussels
Date: 29.09.2017

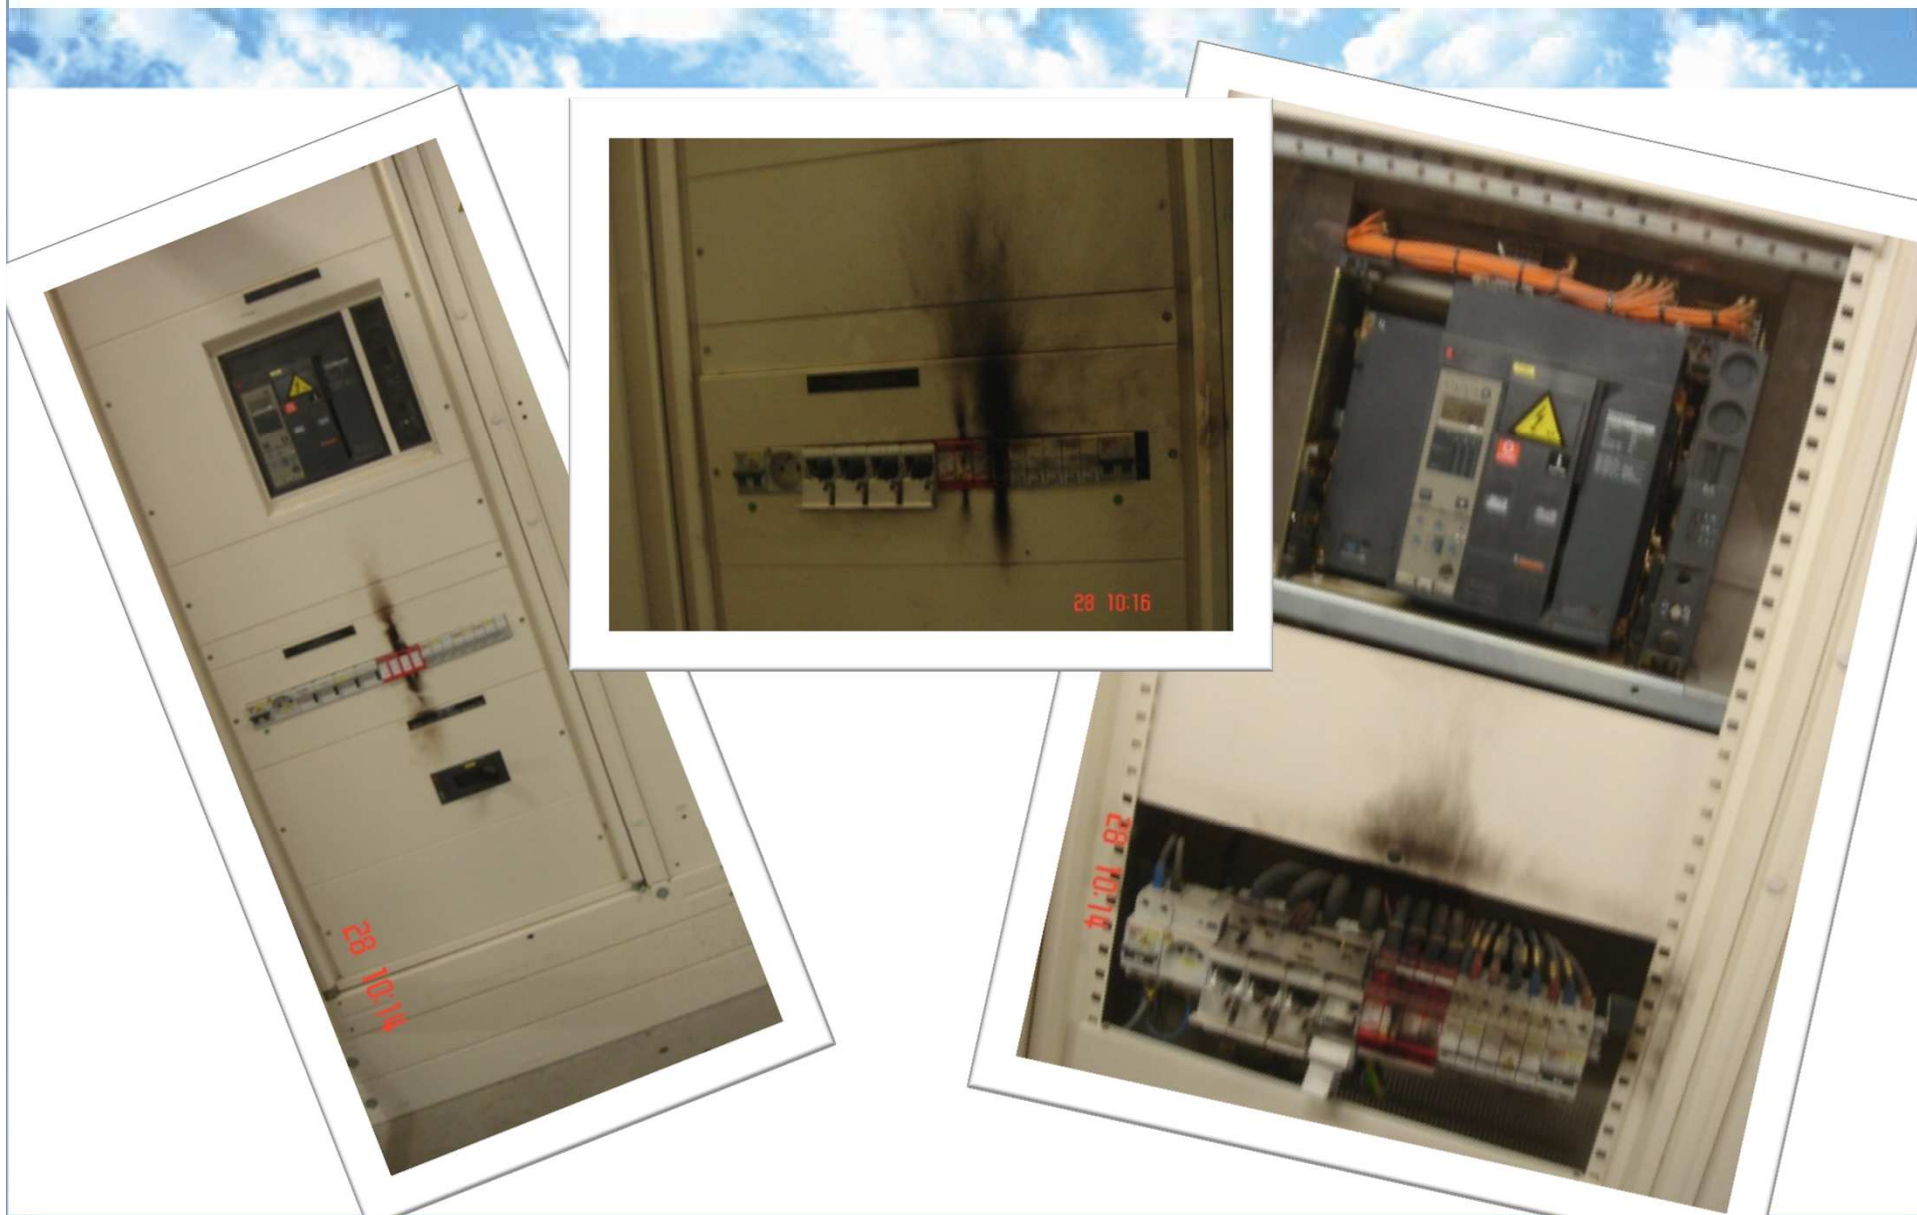
Damage found upon visual inspection

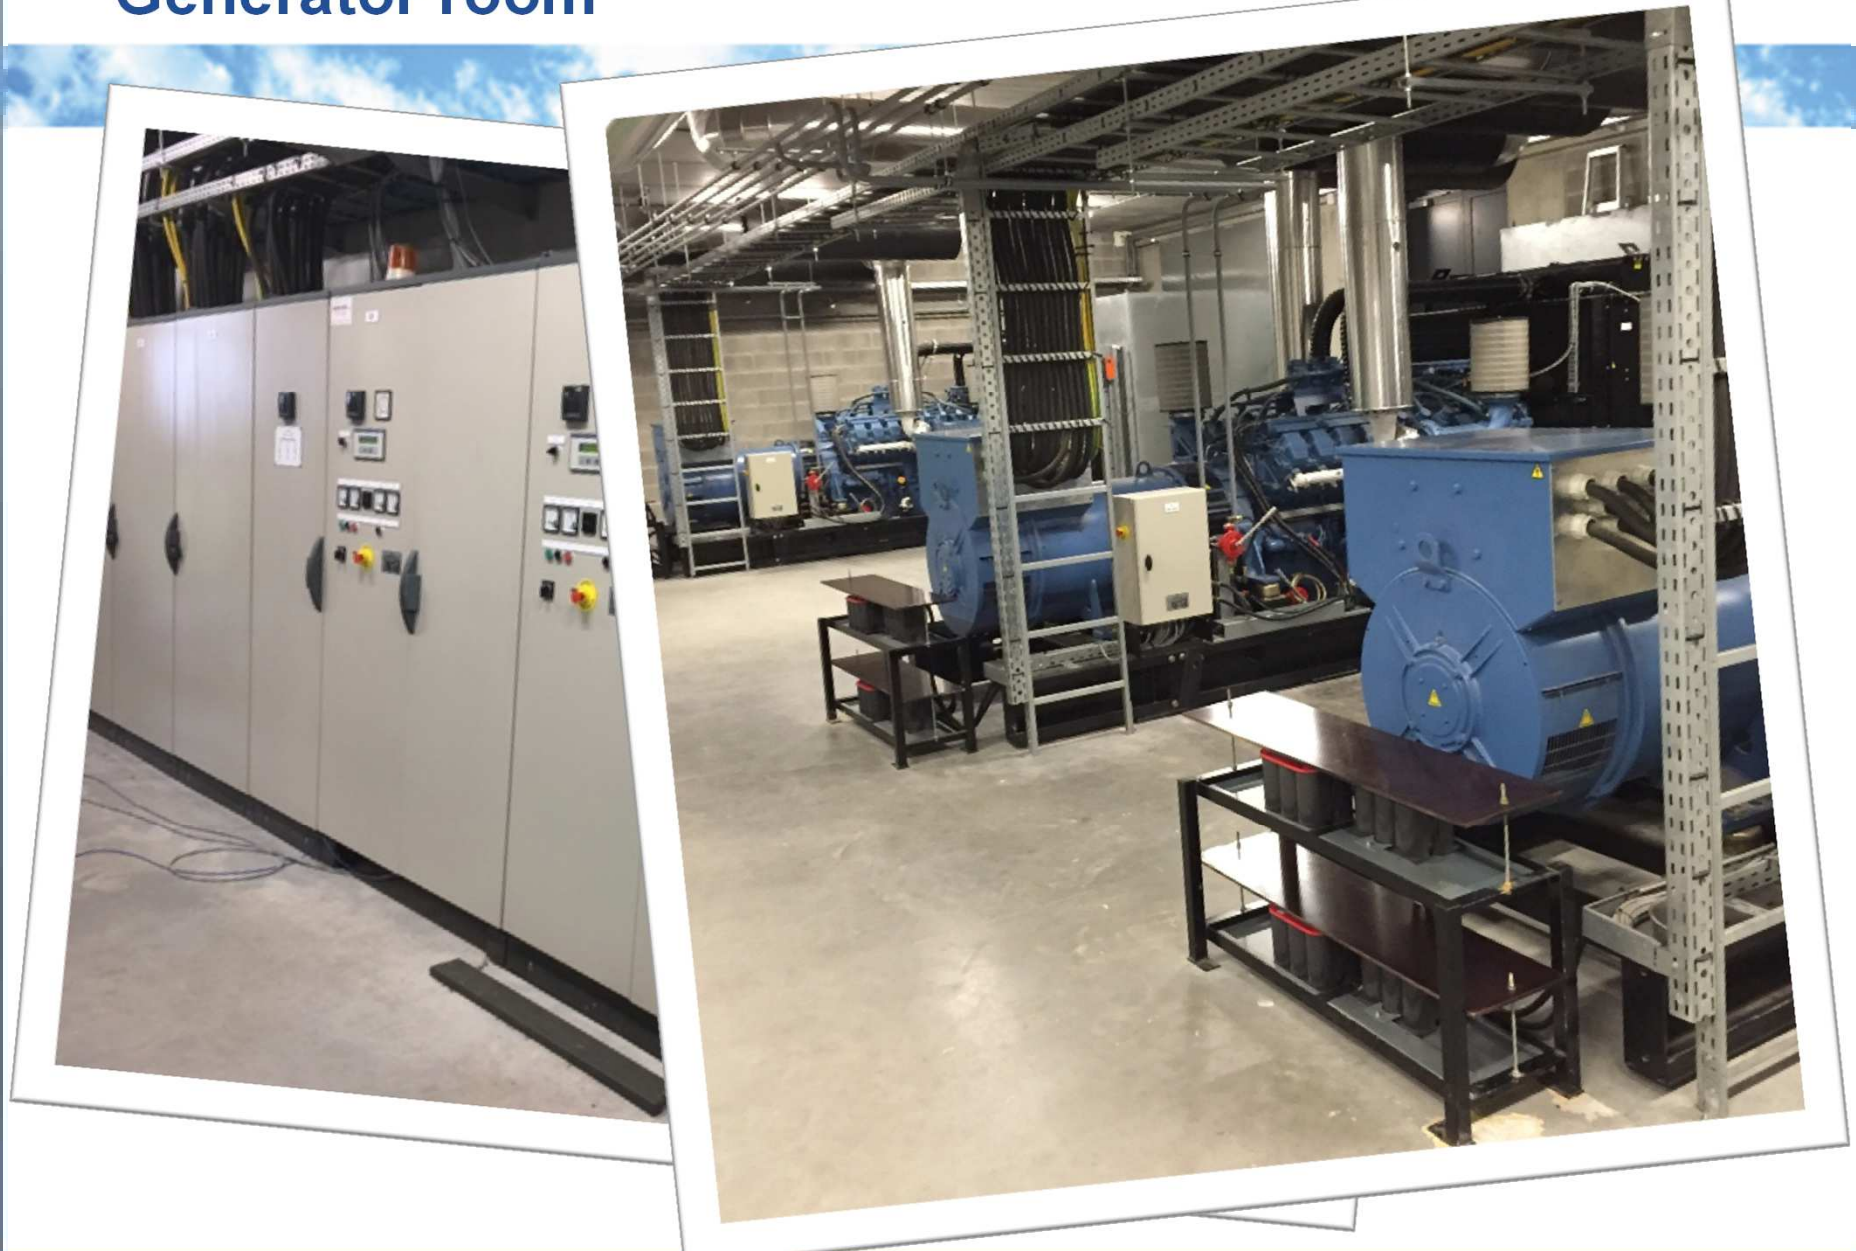
Generator room

1
Absence of connection between the neutral conductor of the emergency generators and earth (diesel generators).

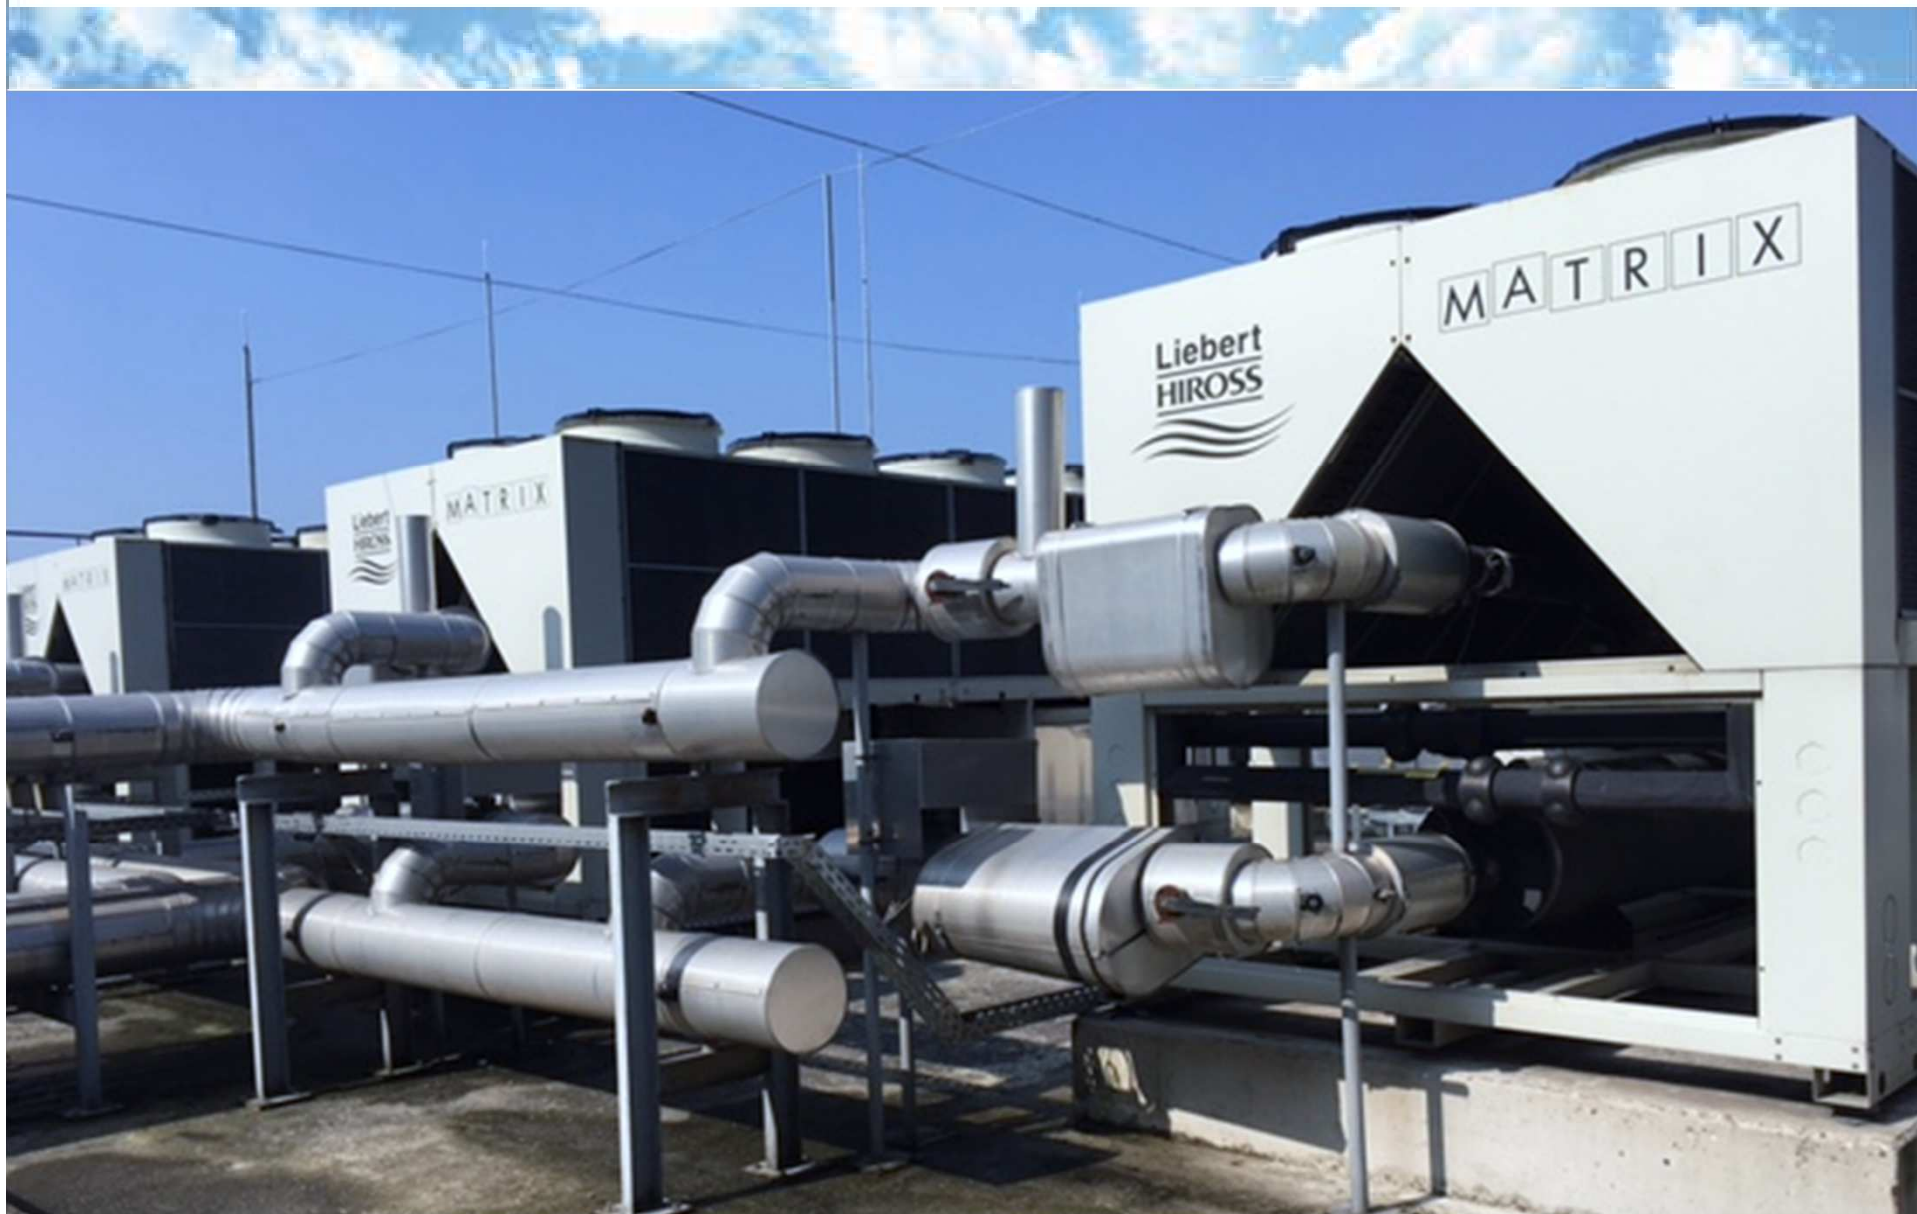
Cooling installation

2
The occurrence of a coincidental fault on one of the loads (motor of the cooling installation).

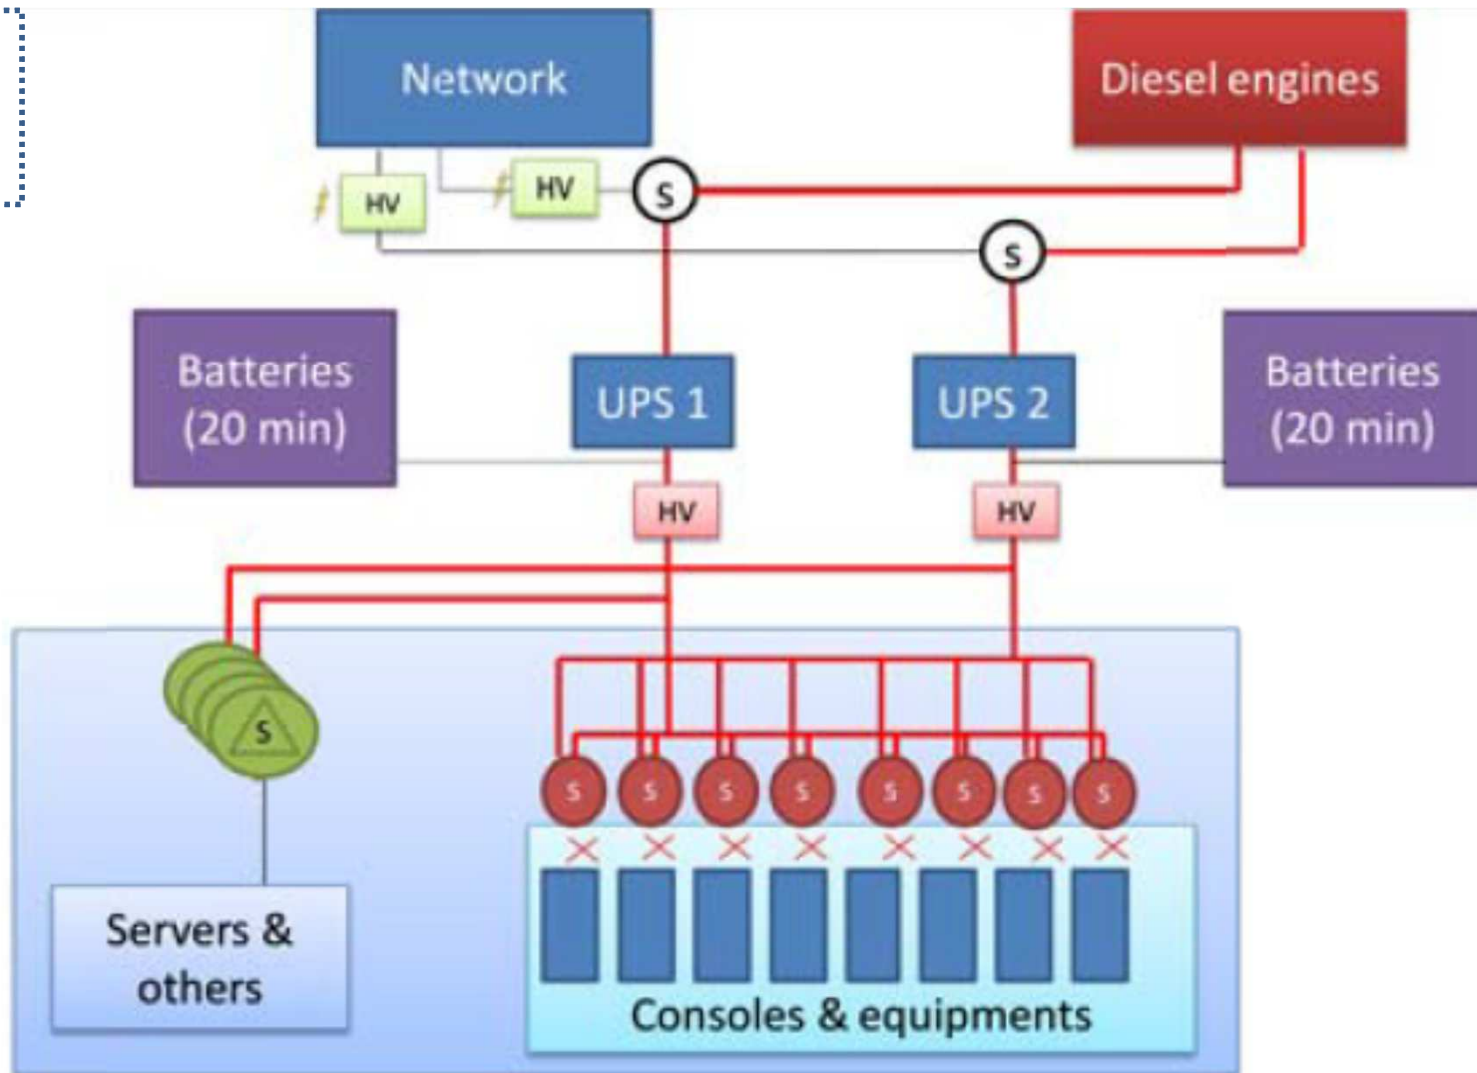
Power distribution network

07:15
Power
failure
