*Serious incident
 at Nantes
 on 21 March 2004
 to the MD-83 registered SU-BMF
 operated by Luxor Air*

REPORT
su-f040321a

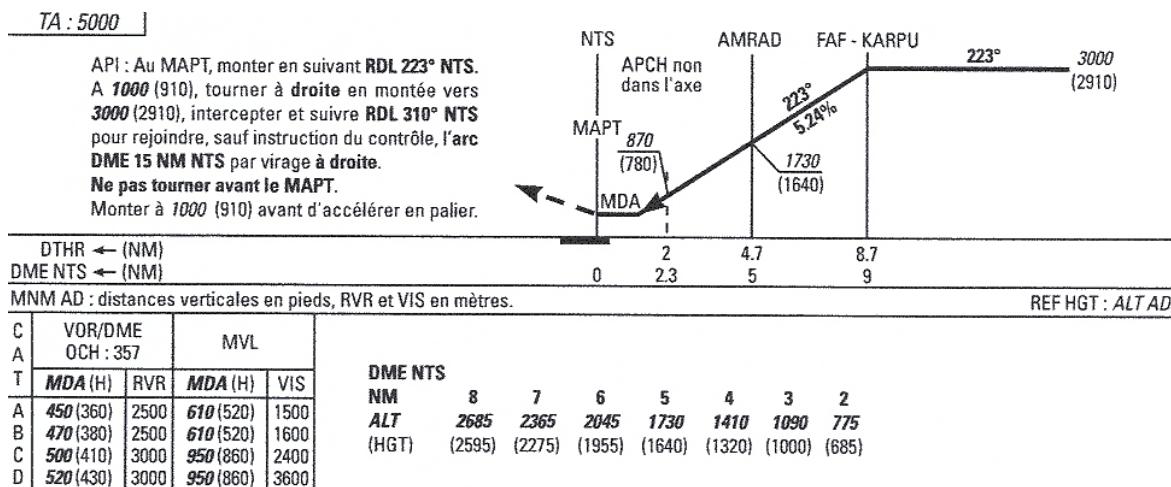
- AMRAD, located 5 NM from NTS, which must be over-flown at a minimum altitude of 1,730 ft;
- the point located 2.3 NM from NTS, which must be over-flown at a minimum altitude of 870 ft.

After the final approach, the pilot must not descend below the minimum descent altitude (MDA) until he has acquired the external visual references necessary for the landing. He determines his MDA using the approach chart, with reference to the category of his aircraft. For an aircraft in the category of the MD-83, the MDA is five hundred feet.

- **the DGAC introduce as soon as possible the representation of obstacles recommended by the ICAO.**

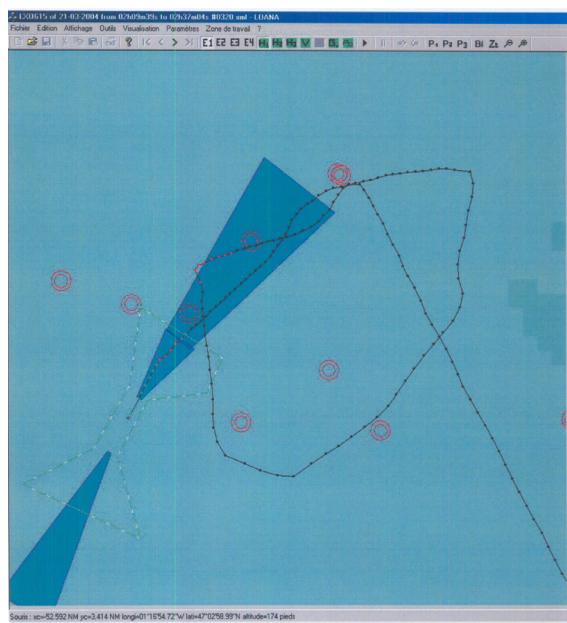
Radar representation

The system had been under evaluation at Nantes since 18 March. Since it was not yet operational, the warnings were not passed to the controller. A simulation was done using the radar data. On the graph drawn from this simulation, the red points indicate the radar plots that would have generated an alarm.

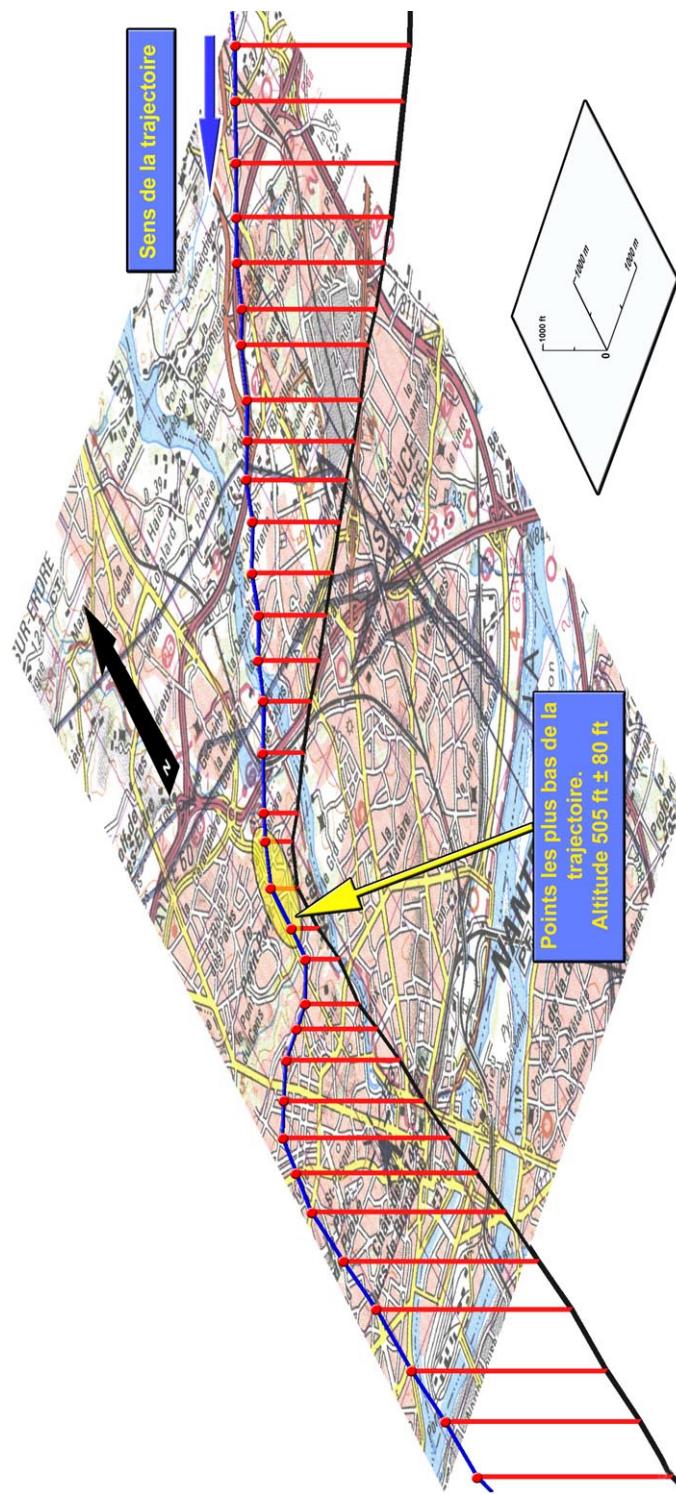
Reconstitution of the vertical path

The airplane made its descent at an average rate of descent of a little less than 1,000 ft/min. The crew reported suffering significant turbulence during this phase.

At 1 h 27 min 10 s, the controller intervened to say that the airplane seemed to him to be too low. The Captain asked the co-pilot to select ALT HOLD and told the controller that he was maintaining five hundred feet.

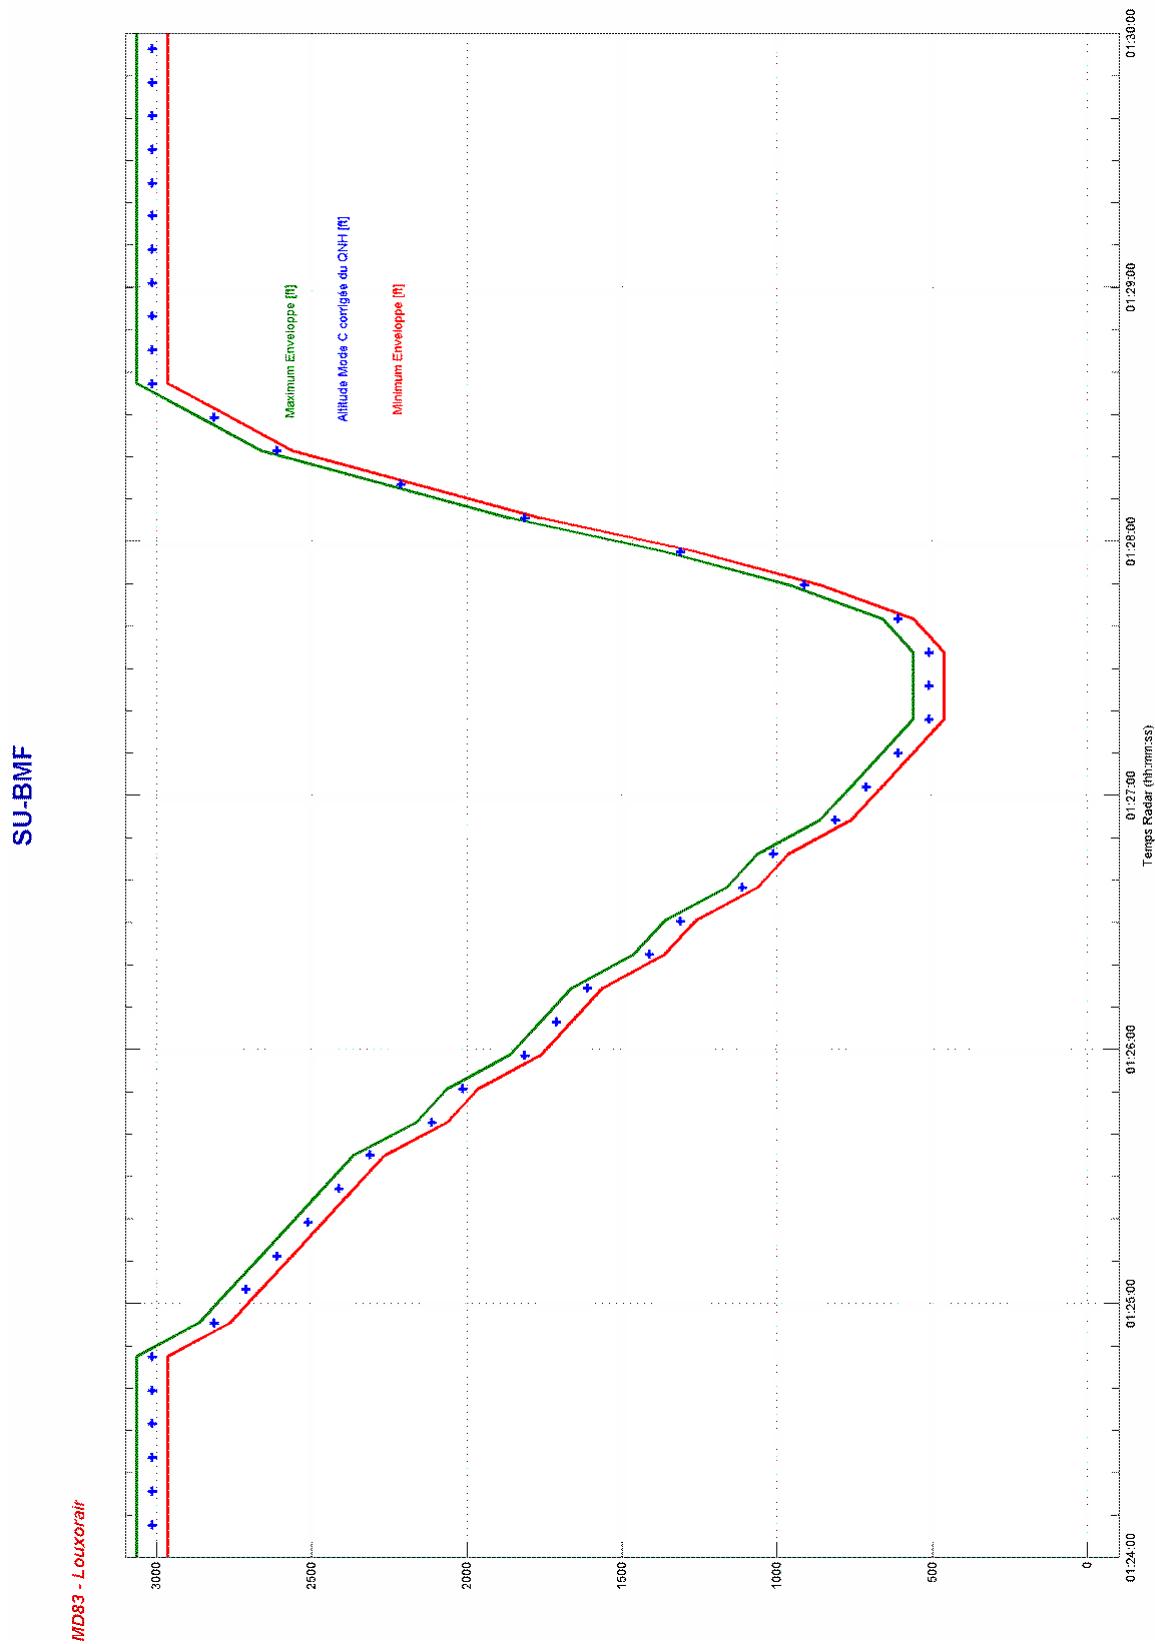
Reconstitution of the track

The crew then noticed, on the navigation instruments, that there was a variation of about 0.8 NM between the airplane's route and the localizer radial. The VOR CAP indicator was displayed on the FMA. The co-pilot changed the autopilot to HDG SEL to intercept the radial with a selected heading of about 250°.

8 NM DME away, a short time before the airplane crossed the radial, the Captain asked the co-pilot to continue on that heading in order to go around a stormy area that he thought he had identified on the weather radar. The airplane crossed the radial at 1 h 25 min 43 s.

In addition, the co-pilot decided to go back towards the radial with an 80° left turn via the HDG SELECT mode.
