Aviation Accident and Incident Investigation Division

**Report on the serious incident to Bombardier CRJ900 with
registration 9XR-WH, operated by RwandAir, involving
engine damage caused by foreign object debris,**

February 4th 2018

Ref AAID 2018-01

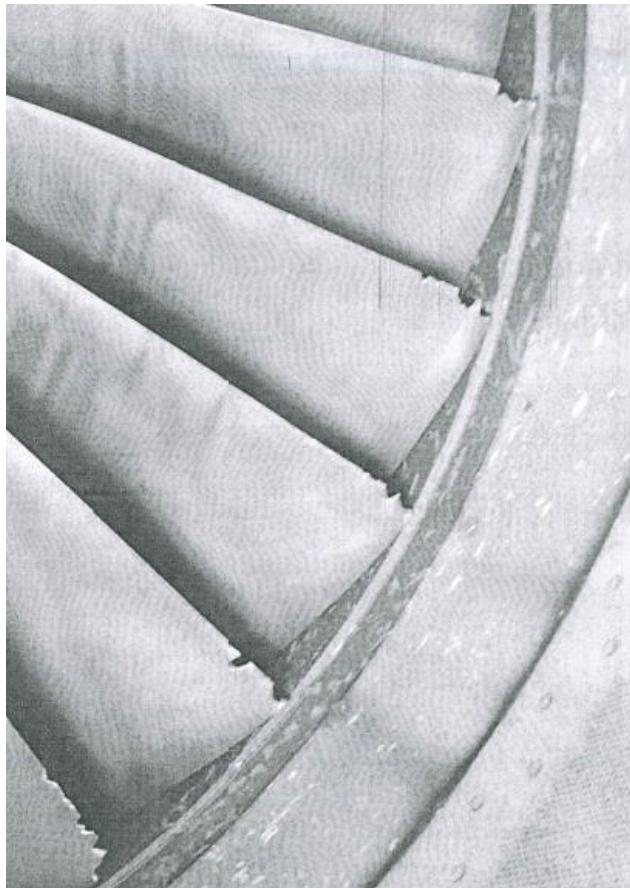
After arrival at KGL at 06:15 LT again a walk-around check was performed by the crew. On that occasion it was found that all fan blades from the left-hand engine were damaged, see the picture 1 below. Further investigation revealed that a metal bolt was stuck in the acoustic lining in the upper part of the fan intake, see picture 2.

*Picture 1:
Damage to fan blades of left-hand engine*

Post flight inspection of the left-engine³ revealed impact of foreign object debris (FOD⁴) to all 28 fan blades and the nacelle intake. As a result of the FOD damage the engine as well as the nacelle intake were replaced. An initial borescope inspection suggested additional FOD damage to compressor section of the engine, findings from the engine overhaul facility however indicated clearly that the FOD damage was confined to the fan section only.

The fan blade damage, that was found after arrival of flight WB465 at KGL, was consistent with impact forces from the bolt that was found lodged in the acoustic liner of the fan intake. Since it was unambiguously demonstrated that this bolt did not originate from the engine or the aircraft itself, the bolt must have been ingested by the engine. However, even at high power settings such as during take-off, ingestion of a small object with a mass like that of the bolt concerned is not very likely for a Bombardier CRJ900 aircraft because of its relatively high positioned rear-mounted engines. It is therefore significant that, apart from the fan blade damage, also small punch-type damage to the tread of the left-hand outboard main gear tire was found that had not been detected before, see Appendix 1. This leads up to the most likely scenario whereby during taxi-out or on the runway the bolt was picked up by the left-hand outboard tire at low speed, subsequently came loose from the tire by centrifugal forces during the high speed part of the take-off run and then was ingested by the left-hand engine, running at take-off power.

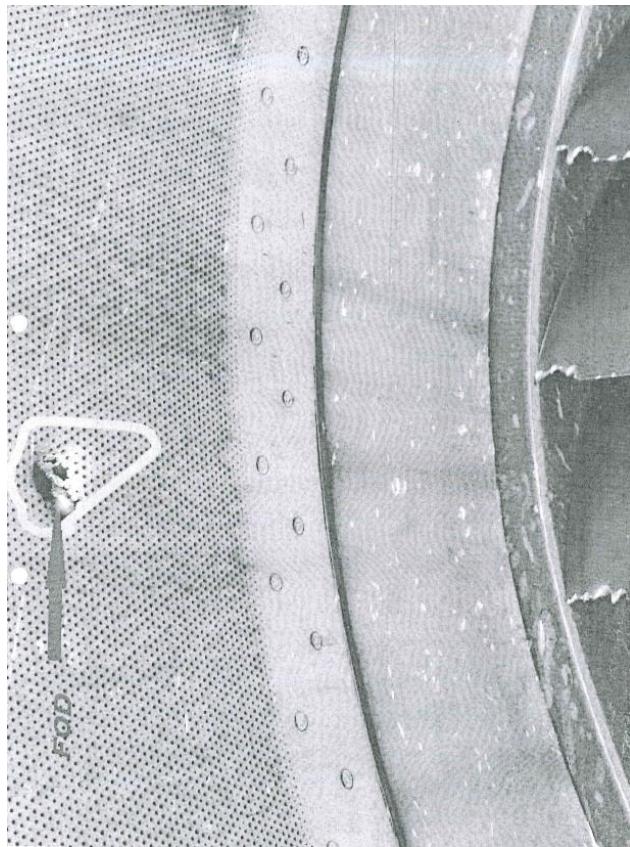
*Picture 2:
Bolt, found stuck in acoustic lining in the upperpart of left-hand fan intake*

- 3.1.2 The fan blade damage was caused by a bolt, that was found lodged in the acoustic liner of the fan intake.
- 3.1.3 The bolt causing the fan blade damage did not originate from the engine and thus has been ingested by it.

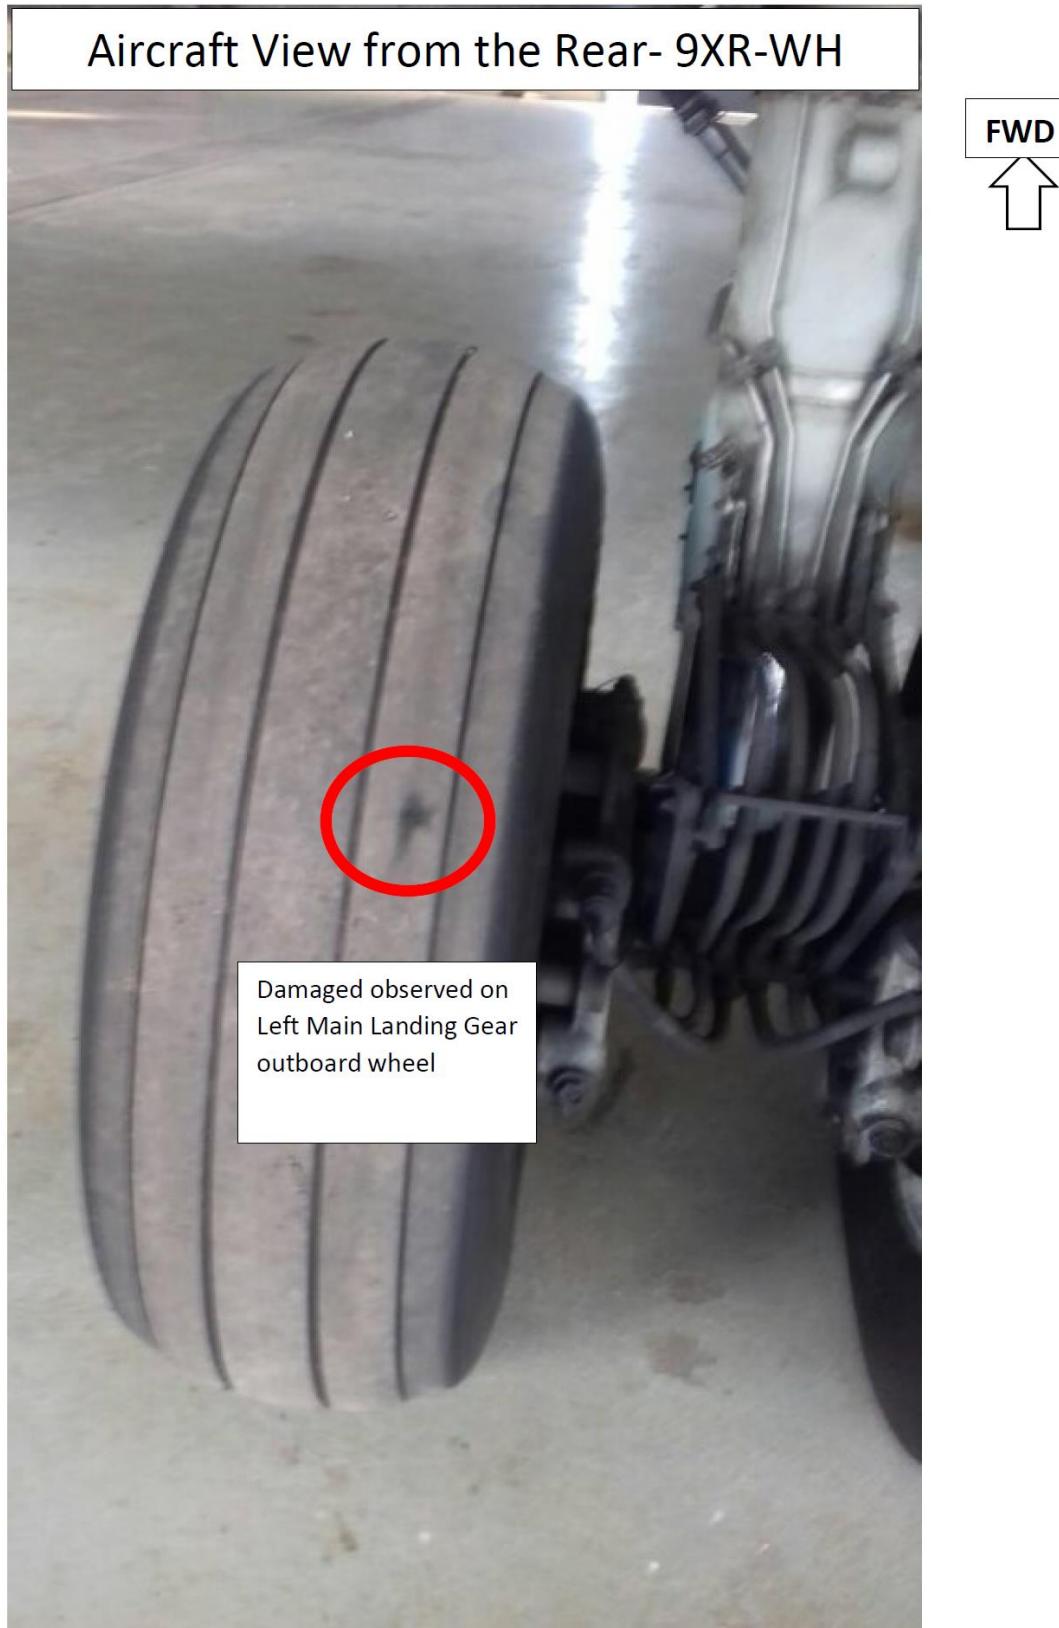
Appendix 1: Damage to outboard tire of left-hand main gear

During inspection of the aircraft after landing in KGL also minor damage to the tread of the outboard tire from the left main tire was found, see Appendix 1.

- 3.1.1 After arrival of flight WB 465 at KGL on Febr. 4th 2018, impact damage to all fan blades of the left-hand engine was found, as well as minor punch-type damage to the left-hand outboard main gear tire.

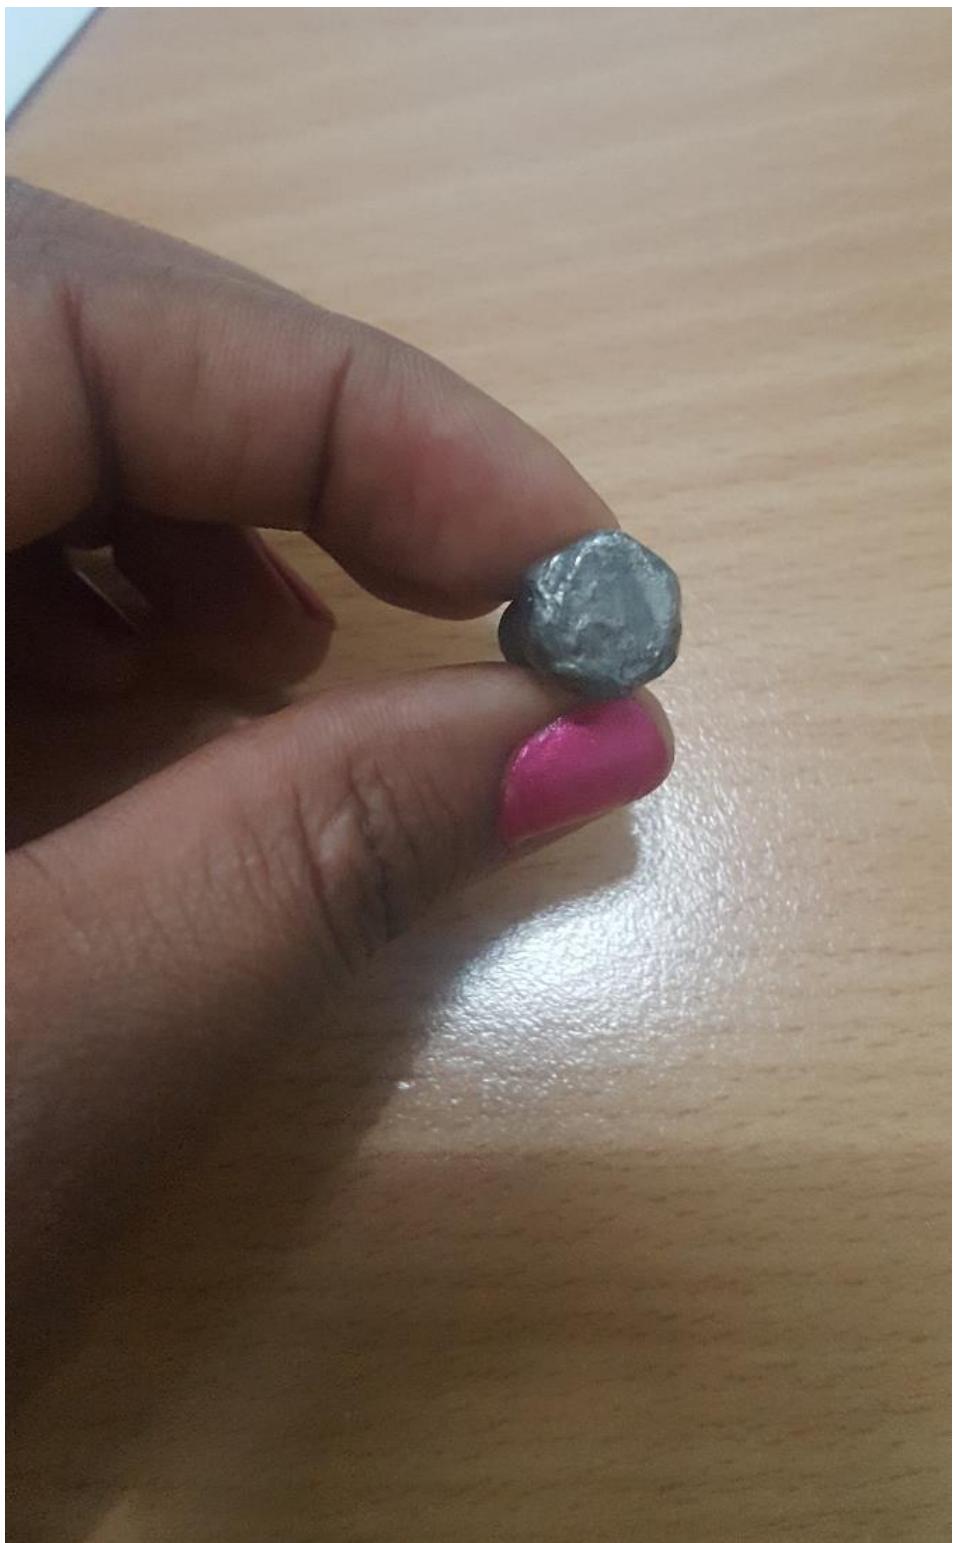
I received some photos of the CRJ900 Foreign Object damage event you are investigating through the GE customer support office and wanted to reach out and provide you some information. All the fan blades look like they experienced hard impact damage, consistent with impact from the bolt that was found lodged in the inlet. Upon closer examination of the bolt (See the first picture), the bolt does not seem to match anything in the inlet of the engine. The event bolts looks like a 6-point bolt whereas the engine and inlet has mainly 12-point bolts with none of the 6-point bolts located ahead of the fan. The only 6- point bolts are airframe bolts that attached the inlet to the engine but they are external to the airflow and well behind the inlet. Additionally these bolts are covered by the thrust reverser so not in a location that could have gotten into the fan inlet. This seems to indicate that the engine pick up this bolt may be from the last airport (if they do a walk around after every flight). Attached are pictures that GE was kind enough to take of the CF34-8C with the inlet cowl installation from their training center. Based on this information, it would be very hard to determine where the bolt originated, it could have come from a number of non-aviation sources, fuel trucks, baggage carts, air stairs, etc. but it looks like it is certainly did not come from this airplane.

Bolt that was found lodged in acoustic lining of fan intake.
