**SERIOUS INCIDENT**

| <b>Aircraft Type and Registration:</b> | Sikorsky S-92A, G-CKXL | |
| <b>Location:</b> | On Approach to the Brae Bravo platform, northern North Sea | |

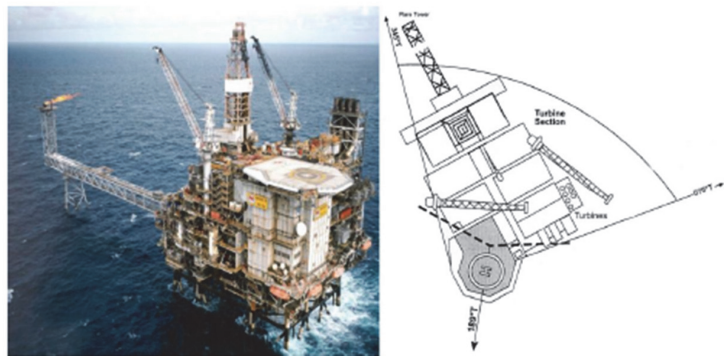
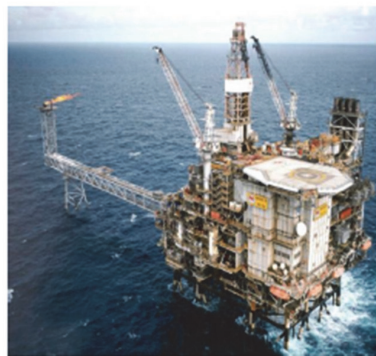
**Figure 2**  
Brae Bravo Platform (HCA)

- Flare-stacks.** The EBRA platform has a flare-stack that rises diagonally from the north-west side, whereas the BRAA platform has two flare-stacks that rise diagonally from the north-west and north-east corners. Meanwhile the BRAB platform has a single flare-stack that protrudes horizontally from the lower side of the platform to the north-west.

3. **Helicopter Directory.** The limitations of the HD hinder the use of the plates by pilots to identify key features for the purpose of visual identification of the platform. The helidecks are reviewed on a 2-year inspection cycle and the photographs used are not routinely updated and may therefore present a visual image that is many years old. Visual aspects, such as platform colour, and the location and visual aspect of the name signs may have changed in the intervening period from when the photograph was taken. The direction from which the photographs were taken is not consistent throughout the HD. There is no reference to the skidded nature of the derricks in the plates. Together, these undermine the ability of the crew to use the plates as a means for establishing visual identification cues.

The differences between the platforms are not obvious from the plates and require closer scrutiny to identify key identification features. While the pilots did discuss the flare stacks, the plates were not drawn upon primarily for means of identification; the PIC considered the pictures are only of benefit if approaching from the same direction as that of the photograph of the plate. He noted some plates do not even provide photographs and many platforms look very similar.

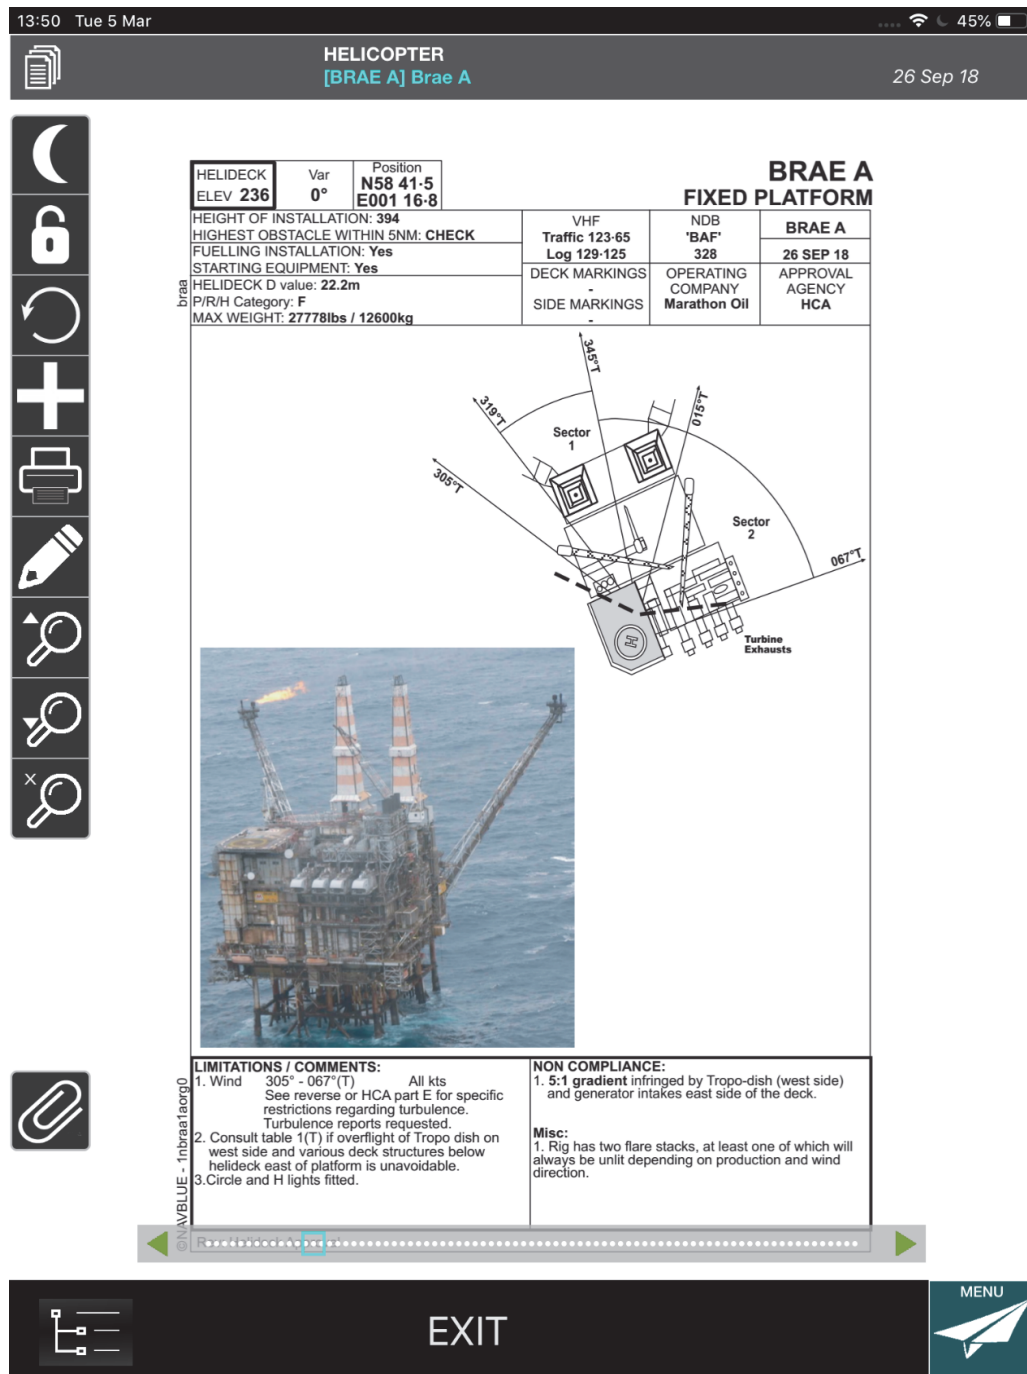
Brae Alpha platform (Navblue Charts+)

4. **Operator EFB.** The pilots had an electronic version of the plates for the platforms available to them in the cockpit through the Navblue Charts+ iPad app on the operator EFB. However, the information provided did not differ in quality or in visual imagery to that provided by the HCA plates which the crew consulted during the flight planning phase. It is considered unlikely that further consultation of the plates in the app by the crew during the brief on the deck of the EBRA would have highlighted the key identification features that had not been previously detected during the flight planning phase. Its use by the pilots during the transit to corroborate correct identification of the platform would have been inappropriate due to the short sector and associated high workload
