Report IN-017/2017

Serious incident involving a Boeing B787-900, registration N825AA, and a Cessna 172-M, registration EC-IEO, in the Madrid TMA on 8 August 2017

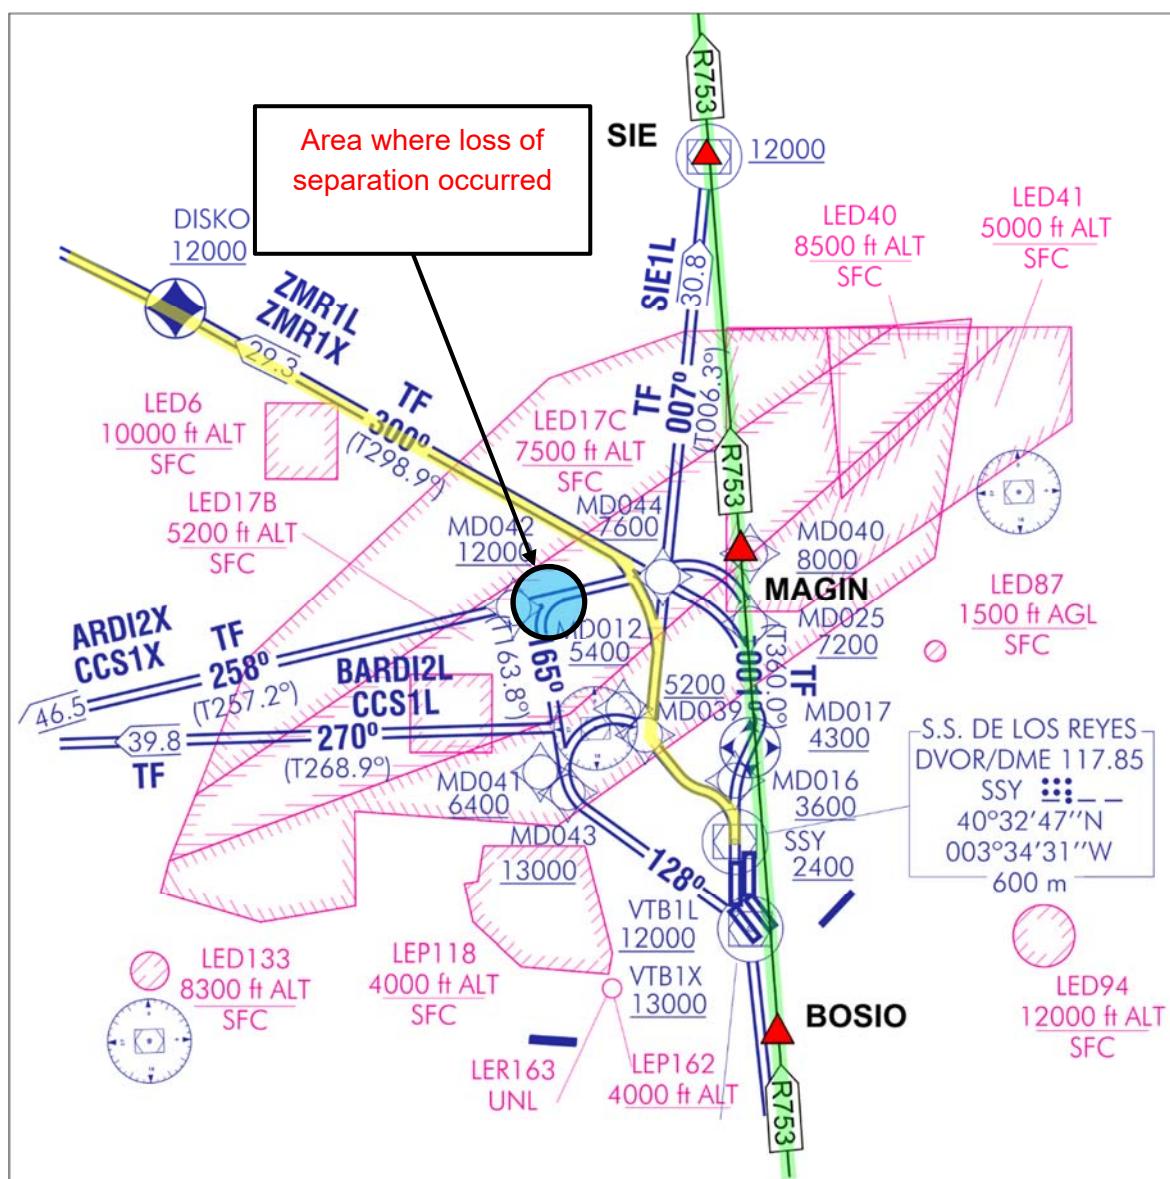
Figure 1. Section of P-RNAV chart for standard instrument departure, runway 36L daytime, with the route taken by aircraft AAL37 shown in yellow and the route indicated in the flight plan for aircraft ACR31 shown in green. Also shown in the blue circle is the area where the loss of separation took place.

It had been cleared to climb to FL240, following standard instrument departure (SID) ZMR1L (shown in yellow in Figure 1).

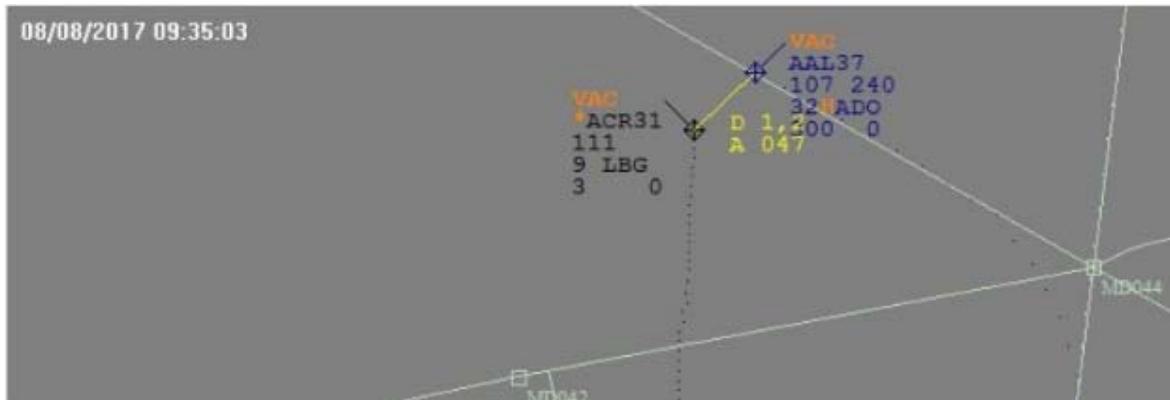
Figure 2. Image of the closest point of approach between the aircraft

The minimum separation between the aircraft during the event occurred at 09:35:03, when they came within 1.2 NM horizontally and 400 ft vertically of each other (see Figure 2).

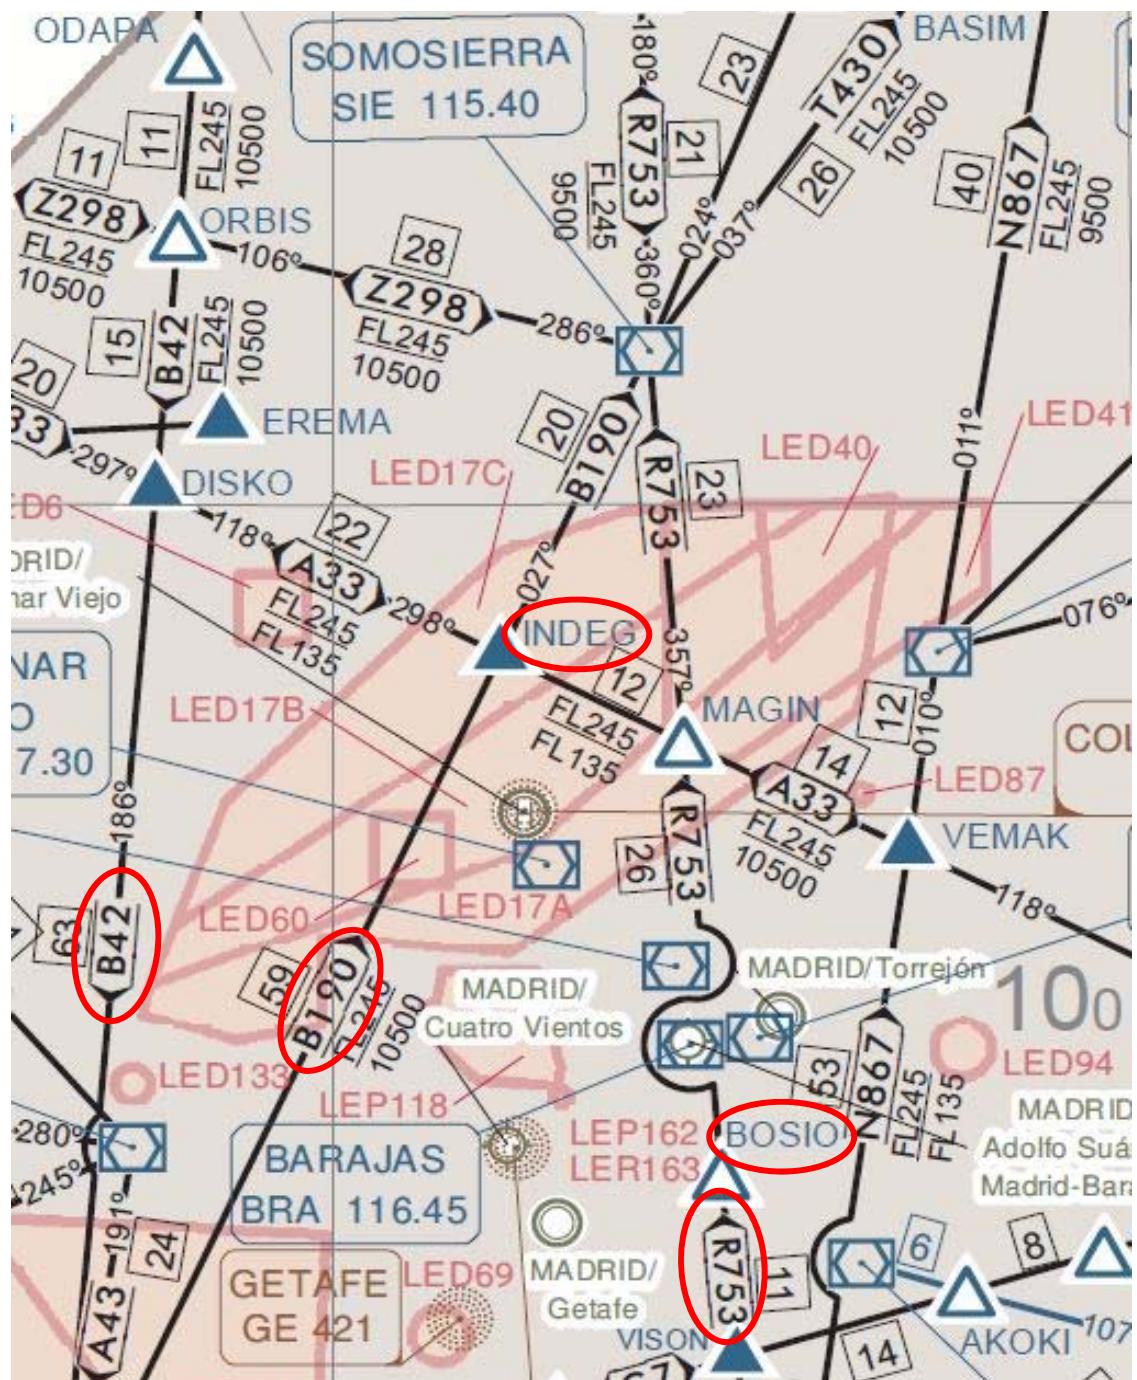
Figure 4. Extract from lower airspace chart (ENR 6.1-1), with airways B42, B190 and R753 and points INDEG and BOSIO circled in red

BOSIO is a point on airway R753 that is in the segment between the VTB VOR/DME and the SIE DVOR/DME, and is not to be filed in flight plans (see 1.8). As a result, the change made to the flight plan by the IFPS was in violation of this restriction.

REC 34/18. It is recommended that ENAIRE establish a route for aircraft taking off from the Madrid-Cuatro Vientos Airport (LECU) on northerly routes under IFR, to facilitate its incorporation to an airway and to minimize possible conflicts with other traffics in the Madrid TMA.

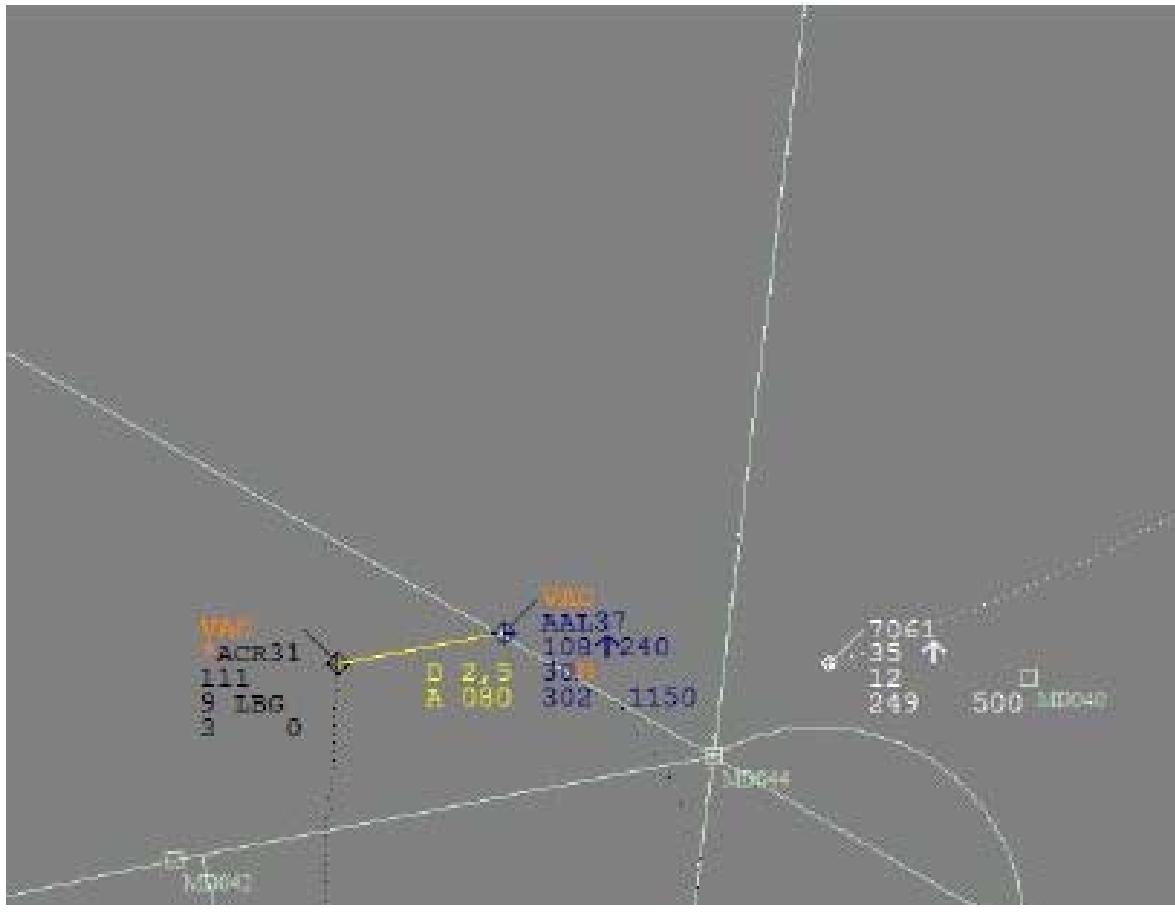
Figure 5. Image of the moment when the VAC conflict alert occurred

In the 40 seconds before the violation alert (VAC) was issued by the SACTA system, aircraft ACR31 flew a straight path and kept a practically constant altitude of 11,000 ft.

REC 35/18. It is recommended that ENAIRE revise the conflict alert prediction algorithm (STCA) in an effort to improve its ability to detect future conflict scenarios. This recommendation also includes the suitability of evaluating the viability of improving the capability of the system to use flight plan data.
