**SERIOUS INCIDENT**

| <b>Aircraft Type and Registration:</b> | Boeing 737-4Q8, G-JMCR | |

**Synopsis**

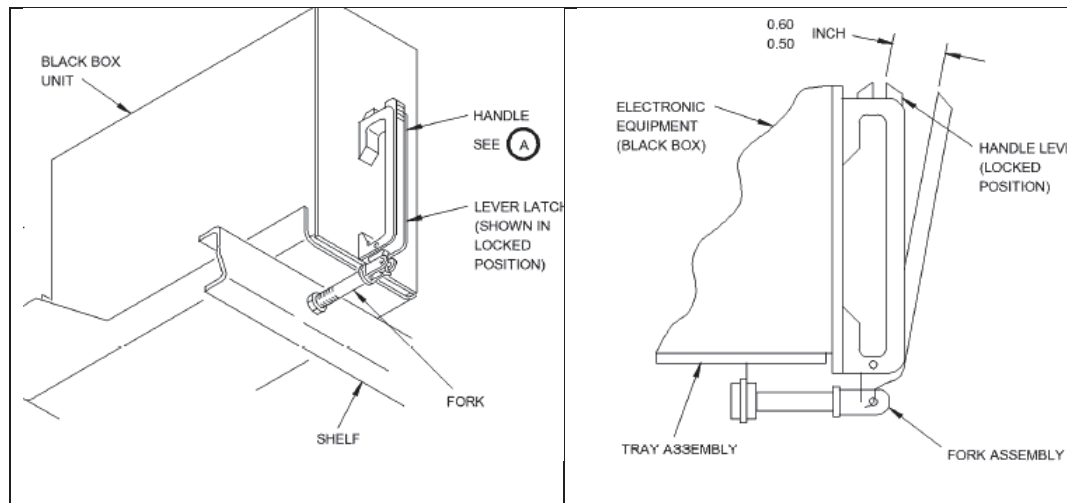
**Figure 3**

The GCUs are mounted in the electrical equipment rack and are fitted by sliding the unit rearwards into the tray with the handle lever in the open position and ensuring that the guide pins at the back of the tray engage in the frame (Figure 3). Once the unit has been pushed in far enough, the hook at the bottom of the handle lever will engage with the fork assembly that is attached to the shelf. The handle lever is then moved into the locking detent securing the box in the tray. The Aircraft Maintenance Manual<sup>3</sup> (AMM) provides further instructions to ensure that the handle and fork assembly have been correctly adjusted.

Racking of Generator Control Unit

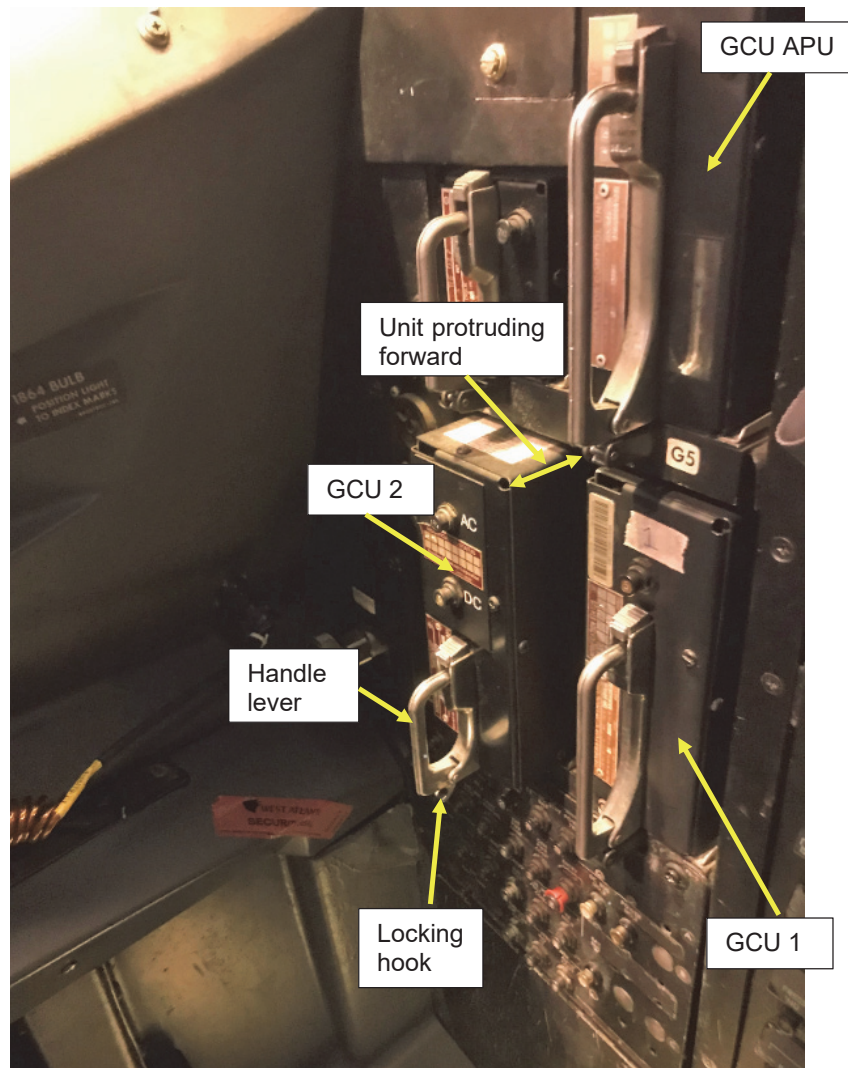
**Figure 6**

After the incident flight, GCU 2 was found to be protruding from the equipment shelf by approximately 3 cm. This would have been sufficient for the contacts at the rear of the electrical unit to disengage with the contacts in the shelf (Figure 6). The handle lever, which was in the locked position, was found to be serviceable and the locking hook and fork intact. There was no visible damage to the electrical shelf, tray or its connectors. The electrical unit was re-racked and the right engine electrical generating system was tested and found to be serviceable.

GCU 2 protruding forward

The electrical failures that occurred during the landing at Amsterdam and on the subsequent flight to East Midlands were caused by GCU 2 moving forward in its rack far enough to cause the electrical connectors to disconnect. The flickering lights and screens indicate that initially there was a partial connection that was intermittent, but on landing at East Midlands the GCU appears to have moved forward sufficiently for the connector to fully disconnect. This would have resulted in the loss of: Gen 2; Gen Bus 2; Transfer Bus 2; 115V AC Electronic Bus 2; 28V DC Bus 2; and 28V DC Electronic Bus 2. Electrical System 1 would still have been powered by the APU generator through Gen Bus 1.

This serious incident was caused by the incorrect racking of GCU 2 which moved forward in flight initially causing an intermittent and then total disconnection of the electrical connector. The aircraft was not designed to operate with the GCU disconnected and the crew were presented with an unusual situation that was not covered in the QRH.

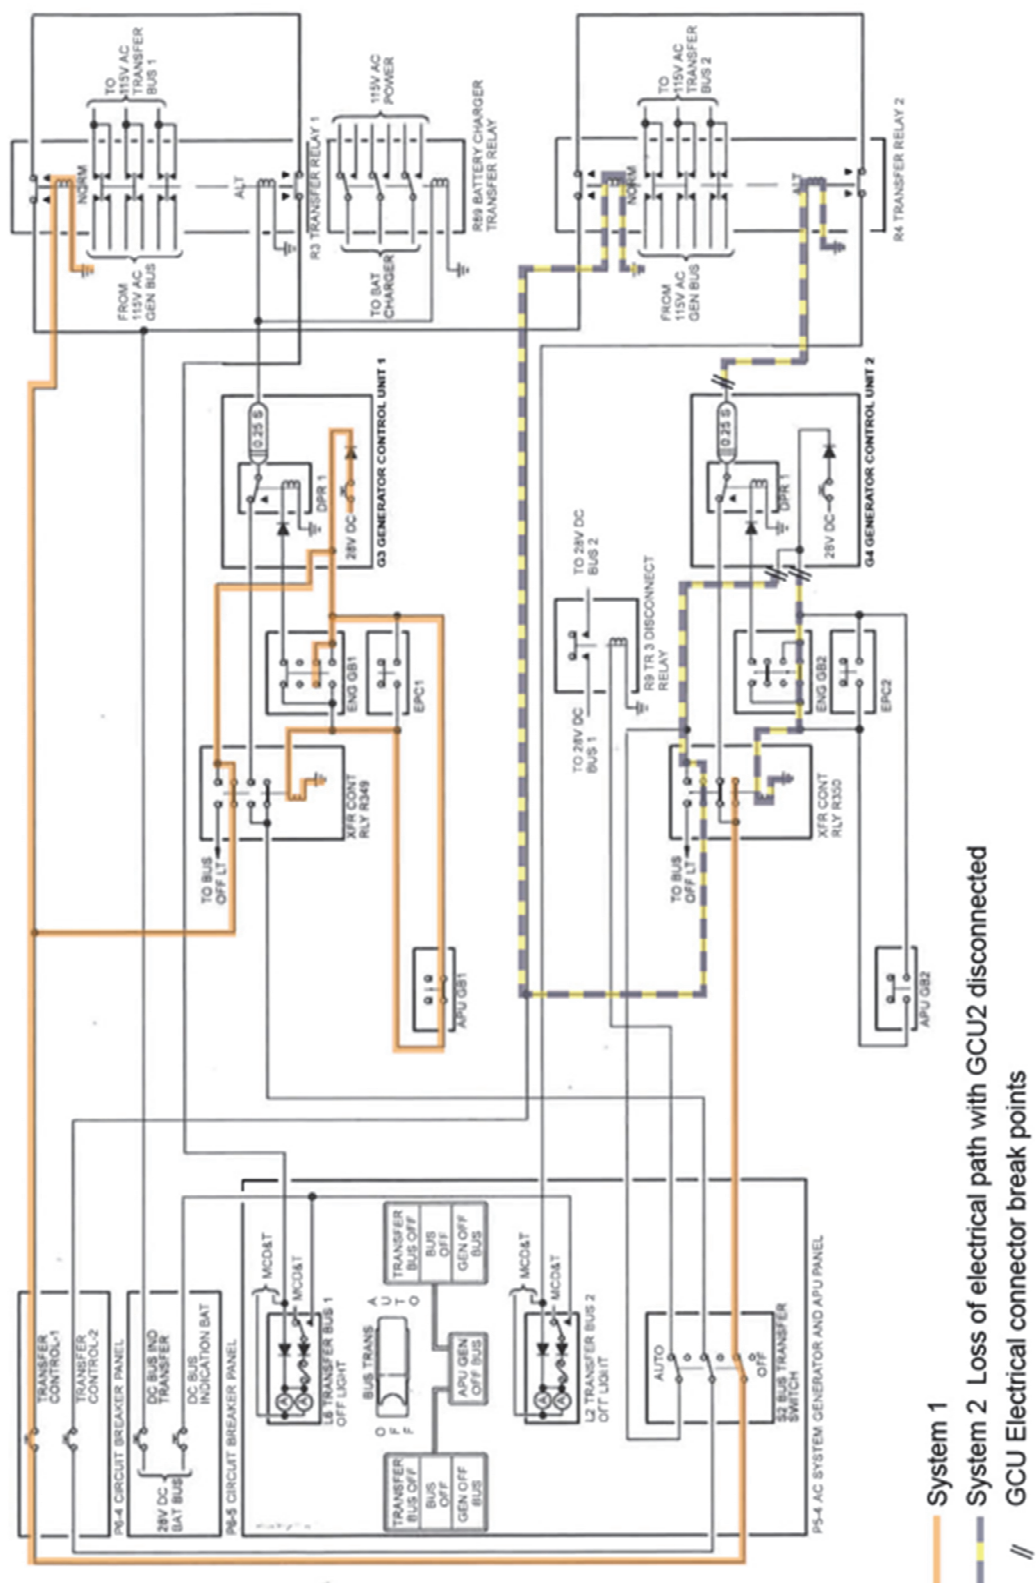
Figure 8

Routing for electrical power after disconnection of GCU2
