Air Accident Investigation Sector

Incident - Final Report -

AAIS Case N°: AIFN/0004/2018

Slow Cabin Depressurization during Descent

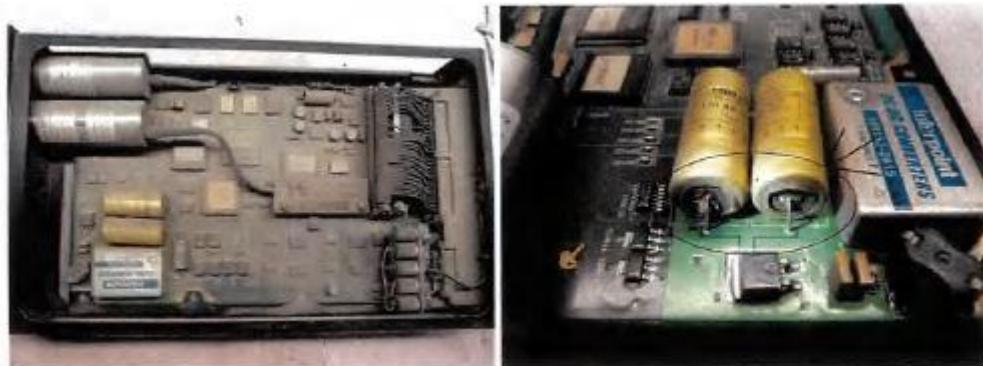
Figure 5. CPC1 transduced boards

During the visual inspection of CPC1, heavy contamination of capacitors 1803 and 1804 was found. The mainboard was heavily covered in dust. Leaking and corrosion marks

were visible on the ARINC⁸ plug and the pins of the transducer board (figure 5). The unit had been in service for about 5 years and 4 months, which explained the level of contamination. An NVM readout was performed.

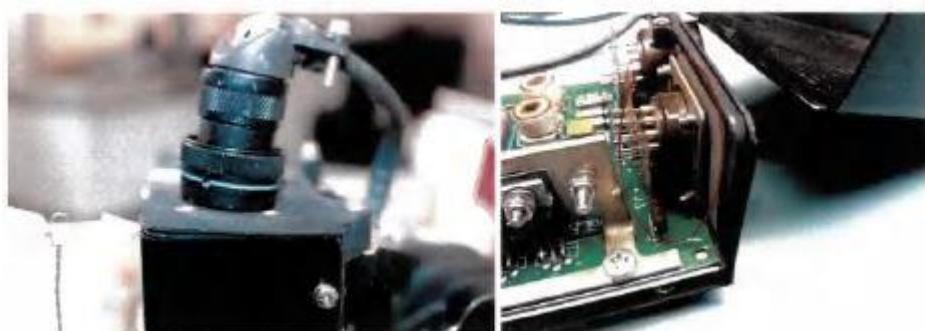
Figure 6. Outflow valve – E-box 1 with damaged cover and bent connector J3

It was revealed that electronic box 1 (E-Box 1) had a damaged cover, and the connector J3 was in a bent condition (figure 6). Despite these findings, the outflow valve passed the functional test in accordance with the CMM. Both electronic boxes also passed the functional test in accordance with the CMM.

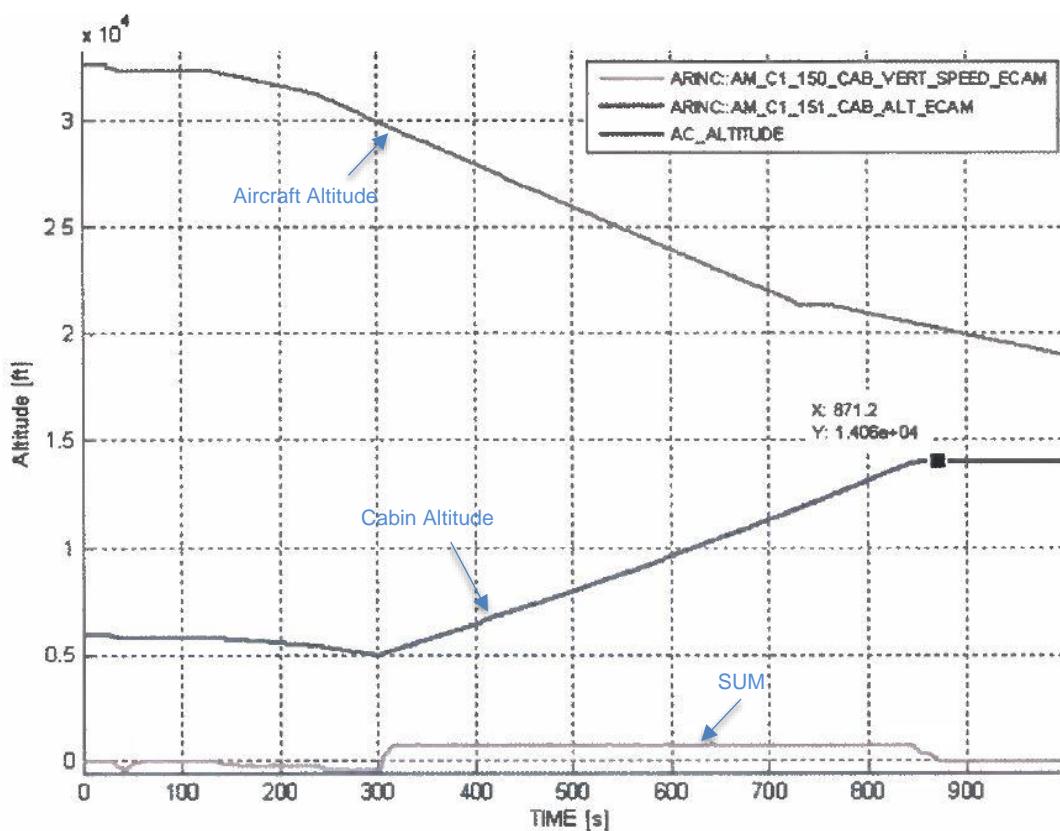
Figure 7. Hardware in the loop system test – faulty state change

The above-mentioned system behavior was detected using an analytical approach that had been verified in the earlier hardware in the loop system tests. A faulty state change in the SUM software parameter was entered into the CPC in descent mode, and the expected behavior could be proven (figure 7).

As shown in figure 7, at the time of 140 seconds, descent mode was commenced by the CPC, and the cabin altitude commenced to pressurize towards a landing field elevation of 1,000 feet.

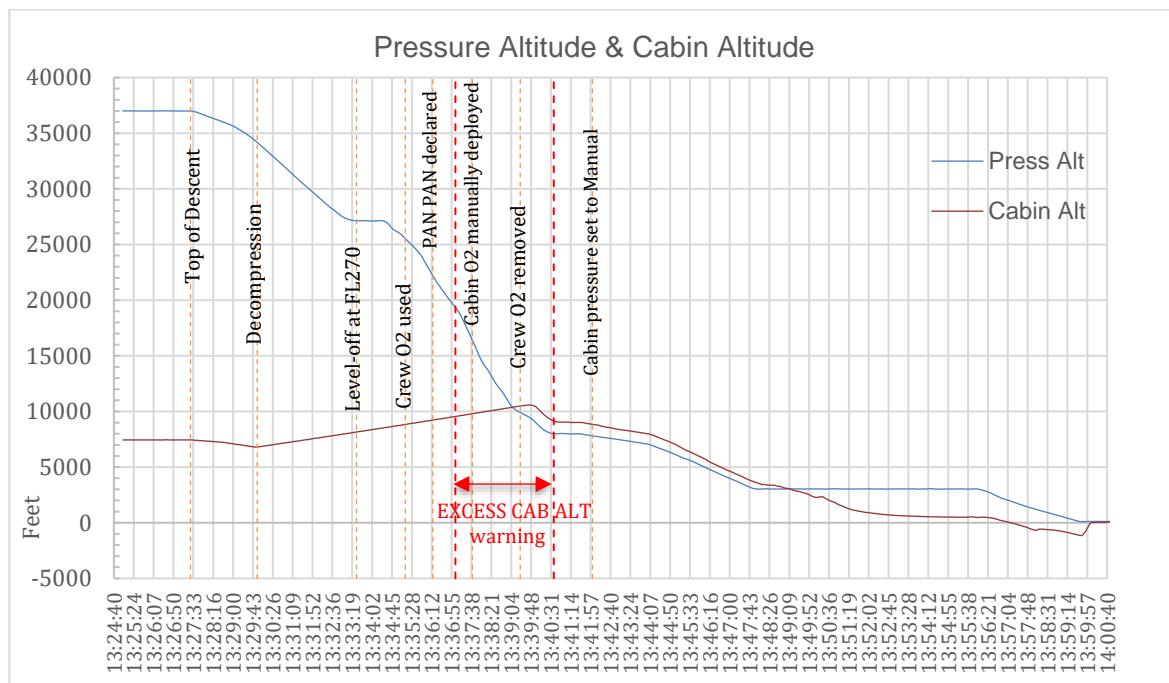
Figure 11. Aircraft pressure altitude and cabin altitude

CPC1 was in control of the cabin pressurization system and it regulated the cabin altitude towards the landing field elevation. However, CPC1 performed 'normal' operation of pressure control for a high landing field elevation. The cabin altitude rate of 300 to 400 feet per minute and the outflow valve function were found fit and stable for the controlled decompression rate. Even though the landing field elevation was adjusted correctly to the OPKC airport elevation, CPC1 did not use this correct value to regulate the cabin altitude towards the scheduled landing field elevation of 96 feet. Instead, it most probably used a corrupt value that led it to regulate the cabin altitude towards a high landing field elevation.
