Investigation Report

Type of Occurrence:	Accident
Date:	15 February 2013
Location:	Berlin-Schönefeld Airport
Aircraft:	Airplane
Manufacturer / Model:	Embraer / EMB-500
Injuries to Persons:	None
Damage:	Aircraft severely damaged
Other Damage:	Aerodrome equipment
State File Number:	BFU CX001-13

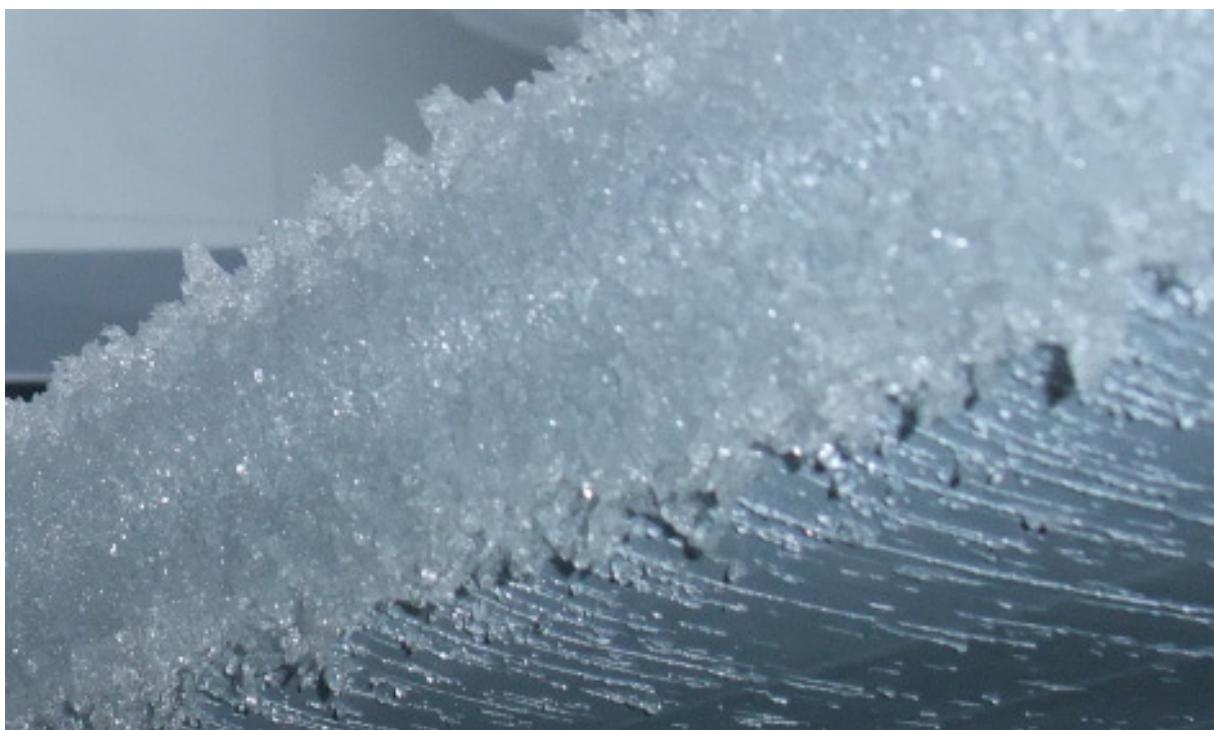
Image 6: Detail of the ice accretion at the wing leading edge

Depending on the temperature and size of the water droplets in the air, aircraft structural icing can appear in different forms. Large, supercooled water droplets do not freeze completely on impact with the aircraft structure but spread as liquid and then freeze as clear ice. Small, supercooled water droplets result immediately in rime on impact with the cold aircraft structure. Rime consists of ice crystals with enclosed air and has a milky-white appearance. With regard to wings rime accretion starts in the area of the stagnation point. There also is a mixed form of clear ice and rime.

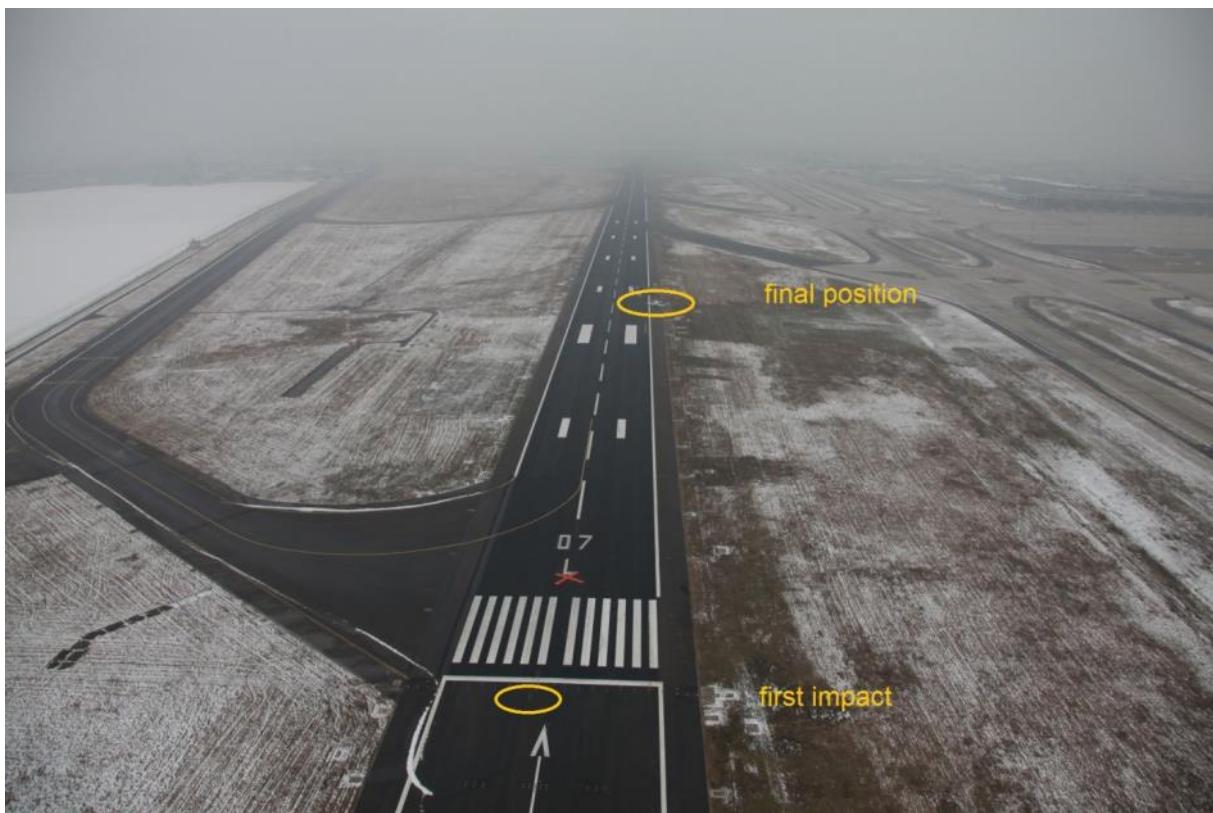
Image 7: Overview accident site, viewing direction north-east

The traces on the asphalt of runway 07L and on the left wing of the aircraft showed that the airplane's left wing tip had initially had ground contact about 7 m prior to the displaced threshold, which is marked with a white bar, and about 4 m left of the runway centre line. Rubber deposits were found about 4 m behind the threshold from the nose landing gear wheel and another 6 m farther from the right main landing gear wheel.

The airplane had come to a stop about 447 m from the threshold beyond the right runway edge marking but still on the asphalt area.

The right flap was deformed. The right main landing gear had fractured and folded back. Parts of the landing gear had penetrated the upper surface of the wing. The wheel of the right main landing gear was destroyed. About 20% of the wheel rim and parts of the flap track and carriage had been abraded.

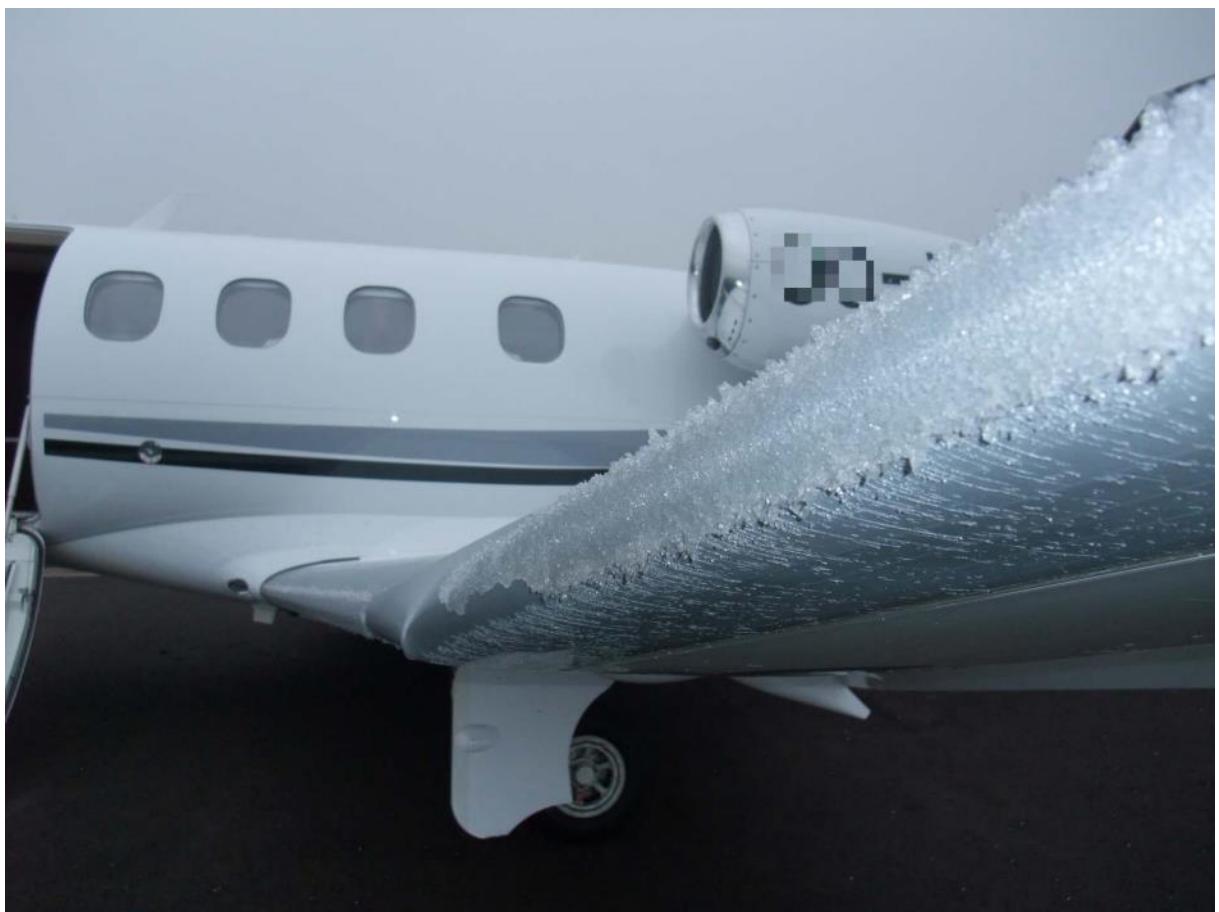
Image 8: Ice accretion about 50 minutes after the accident

Some representatives of the aviation supervision office arrived at the site a few minutes after the accident. They photographed an ice accretion of up to 10 mm at the nose, the entire length of both wing leading edges, the leading edges of the horizontal stabilizer, and the front end of the landing gear components. Three hours after the accident as the BFU investigation team was examining the wreckage the ice accretion was still visible.

The ice accretion was about 4 cm wide, had a milky, rough, crystalline appearance and a slightly concave form with strongly developed feathering at the upper and lower edges. In addition, the upper and lower surfaces of the two wings showed a

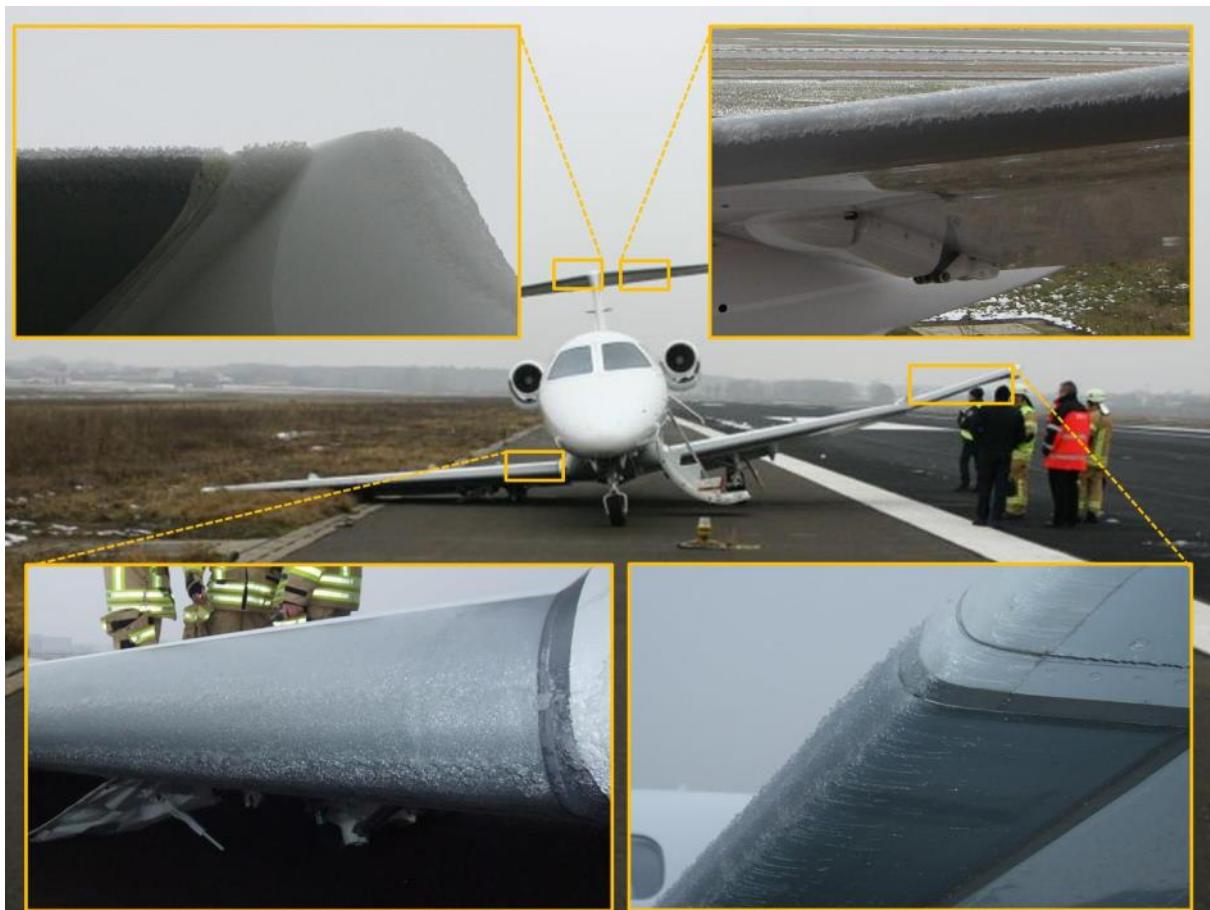
Image 9: Ice accretion

lamellar ice accretion. There was no ice accretion on the left wing, where the impact had caused a bend.

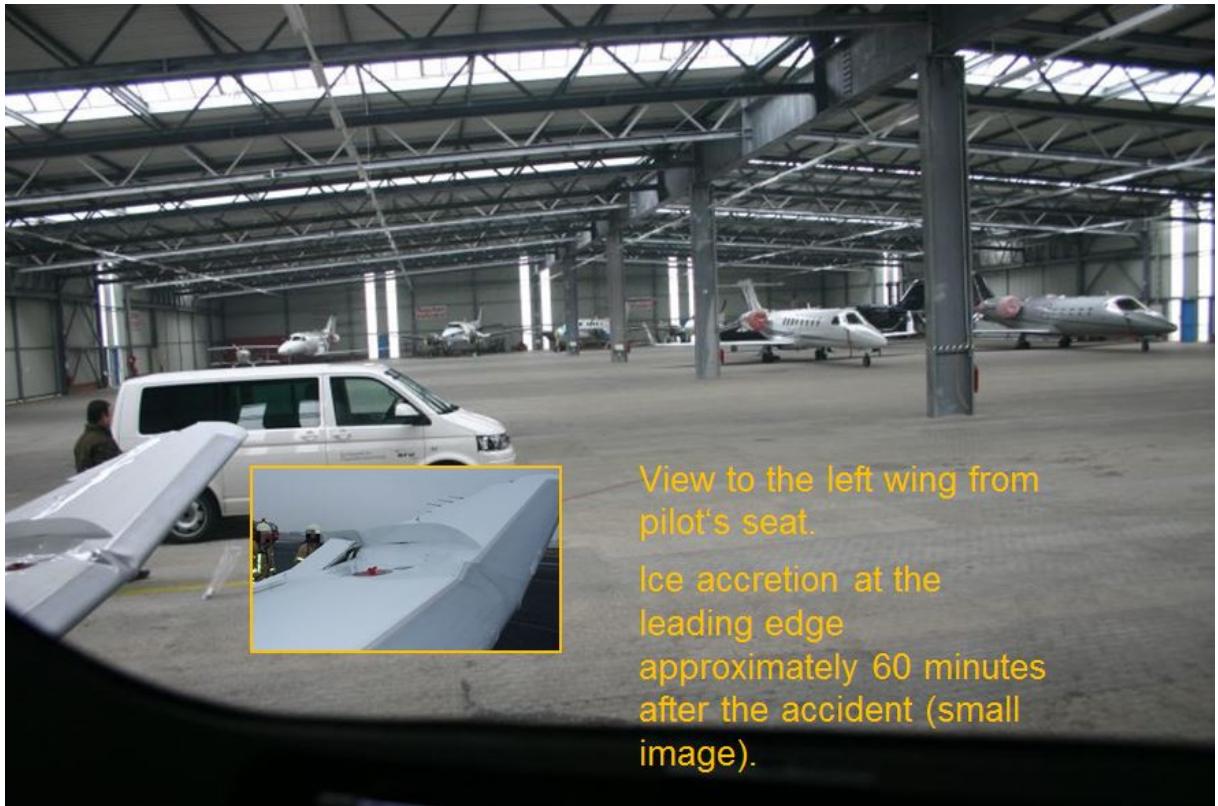
Image 10: View from the left-hand pilot's seat to the left wing

During the investigation of the aircraft a photo was taken of the view from the left-hand pilot seat toward the left wing. In order to understand the PIC's statement, a photo with a similar viewing direction, documenting the ice accretion on the left wing leading edge approximately 60 minutes after the accident, was inserted (Image 10).
