Aircraft Accident Investigation Board

Interim Report

State File Number: A961129EPATS
Type of Occurrence: Accident
Date of Occurrence: Feb 18th 2018
Place of Occurrence: Near Yasouj Airport
IRI of IRAN
Aircraft Type: ATR 72-212
Registration: EP-ATS
Operator: Iran Aseman Airlines

Aircraft ATR72-212 registered EP-ATS

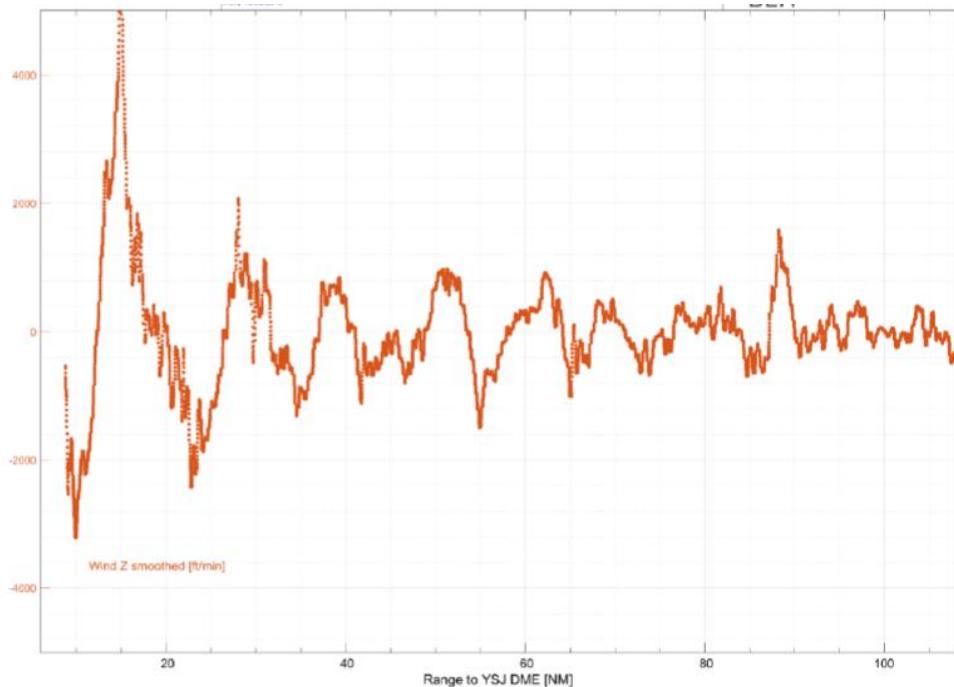
Figure No; 6 calculated Vertical Wind

Based on FDR Analysis by BEA, Drawing the computed vertical wind values versus the range to the DME of Yasouj really shows the oscillations of the vertical wind (Figure 6) with a long range period during the accident flight.

It was estimated that the accident site had moderated turbulences with condition moderate up to locally severe icing. There was unstable conditions and stormy in the accident site and it was covered by clouds. The Area Forecast at the time of accident was received on 03/03/2018 from METEO France which shown in Fig7 .

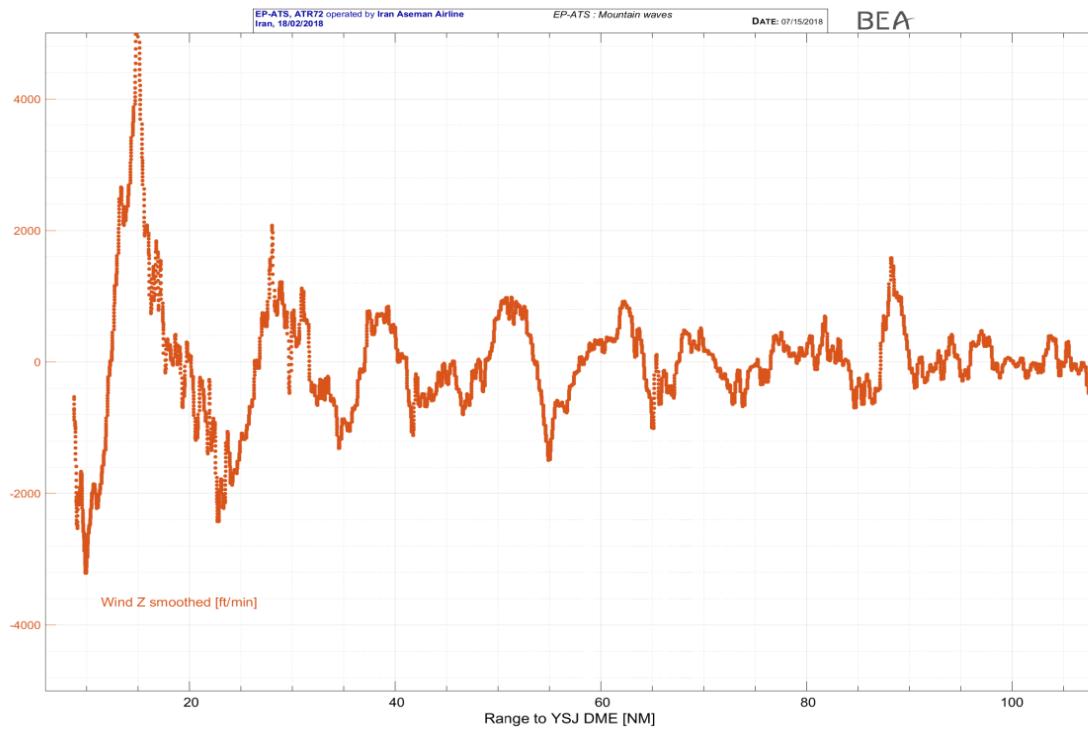
Figure 12: Computed vertical wind during the accident flight.

Drawing the computed vertical wind values versus the range to the DME of Yasouj really shows the oscillations of the vertical wind with a long range change during the accident flight.

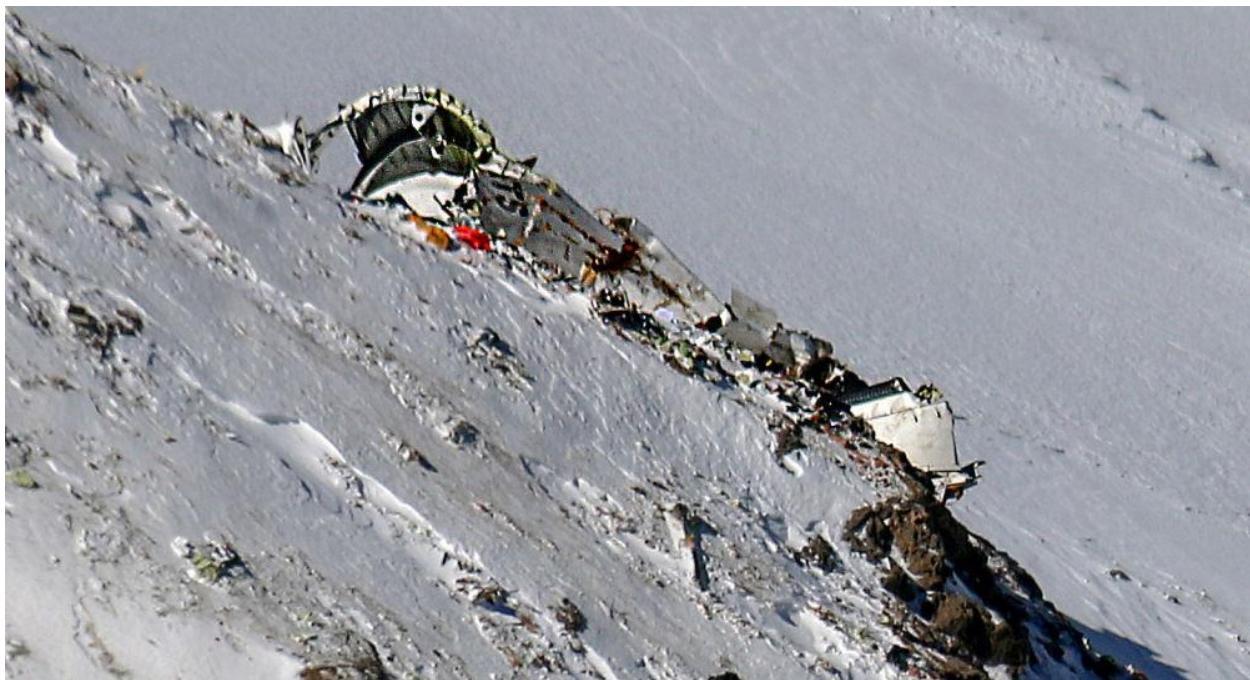
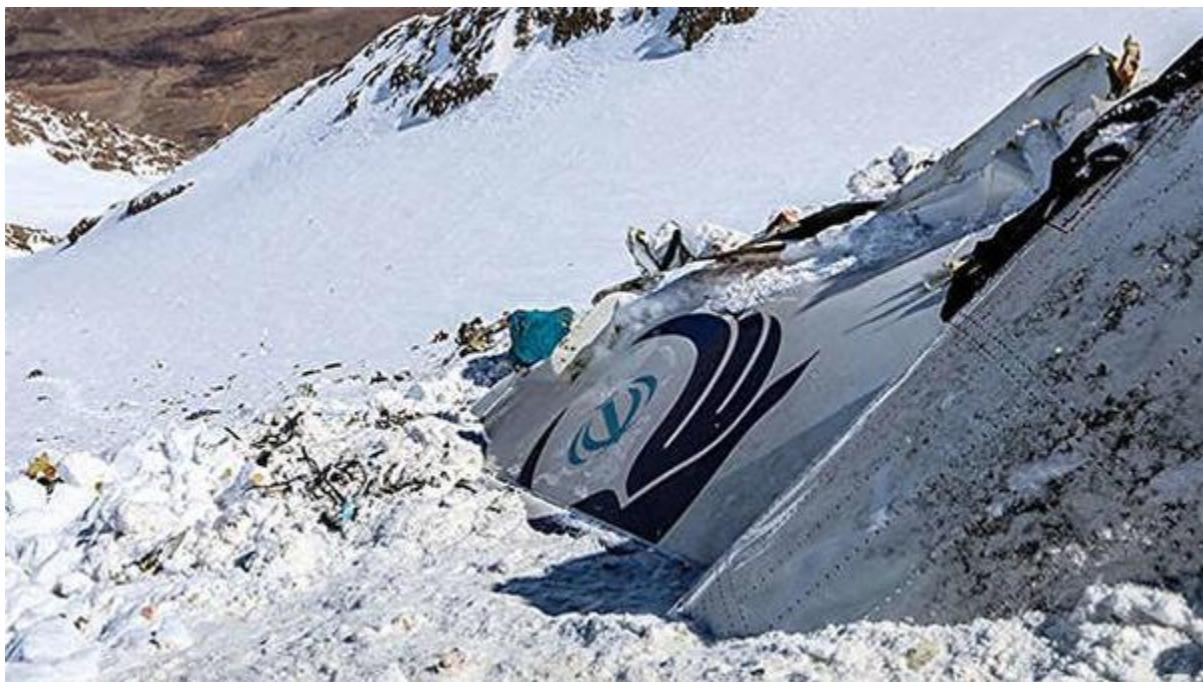
Figure No; 13 Accident Site:

The accident site was found by localizing tail section of aircraft with Aseman airline logo on vertical stabilizer.

The wreckage was fragmented with a large amount of debris spread over an area in a sloping rocky ravine which was covered by snow. Due to snowfall on the night after accident time, the wreckage was covered with snow completely and it was not possible to find parts of the aircraft and transfer the pieces easily. The technical investigation on wreckage parts was not possible. At the scene of the accident, the Mountain ravine and local winds have been felt to endanger any flight to the accident site to access the site.

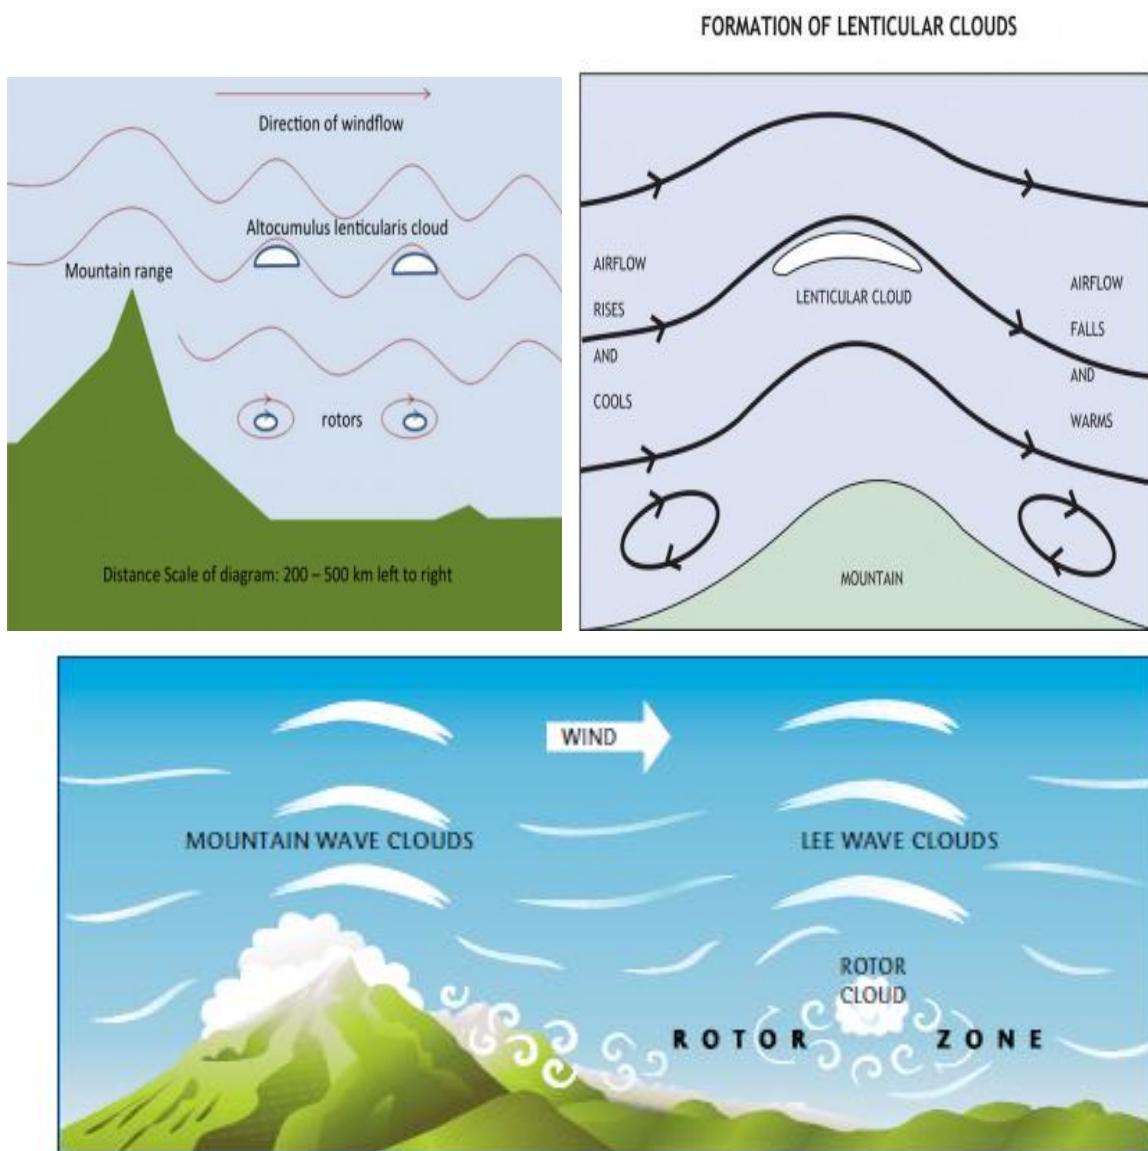
Figure No; 19 Effect of Mountain Wave

Vertical air stream (up & down Drafts) with turbulences can reach more than 3,000 ft/min. Mountain Waves are associated with severe turbulence, strong vertical currents, and icing. The combination of these strong vertical winds and surface friction may cause rotors to form beneath the mountain waves causing severe turbulences with high load and acceleration on the aircraft. Usually, the pilots like to fly with minimum safe speed to prevent vertical oscillation of the aircraft. They should be careful for speed monitoring and stall prevention.

The aircraft tracking and FDR analysis showed the flight crossed the Up & down draft. The updraft and downdraft computed wind values were confirmed by the airplane attitude. Following the engagement of the altitude hold mode, an updraft wind made the autopilot request a pitch down attitude, while a downdraft wind made the autopilot request a pitch up attitude. The reactions of the autopilot were consistent with maintaining the airplane at the target altitude. The crew increased the engine power from 47% to 73% TQ to prevent speed drop but aircraft performance was not enough against high rate of down draft (about 3200 ft/min). So near the mountain the aircraft experienced significant reduction in airspeed and wing lift factor as effect of down draft.

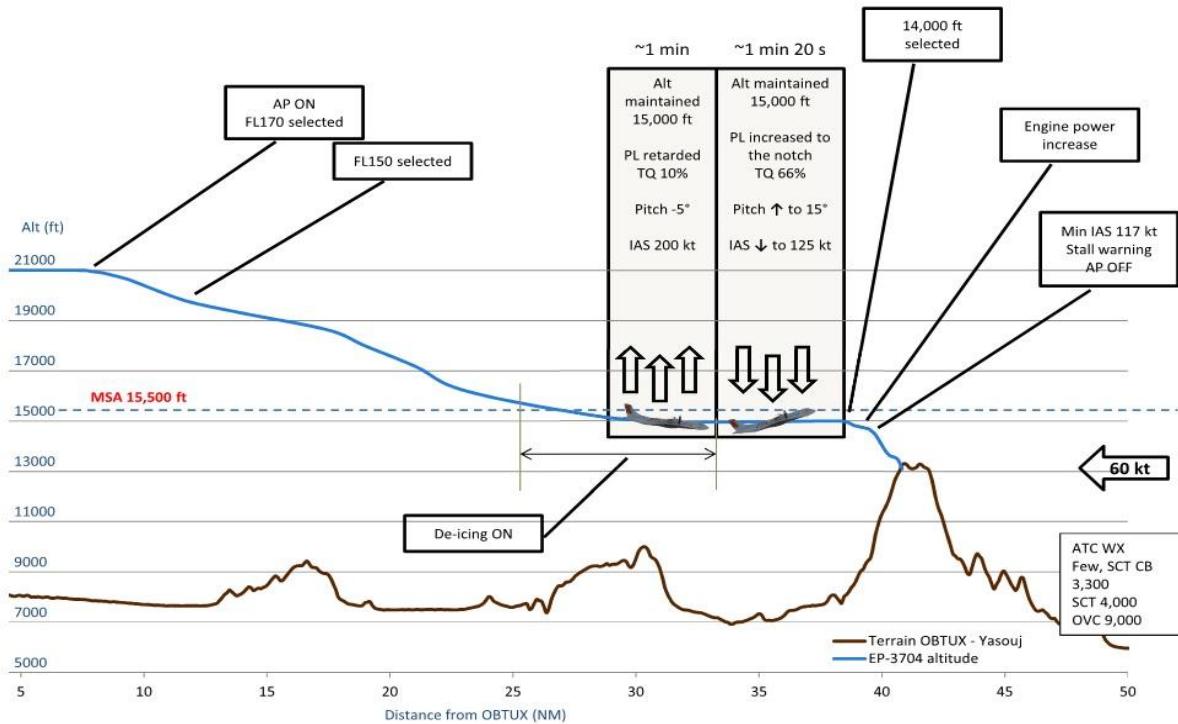
Figure No; 22 Up & Down draft for flight prepared by ATR

From 09:29:28 to 09:30:45, the vertical wind direction changed. It gradually moved from an updraft wind to a downdraft wind. The aircraft pitch started to increase and the IAS decreased, drag increased accordingly. Then power levers were progressively pushed towards the notch, with engine torque increasing. Based on CVR, the pilot told "wow" which might be due to understanding low speed and focused on putting off a system which leaded to warning prevention. They might refer to AoA after disconnecting LEV II anti-ice system.

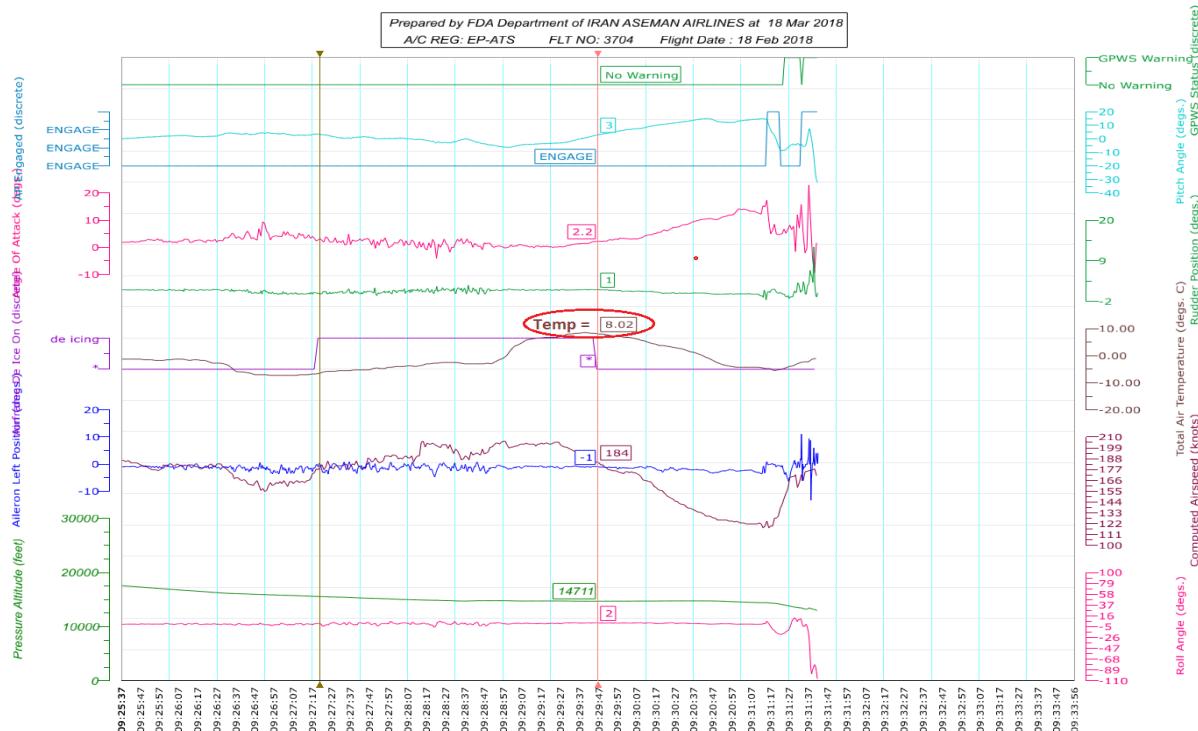
Figure No; 23 Temperature Graph of FDR

Based on FDR & CVR crew canceled Icing AOA caption and never spoke about any observation on Ice Evidence Probe (IEP).

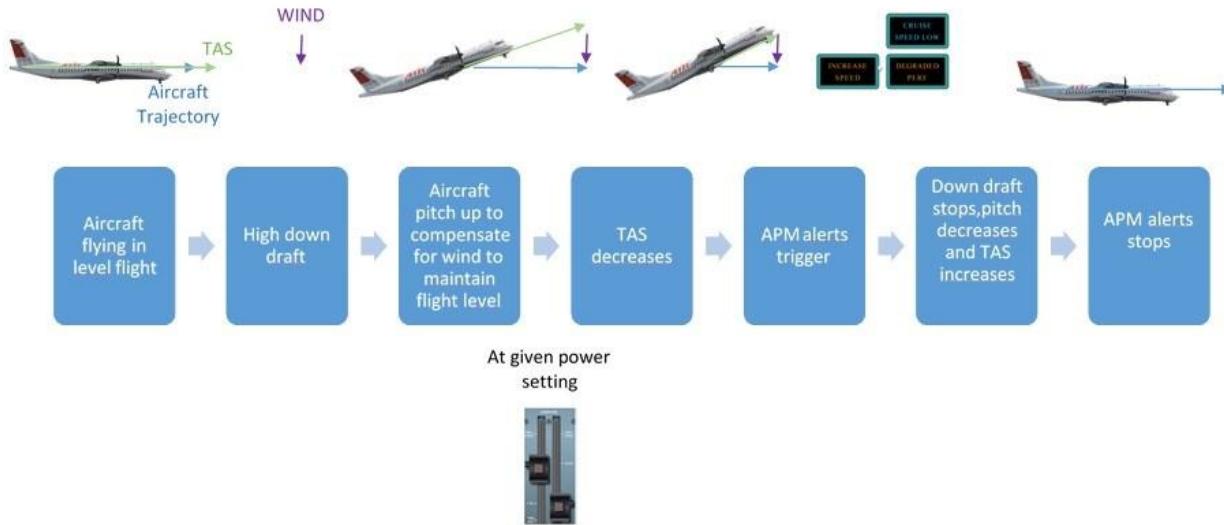
Figure 25, Illustration of wind effect on APM calculation

As a conclusion, the APM simulation tends to shows that the alerts that would have triggered are linked to a decrease in performance due to external conditions (wind gradient) rather than icing, as illustrated in the following Figure:

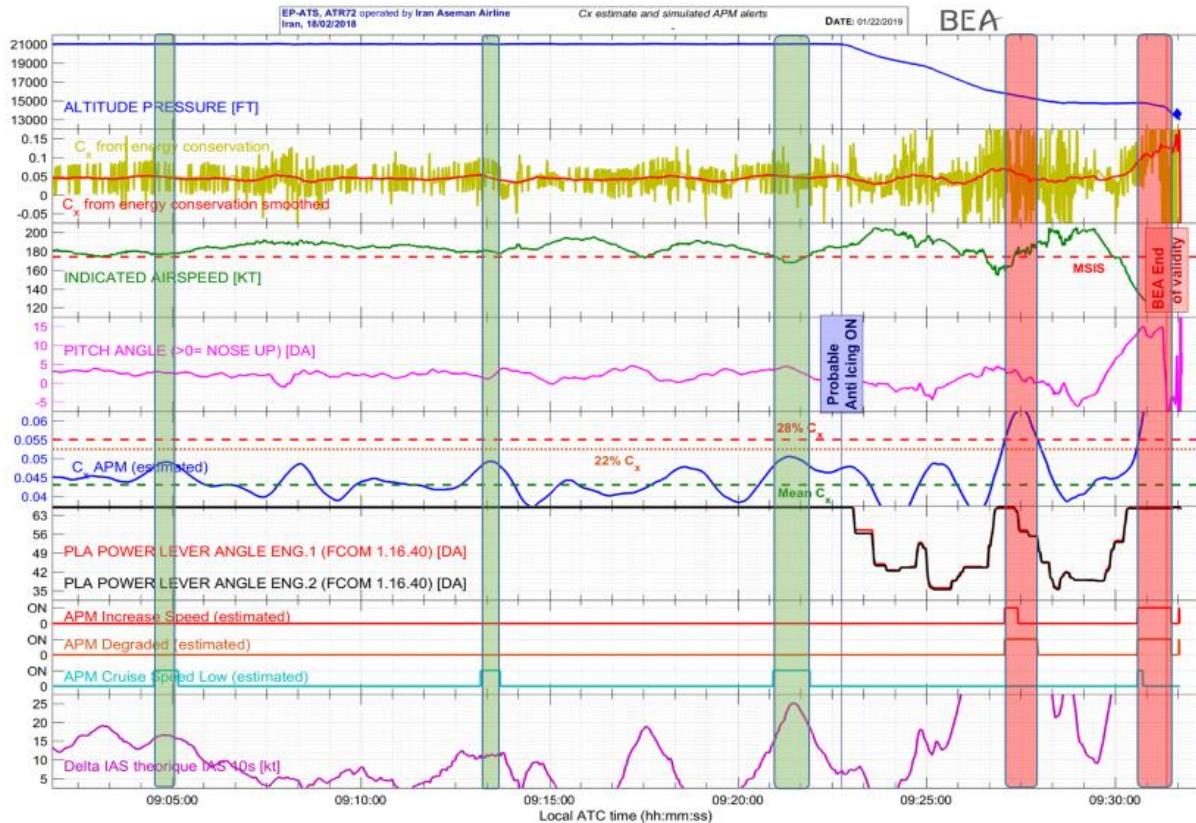
Figure 26, Estimate of C_x and potential APM alerts

The average value of the computed C_x was 0.043 during the level off at FL 210 which is a consistent value for this airplane. Specific periods of interest that are highlighted in the figure:

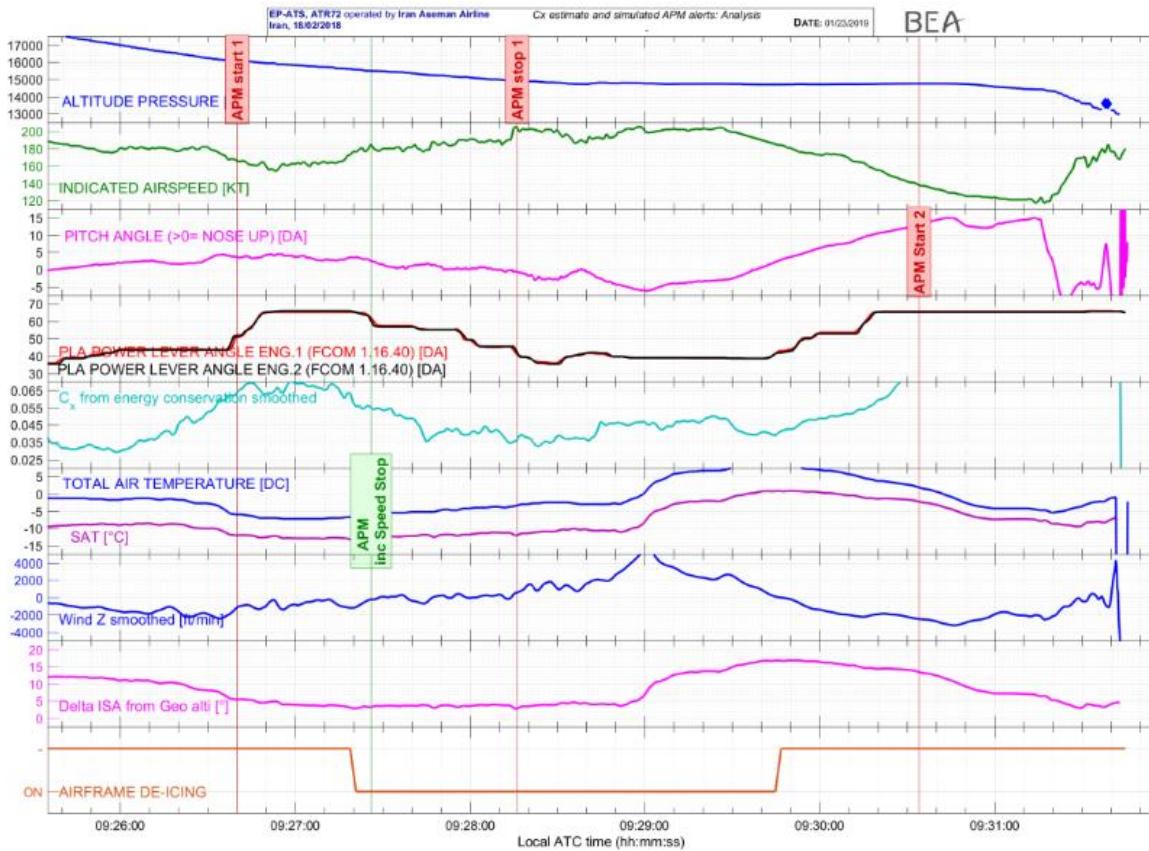
Figure 27, Simulated APM alerts - Analysis

At that time, the anti-icing level had been previously engaged. APM alert would have then triggered. APM calculation uses smoothed values over a rolling average of 60 s. The true increase of the C_x occurs before any APM alert triggering. During the flight of the event, the C_x increase leading to the first simulated APM alerts started at 9 h 26 min 00 s, the C_x increase leading to the second simulated APM alert occurred at 9 h 30 min 00 s.

- The first simulated APM alerts (both Degraded Performance and Increase Speed) would have triggered at 9 h 26 min 40 s. The first simulated APM alerts:
 - They triggered more than 30 s before the ice detector caution and the true Cx increasing occurred 70 s before the ice detector caution.
 - The degraded performance alert stopped while the SAT was still lower than -10°C.
