Accident Investigation Coordinating Committee

Report 2018/02

Final Report on the Serious Incident to
Airbus, A320-251 (VT-EXL)
Velana International Airport, Maldives
7 September 2018

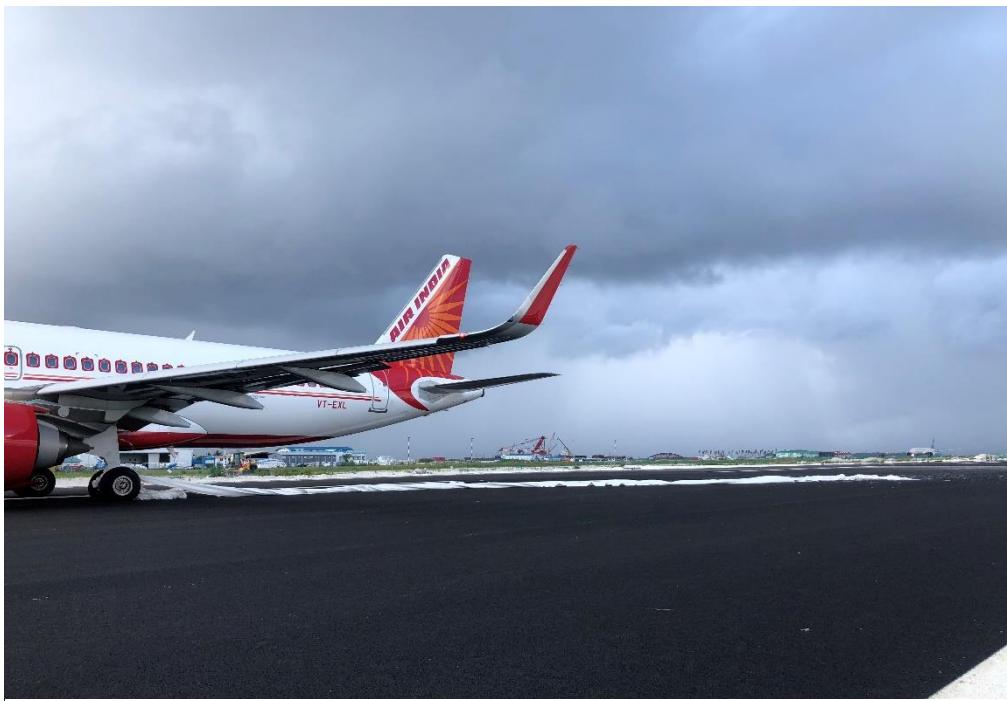
1Aircraft with white clothing

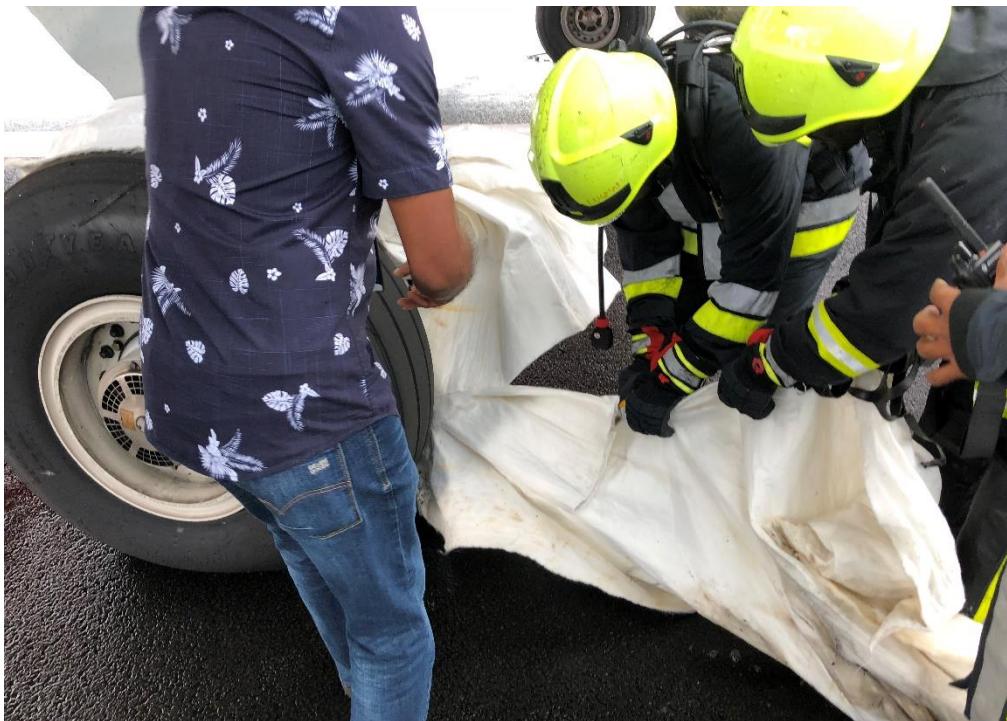
The LH main landing gear tyre was damaged.

White Clothing on tyre

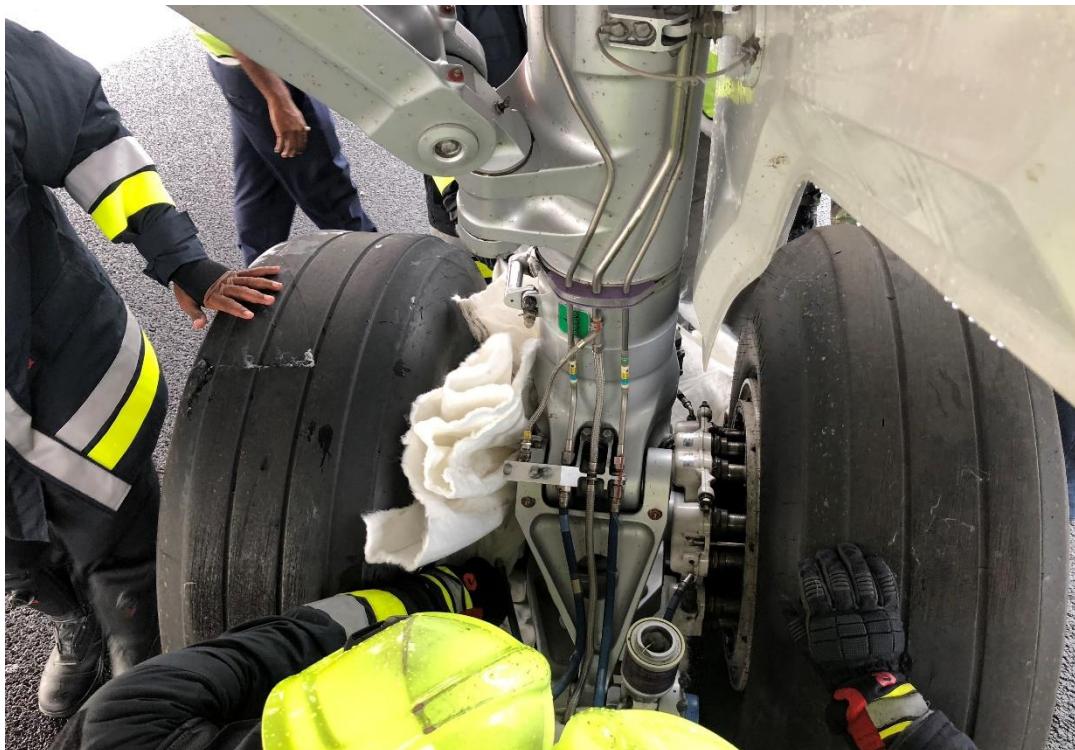
In process of removing the clothing

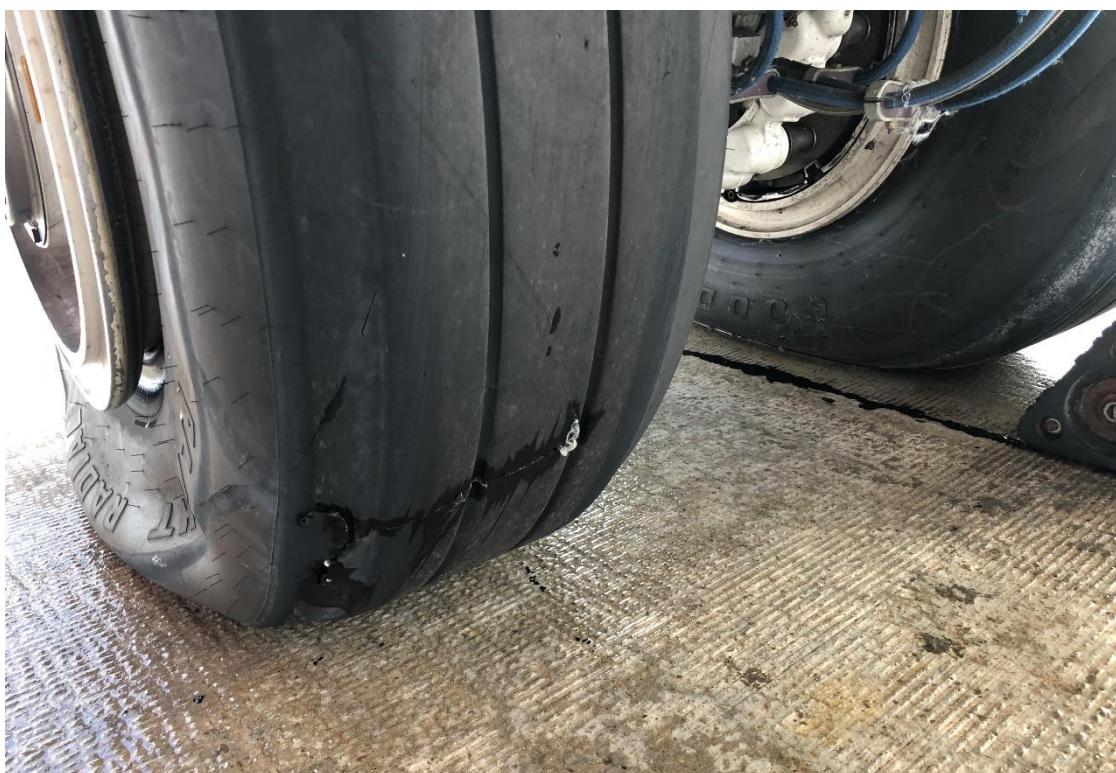
Damage to Tyre

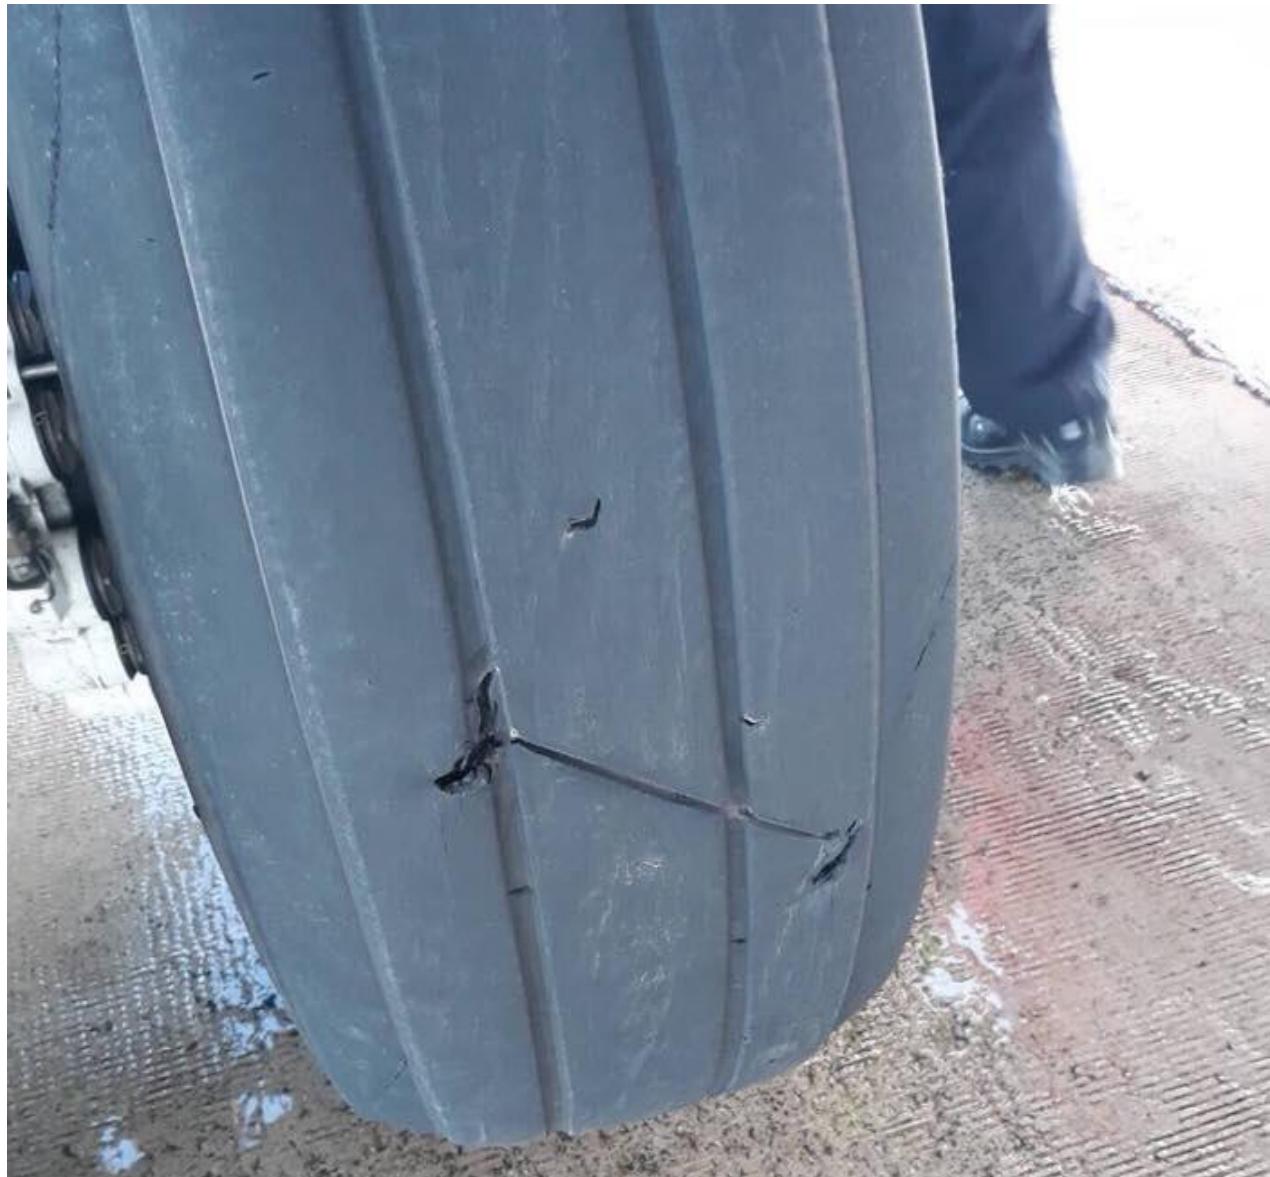
Damage to Tyre
