AIRCRAFT ACCIDENT REPORT

BHNL/2015/08/12/F

Accident Investigation Bureau

**Report on the Accident involving Bristow Helicopters
(Nig.) Limited Sikorsky S-76C+ helicopter, Registration
5N-BGD at Latitude 6°31'54" N and Longitude 3°26'16" E,
Oworonsoki, Lagos, Nigeria
on 12th August, 2015**

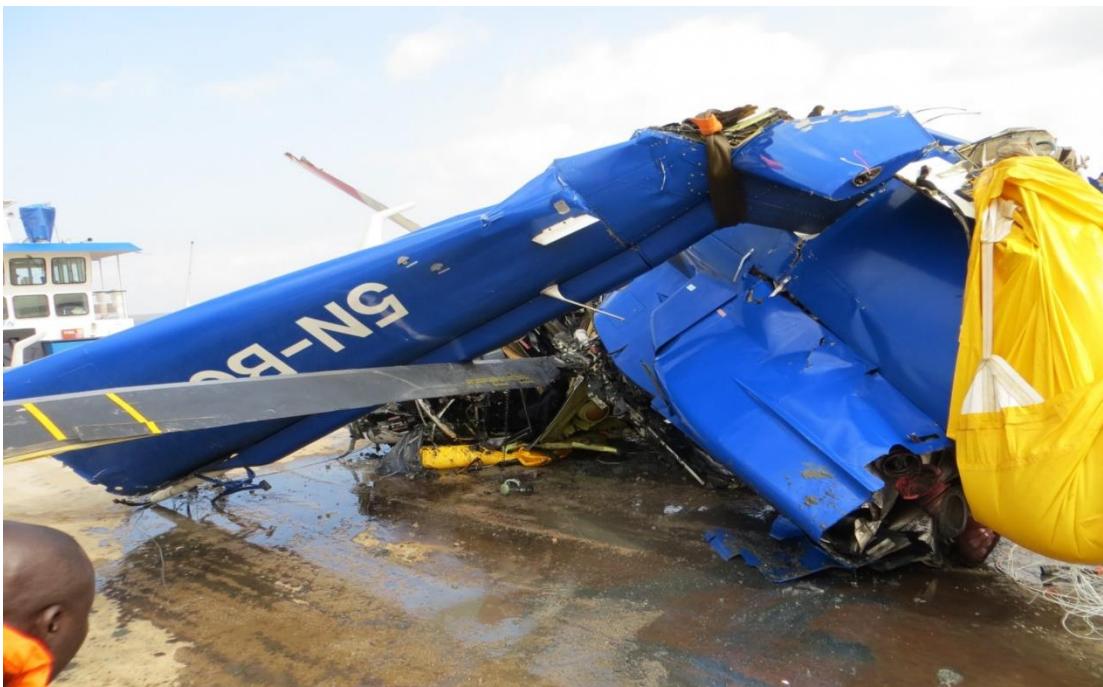
The wreckage scattered around the vicinity of the crash due to the impact forces with the water. The main wreckage was submerged except the destroyed floats that were hanging loose, still attached to the main wreckage that was visible on the surface of the Lagoon.

Figure 7: Helicopter Wreckage

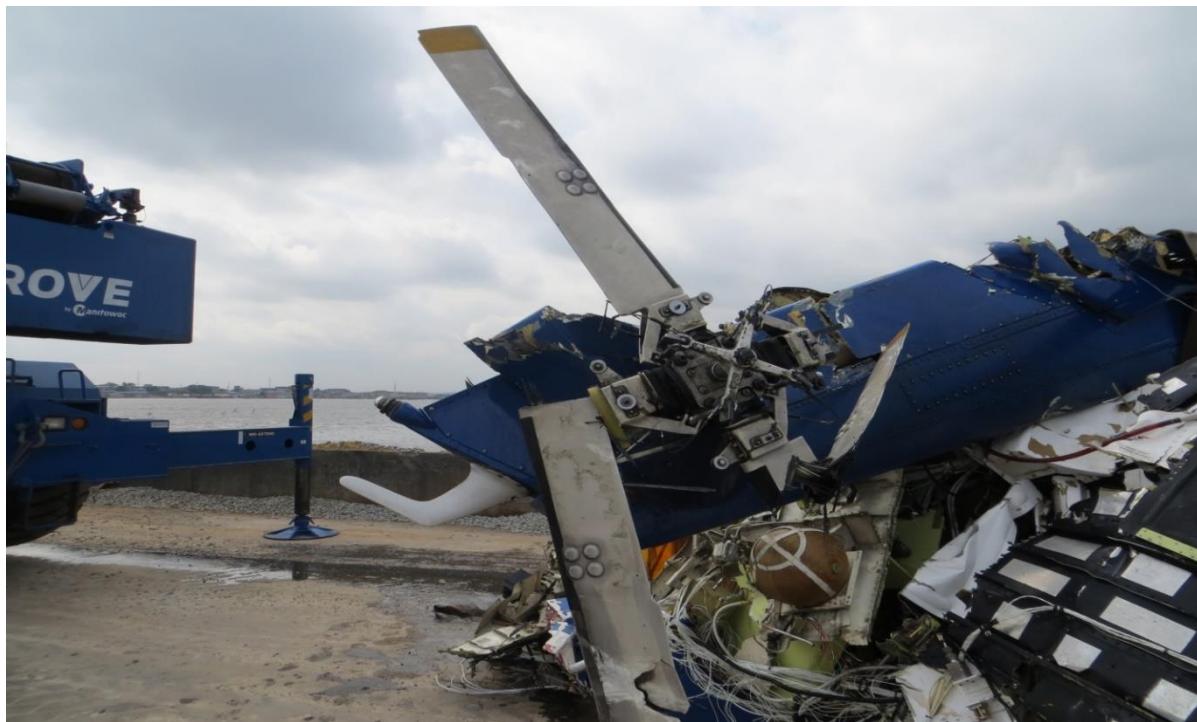
Figure 9: Parts of the destroyed tail rotor area

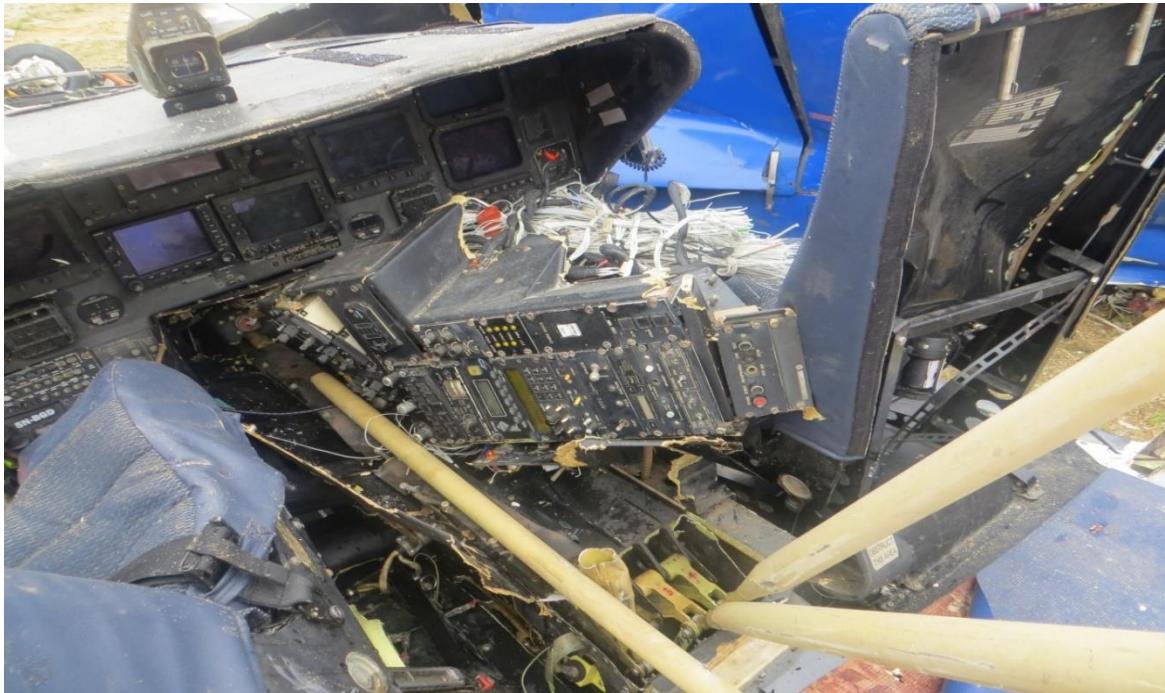
Figure 10: The Cockpit area of the wreckage

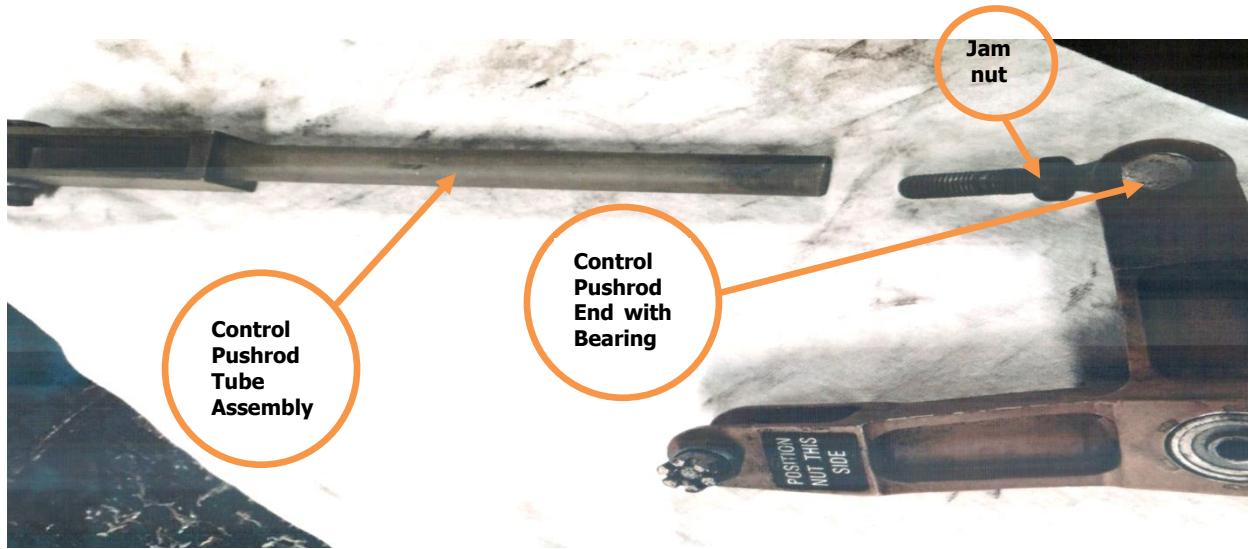
During the preliminary investigation, the Bureau discovered that the Forward Main Servo Input Control Pushrod Assembly which is also called Forward Servo Clevis Rod and Bell crank Assembly failed. The Control Pushrod tube separated from Control rod end with the bearing and the Jam nut. The Jam nut was loose and was not seating against the Control Rod. See Figures 12 and 13.

Figure 12: The control rod separated from bearing end and Jam nut

However, the cause of this accident was the wear in the Forward Servo Clevis Rod end fitting shank found in the Main Rotor Servo Pushrod Assembly. The jam nut end fitting which fits into the rod end shank, rotated freely when turned by hand pressure. According to the Materials Laboratory Factual Report, the thread peaks at the middle

National Transportation Safety Board (NTSB) USA, Laboratory metallurgical examination of the Forward Servo Clevis Rod revealed that the separation was a pre-impact condition, that is, the separation existed before the impact and therefore, the cause of the accident.

Purpose: "To perform a onetime inspection of installed Forward, Aft and Lateral Main Servo Input Control Pushrods and Jam nuts and Tail Servo Input Control Pushrods and Jam nuts for proper installation, condition and security followed by application of slippage mark on all Main and Tail Servo Input Control Pushrod Jam nuts".

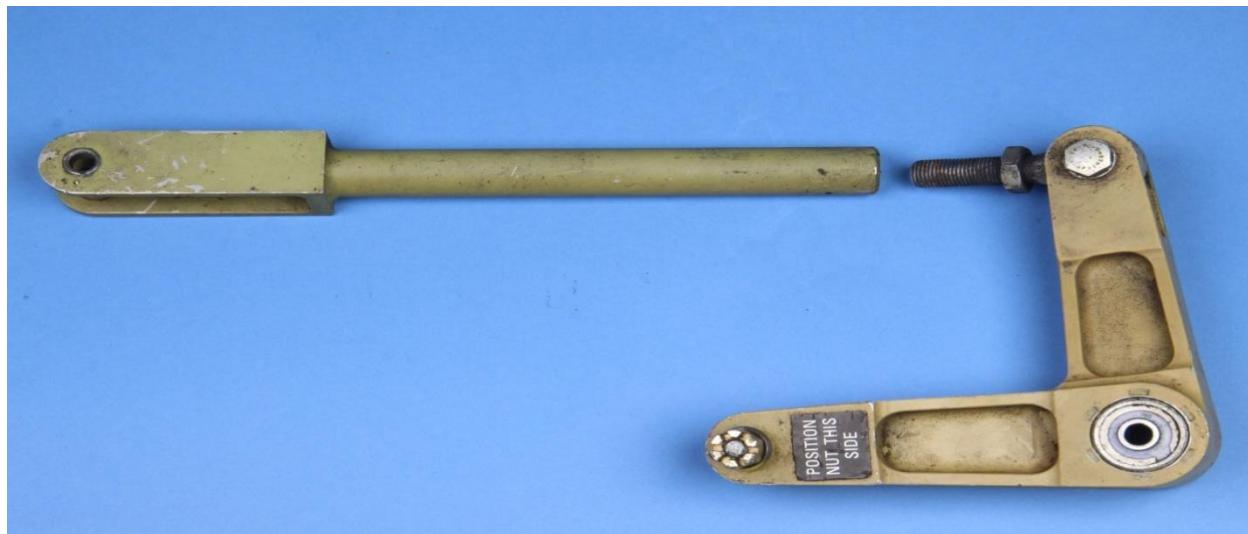
Figure 13: Control Pushrod tube separated from Control rod end with the bearing and the Jam nut (The separation of the Forward Servo Clevis Rod Assembly from the Bellcrank Assembly)

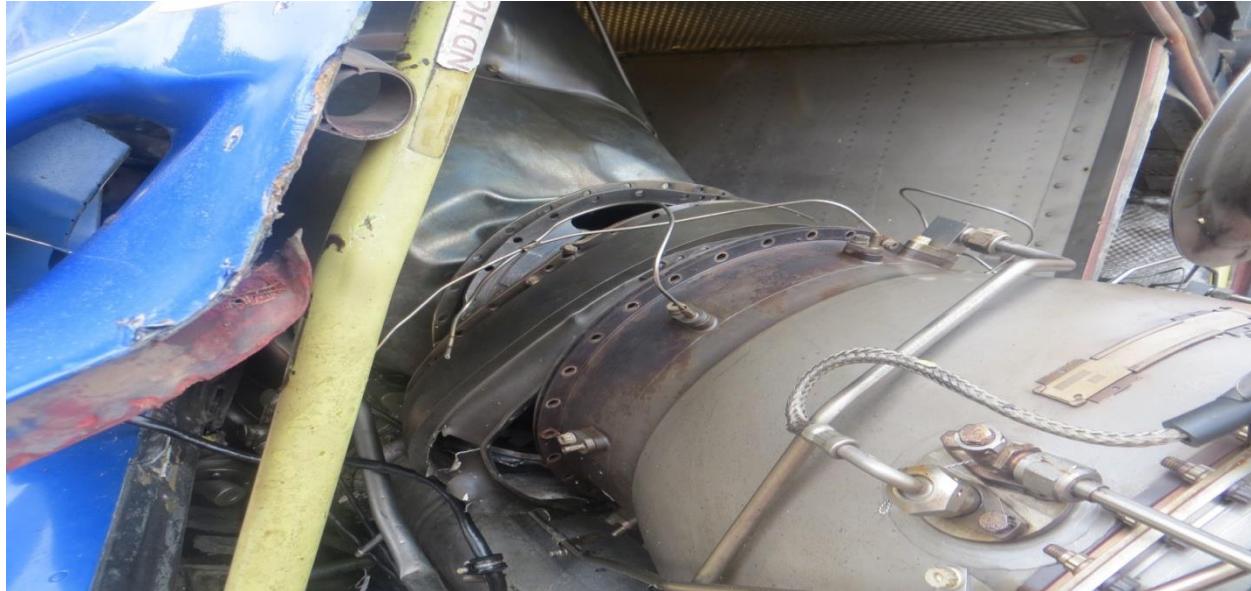
Field/Crash site examination of No. 2 Engine revealed damage associated with uncontained failure of internal components. The engines were sent to the manufacturer in France for detailed investigation with AIB investigators in attendance. **See Fig. 15 below.**

Figure 15: Uncontained damage to Engine No. 2

- *Module 4: Blade shedding phenomenon. All blades cut under the platform. Deep distortion of the free turbine support bearing. Important distortion of the containment shield. Free turbine disc complete and not damaged.*

- *Engine Number 2: The damage observed on the Modules 1, 2, 3, and 5, are consistent with an impact of the helicopter with the lagoon surface.*
- *Damage observed on the Module 4 are consistent with blade shedding phenomenon.*

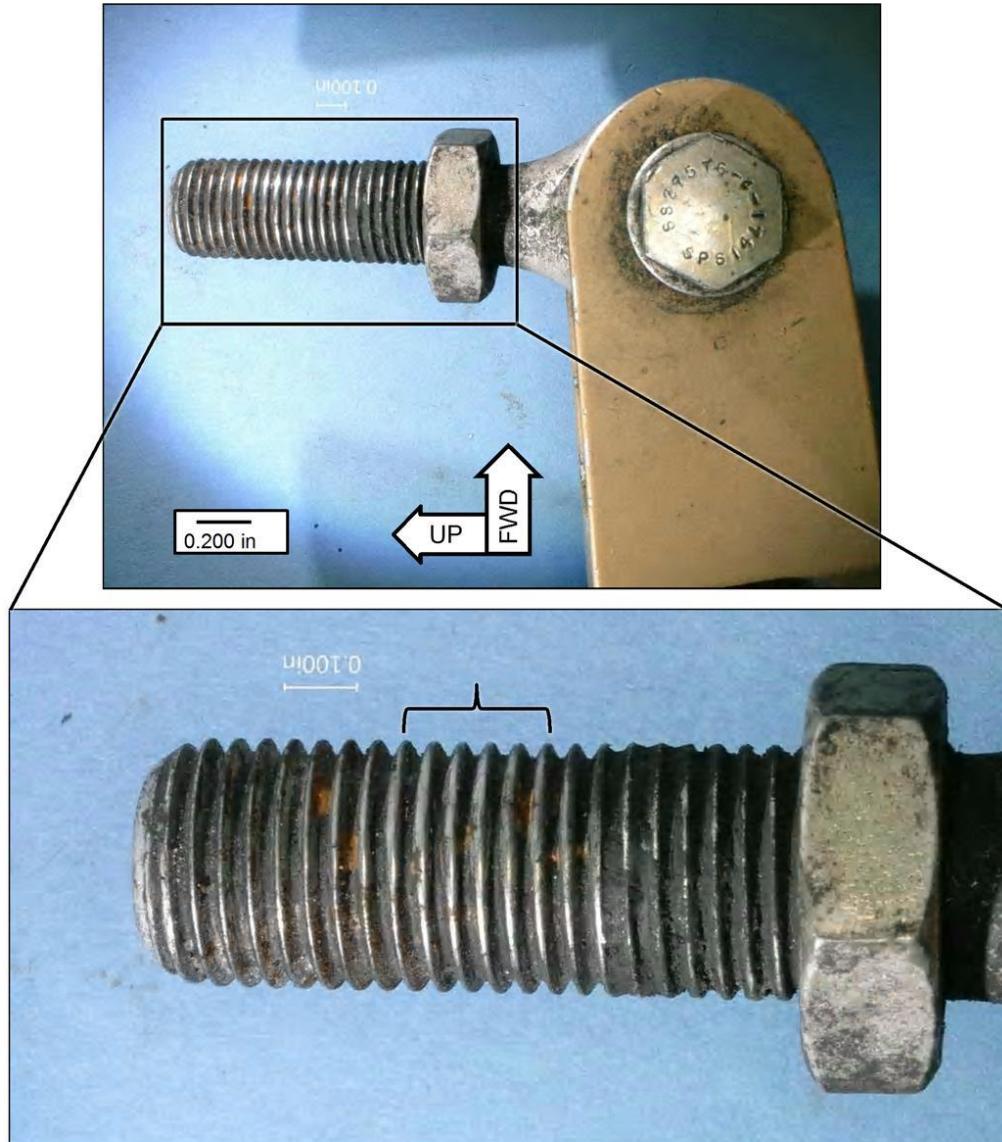
The thread peaks at the middle and upper end of the end fitting shank were smooth and rounded consistent with wear. The wear was greatest near the middle of the shank on the outboard side of the end fitting and near the upper end of the shank on the inboard side of the end fitting. Unlabeled brackets in figure 5 and 6 indicate areas of greatest wear in the threads.

Figure 5. Close view of the forward clevis servo end fitting, outboard side. An unlabeled bracket indicates an area with greater thread wear.

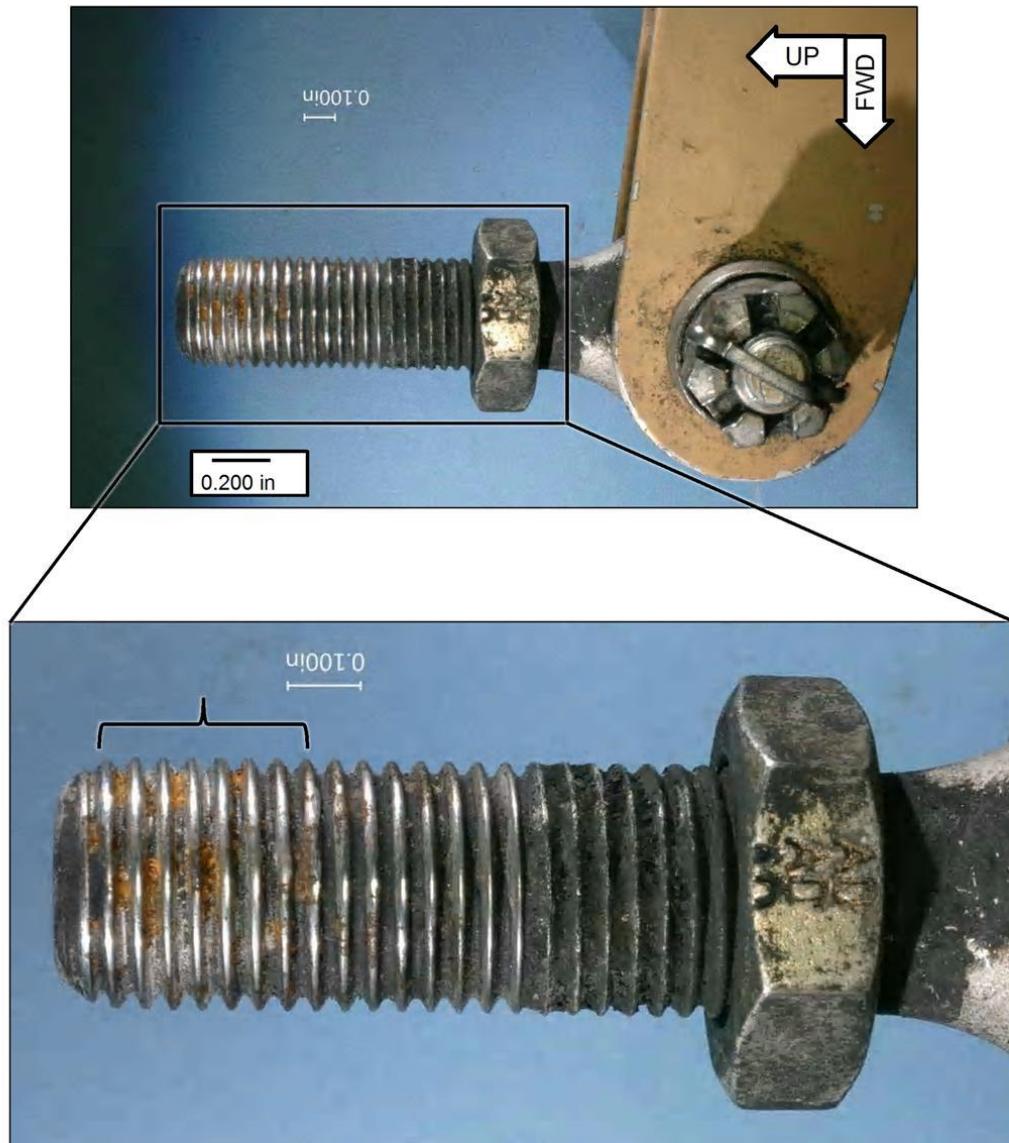
Figure 6. Close view of the forward clevis servo end fitting, inboard side. An unlabeled bracket indicates an area with greater thread wear.

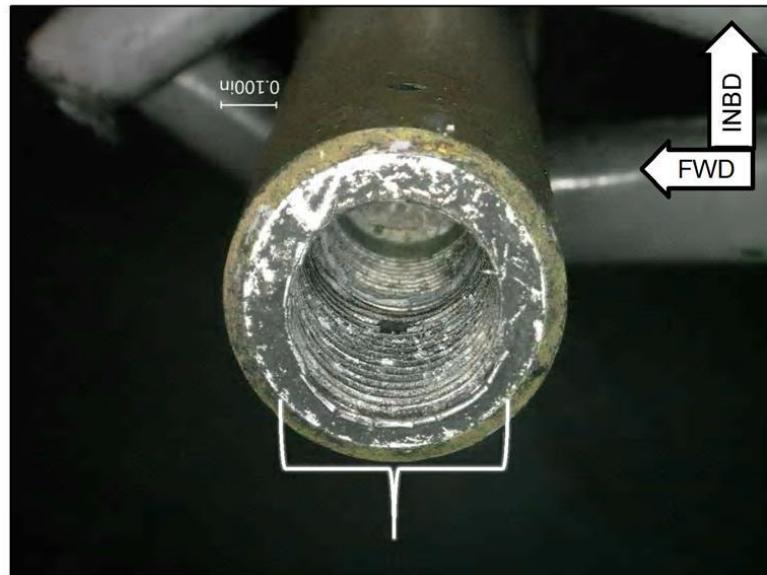
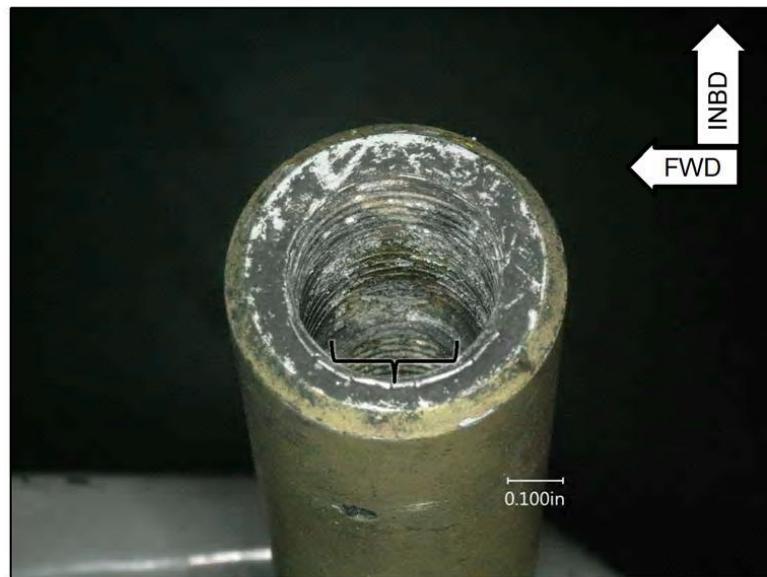
Views of the lower end of the forward servo clevis rod are shown in figure 7. Black-colored deposits were observed in the internal threads and on the lower end surface around the threaded hole. A sample of the deposits in the threads was taken for further analysis.

Internal thread peaks in the lower portion of the hole appeared to be largely missing up to 0.654 inch from the lower end face. The hole at the lower end of the clevis rod was elongated toward one direction consistent with contact wear with the end fitting. Additionally, a lip of material was present on the lower face at the edge of the hole around nearly half the circumference on the elongated side of the hole as indicated with an unlabeled bracket in figure 7. At the opposite side of the clevis rod, the wall of the internal diameter was worn to a depth beyond the major diameter of the internal threads near the upper end of the damaged threads as indicated with a bracket in the lower image in figure 7.

The pattern of hole elongation from wear at the lower end of the rod and deeper wear on the opposite side of the hole near the upper end of the damaged thread region corresponded to the wear pattern observed on the inboard and outboard sides of the end fitting threads (bracketed areas in figures 5 and 6). The orientation of the clevis rod was not marked on the as-received part. However, the pattern of wear damage on the rod and end fitting was consistent with the clevis rod oriented as indicated in figure 7, and the rod is referenced in that orientation throughout the rest of the report.

Figure 7. Views of the lower end of the forward servo clevis rod showing worn internal threads on the outboard side (upper image) and inboard side (lower image) of the rod. Unlabeled brackets indicate areas where wear was greatest on each side.

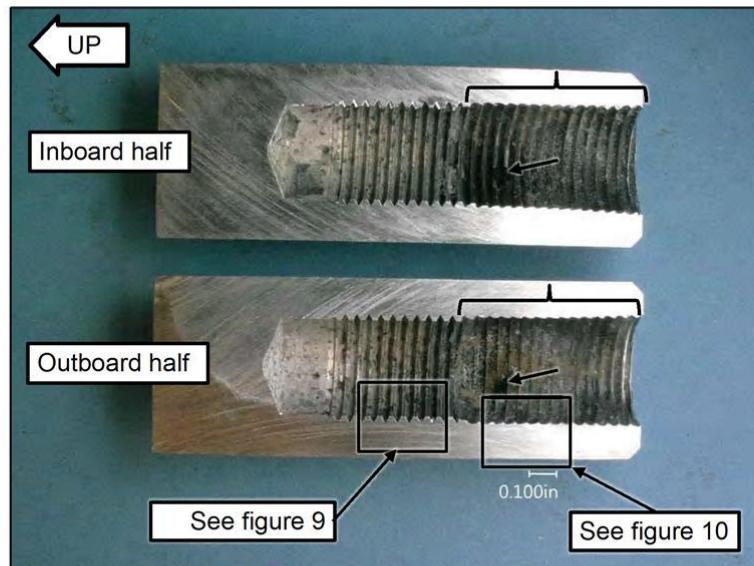
internal threads of the clevis rod. A view of the sectioned pieces resulting from the cuts is shown in figure 8. Unlabeled brackets in figure 8 indicate the extent of worn threads at the lower end of the rod, and unlabeled arrows point to inspection holes, filled with black deposits, located within the worn thread area. A point micrometer was used to measure the remaining wall thickness at the location of greatest wear just above the inspection hole on the outboard half of the sectioned clevis rod, and the minimum wall thickness measured 0.103 inches.

Figure 8. Direct view of the internal threads of the forward servo clevis rod after sectioning. Unlabeled brackets indicate the depth of worn threads, and unlabeled arrows indicate the locations of the inspection holes. Closer views of thread profiles in the boxed areas are shown in the figures indicated.

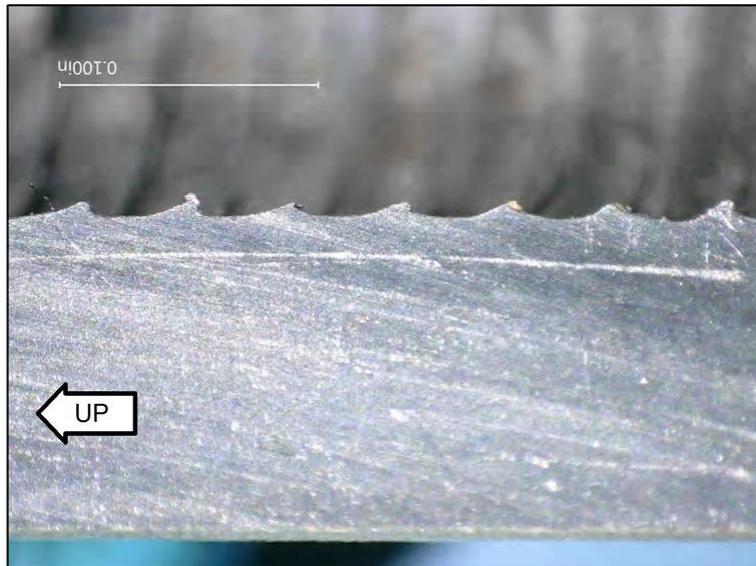
The threads were cleaned using a soft-bristle brush with a solution of soap and water. Close views of the thread profiles after cleaning are shown in figures 9 and 10. The intact threads from the region indicated in figure 8 are shown in figure 9 and appeared to be well formed with no evidence of wear. The remaining thread profile in the worn area indicated in figure 8 is shown in figure 10. Most of the thread was missing.

Figure 10. Internal thread profile of worn threads in the area of the forward servo clevis rod indicated in figure 9.

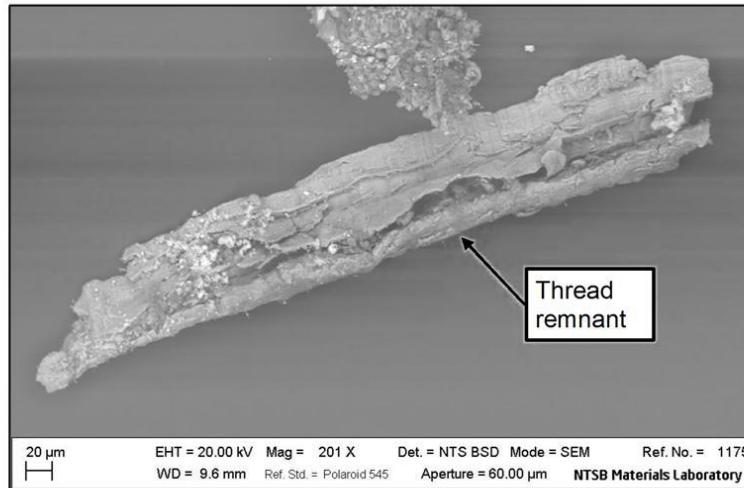
Figure 14. SEM image using backscattered electrons showing a clevis rod internal thread remnant obtained from the deposits sampled from the forward servo clevis rod.
