SERIOUS INCIDENT

Synopsis

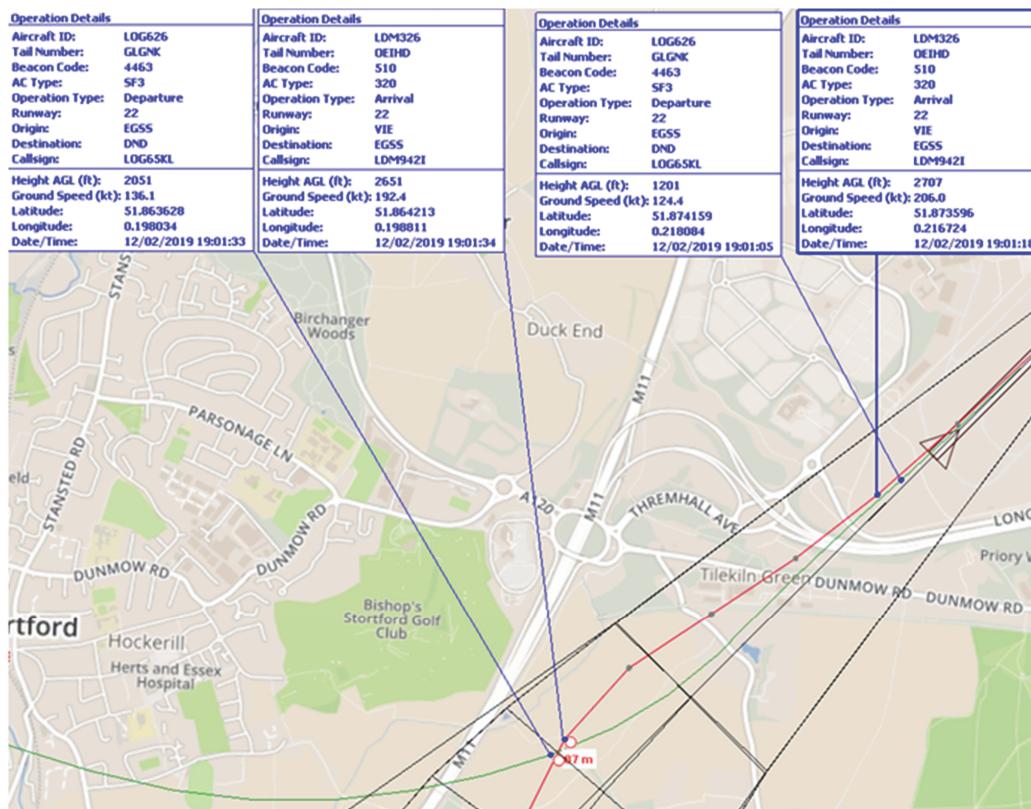
Figure 1
ATC Radar information

The radar and ATC transponder data from both aircraft were analysed. A digest of the analysis showing the closest point of approach is shown in Figure 1. The aircraft passed 87 m apart laterally and 600 ft vertically. A 3D representation is at Figure 2.

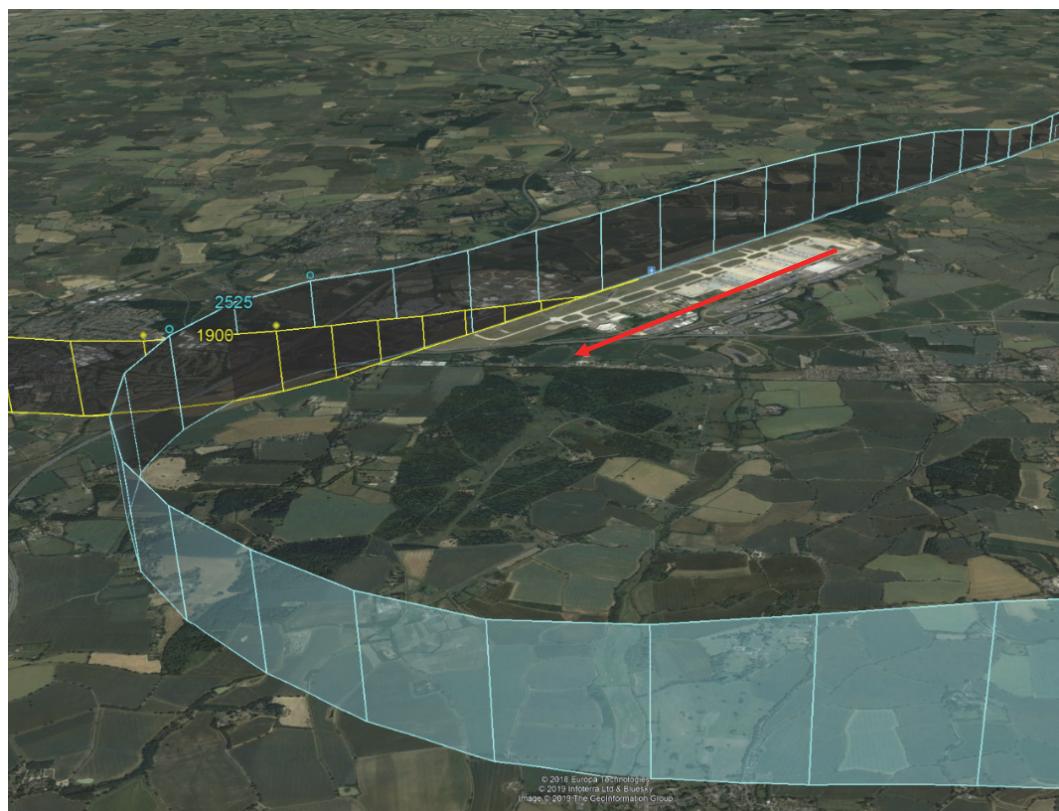
Figure 2

3D Tracks with the red arrow indicating the direction of travel
 G-LGNK in yellow, OE-IHD in blue with altitudes based on 1013 mb
