**ACCIDENT**

| <b>Aircraft Type and Registration:</b> | Airbus A340-642, G-VFIT | |

**Synopsis**

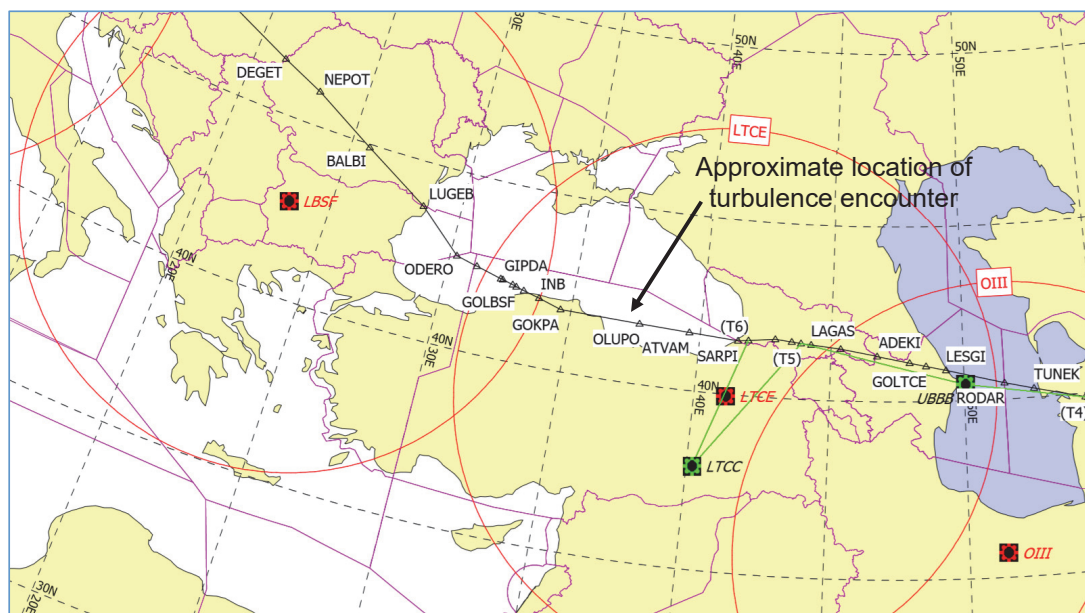
**Figure 1**

The commander reported that as they approached waypoint OLUPO (Figure 1) he saw a single "non-threatening" cloud on their track which was not showing on the aircraft's weather radar. There were cumulonimbus clouds on the horizon but no other clouds in their immediate vicinity. The aircraft was then cleared from OLUPO direct to waypoint ODERO on the Turkey/Bulgaria border, which took the aircraft clear of the single cloud. However, as the aircraft passed abeam the cloud, they encountered moderate to severe turbulence. The

G-VFIT route through Turkey showing location of turbulence event

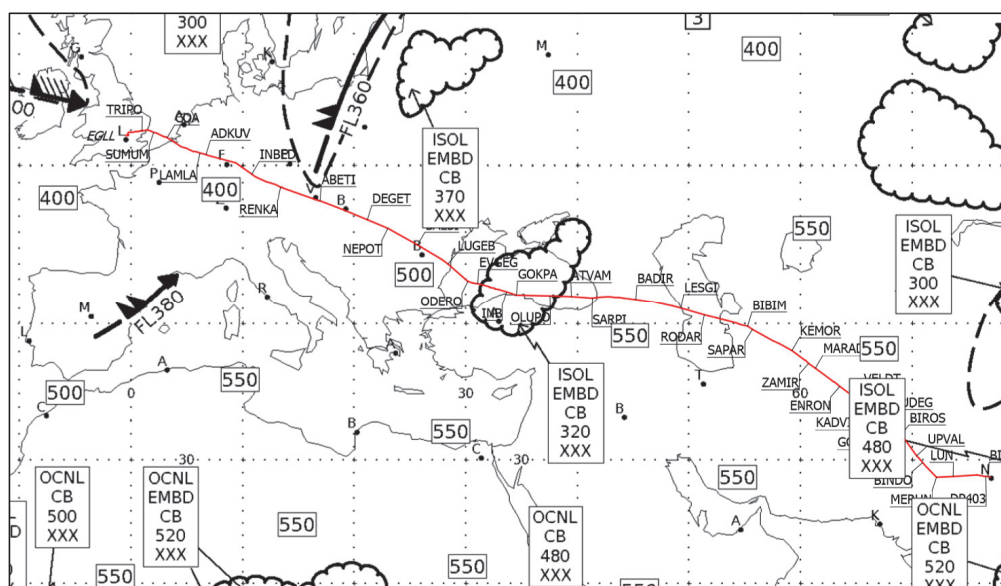
**Figure 2**

Parts of the significant weather and wind charts issued to the flight crew prior to the flight are shown in Figures 2 and 3. The significant weather chart shows an area of isolated embedded cumulonimbus clouds with tops at FL320 in the area where the turbulence occurred. There was no clear air turbulence forecast in this area. The wind chart shows the wind circulating round a low pressure centred in north-west Turkey.

Segment of the significant weather chart valid at 1200 hrs on 21 August 2019

The significant weather chart included a note that cumulonimbus cloud implies moderate or severe turbulence. However, these clouds were below the cruise level of G-VFIT and the commander reported that the aircraft was clear of cloud when the turbulence occurred.

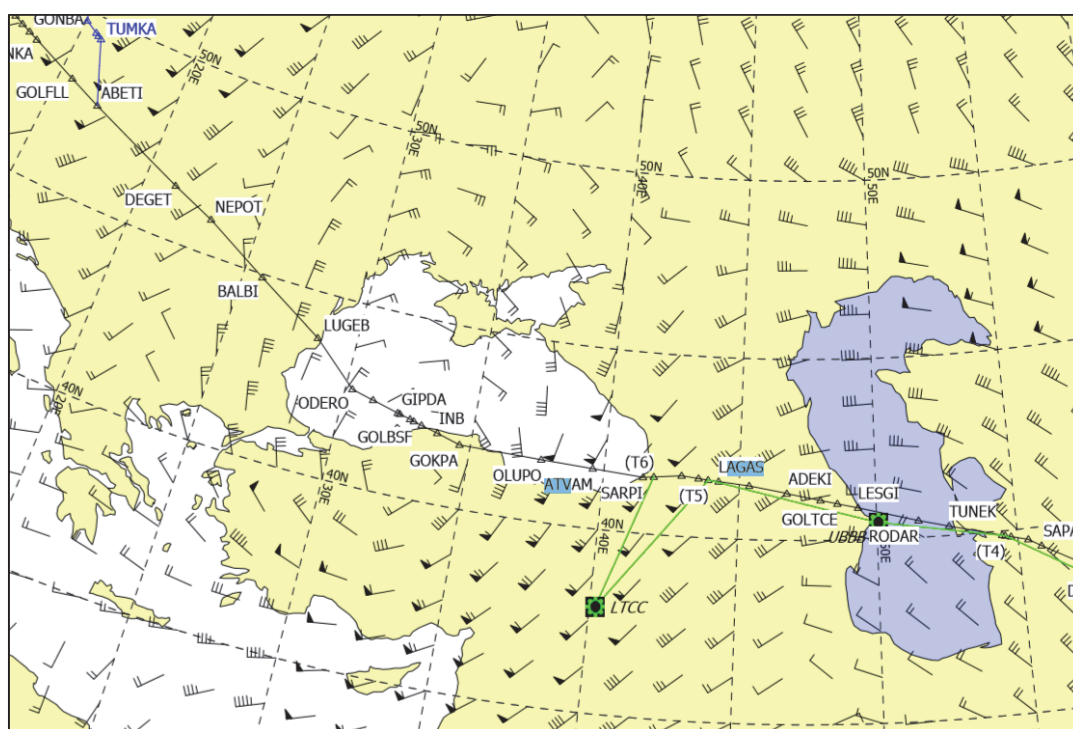
**Figure 3**

Segment of the wind chart valid at 1151 hrs on 21 August 2019

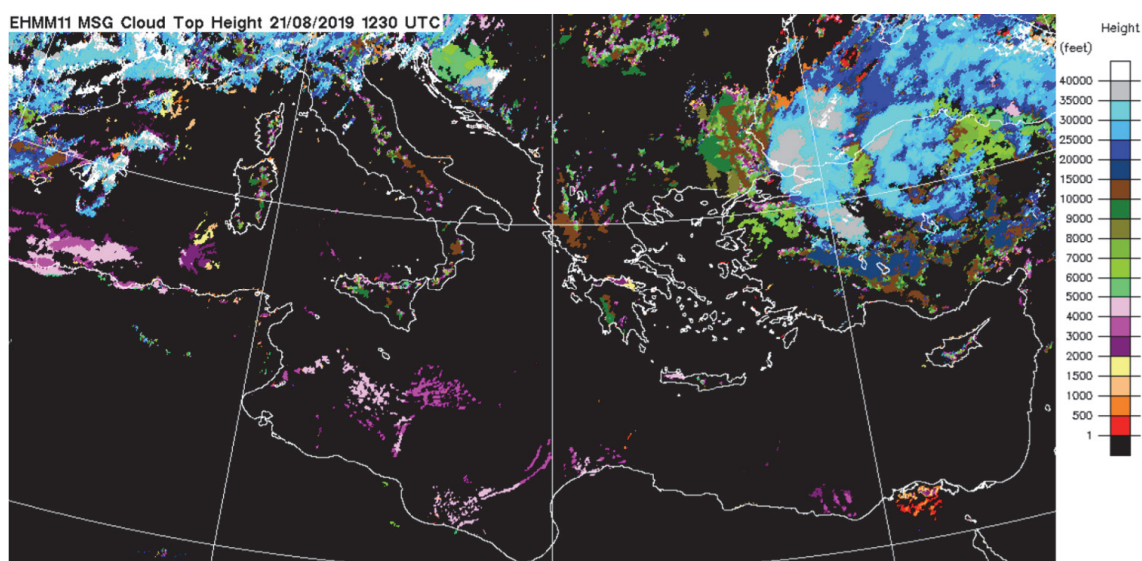
**Figure 4**

Figure 4 shows a derived satellite image showing cloud top heights at the time of the incident, produced by the Met Office after the accident. The image indicates there was a large area of cloud with tops between 30,000 ft and 35,000 ft across the area in question.

Derived Satellite Image showing Cloud Top Heights  
valid at 1230 hrs on 21 August 2019
