**AIRCRAFT ACCIDENT INVESTIGATION**

**LOSS OF CONTROL INTO TERRAIN**  
**INVOLVING**  
**SKYWARD INTERNATIONAL AVIATION LTD**  
**FOKKER B. V. F27 MARK 050,**  
**KENYAN 5Y-CET**  
**UTAWALA, NAIROBI, KENYA**  
**02 JULY, 2014**

### PRELIMINARY REPORT

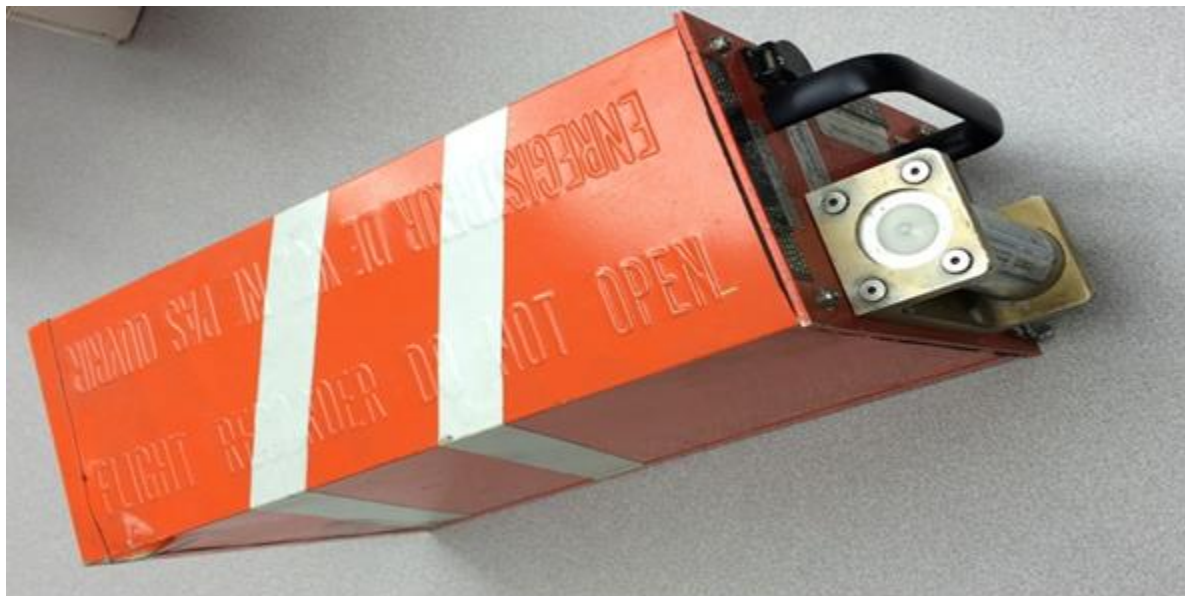
Recorder Serial Number: 59652

The CVR was located in the upper tail section of the aircraft, in the vicinity of the stabilizer attachment point. This section was not damaged by the post-crash fire and did not have much structural damage. The recorders were retrieved from the wreckage on the day of the occurrence without much difficulty.

The CVR had sustained minimal structural damage and the audio information was extracted from the recorder normally, without difficulty.

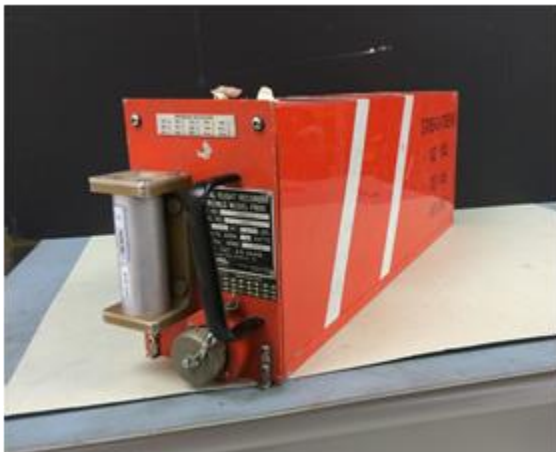
Recorder Serial Number: 04844

The FDR was also located in the upper tail section of the aircraft, adjacent to the CVR. As earlier indicated, this section was not damaged by the post-crash fire and did not have structural damage. The recorder was retrieved from the wreckage on the day of the occurrence without much difficulty.

The recorder was in good condition. The FDR was opened so that the FDR tape could be removed for download and the data were extracted normally using relevant readout equipment.

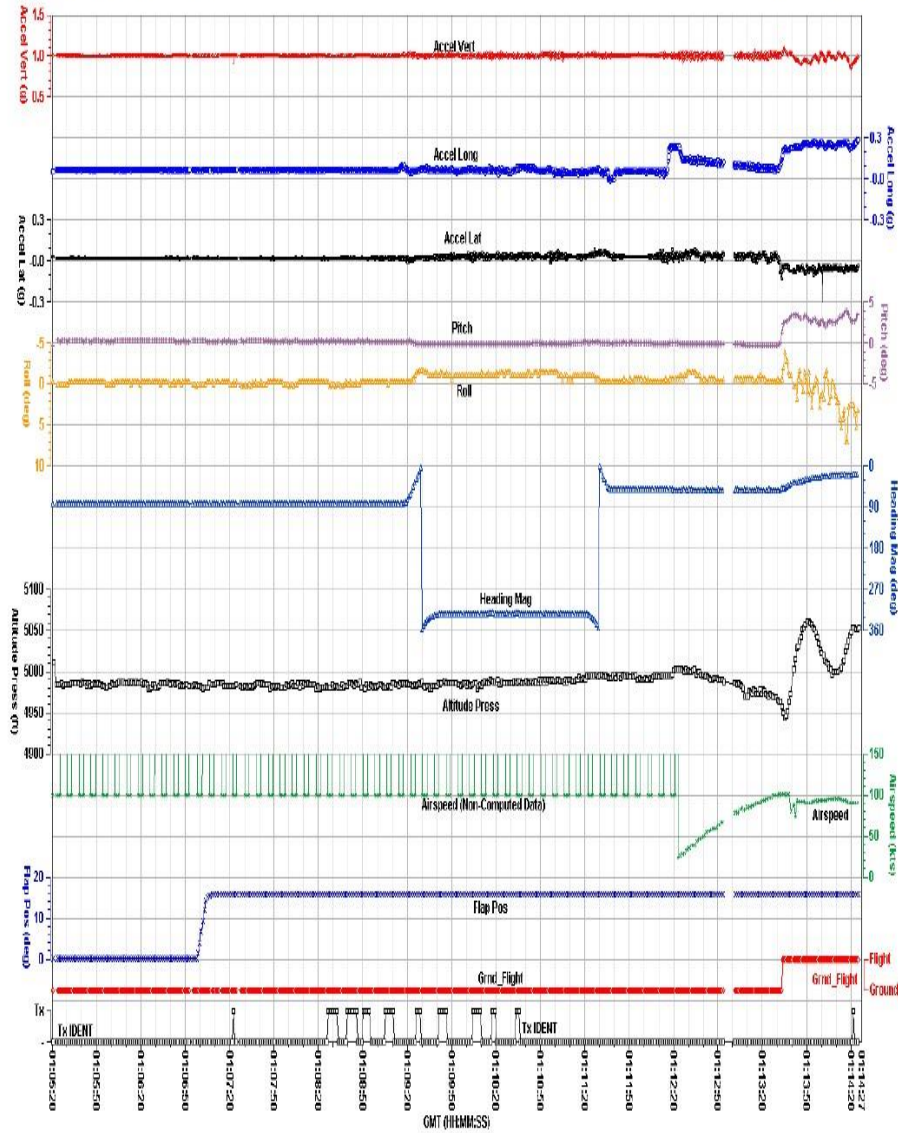
Skyward International, Fokker F-50, 5Y-CET, Basic Parameters (Beginning of Event Data to End of FDR Recording)  
 Location, Date: Nairobi, Kenya, 07/02/14 NTSB No. DCA14WA138

5 seconds after liftoff Engine 1 torque increases to 120% while its propeller RPM increases slightly to 55%. Both parameters remain at those values until the end of the recording 47 seconds later.
