**Civil Aviation Organization of the
Islamic Republic of Iran**

PS752 Accident Investigation

FACTUAL REPORT

July 2020

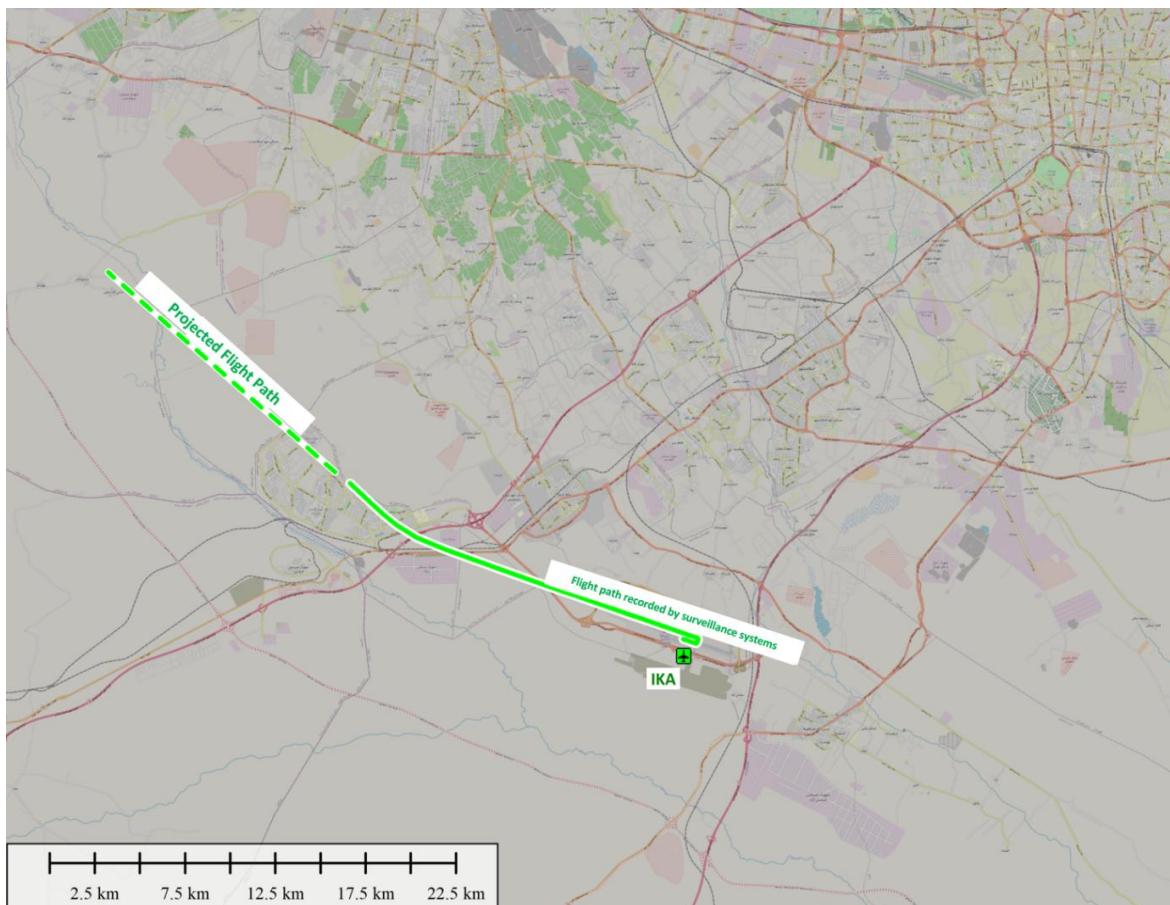
4. At 02:23:48, the Area Control Center forwarded the Ukrainian flight's request to the Air Defense Coordination Center, which subsequently issued the clearance accordingly.
5. At 02:40:20, Ukraine International Flight PS 752 received the takeoff clearance from IKA³ ATC tower.
6. The flight proceeded towards the flight route at the planned altitude and trajectory. (Figure 1)

Figure 1- PS752 recorded flight path

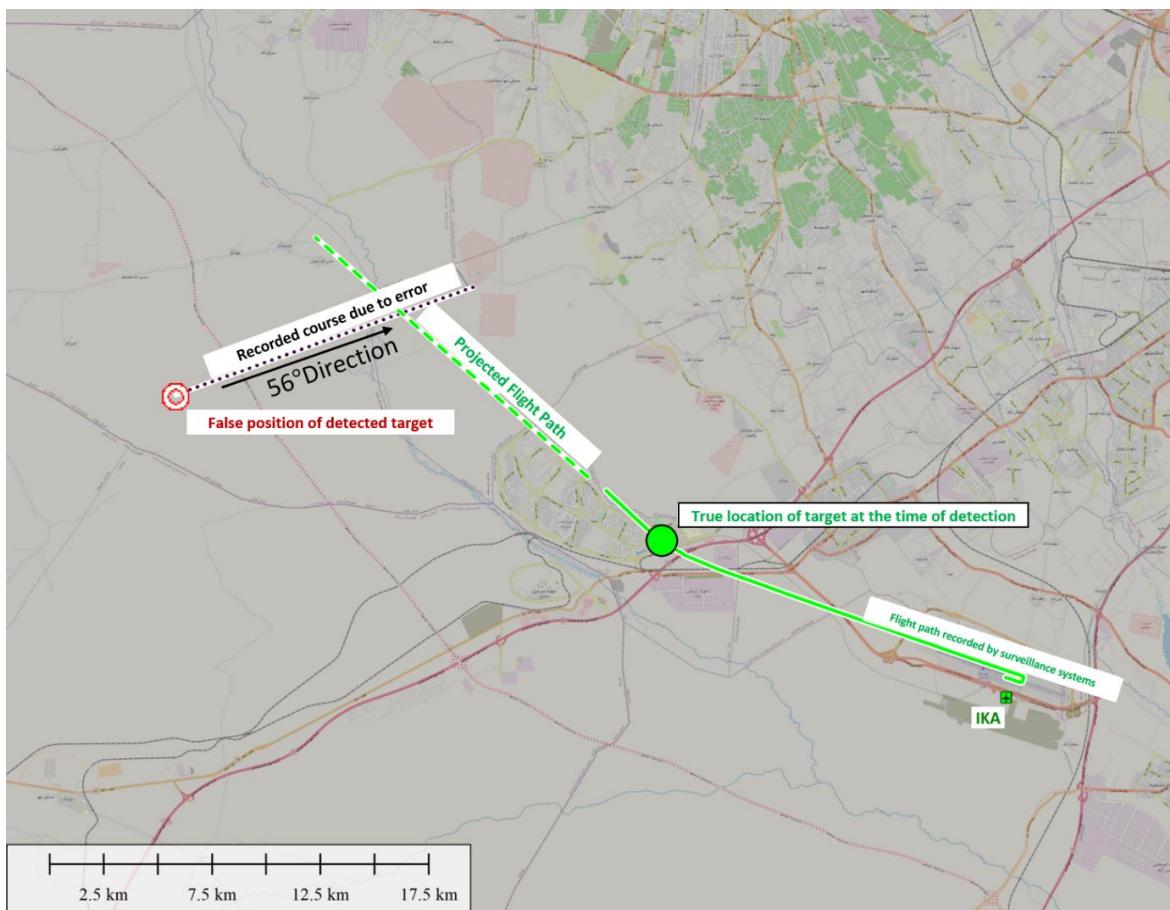
7. ⚠⁴ After the relocation of one of the air defense units of Tehran, clearly causing a change in its heading, a failure occurred due to a human error in following the procedure of system north alignment. As a result, a 107-degree error was induced in the system. As such, while the PS752 aircraft was flying, the direction of objects and targets detected by this system was being observed with an increase

8. At 02:43:56, the air defense unit operator detected a target at his 250-degree azimuth, flying on a 52-degree course. At the same time, after takeoff, the PS 752 had been flying towards the defense system from a 143-degree azimuth. The aircraft was passing a 309-degree course.
9. At 02:44:21, the operator notified the specifications of the detected target to the Coordination Center over the communication network (note paragraph 10 on the communication status). The target was, in fact, the very PS 752 flight departing from IKA, detected by the system as a target approaching Tehran from approximately the southwest. (Figure 2)

Figure 2- The true location of the aircraft at the time of detection and the false location and course due to north alignment error

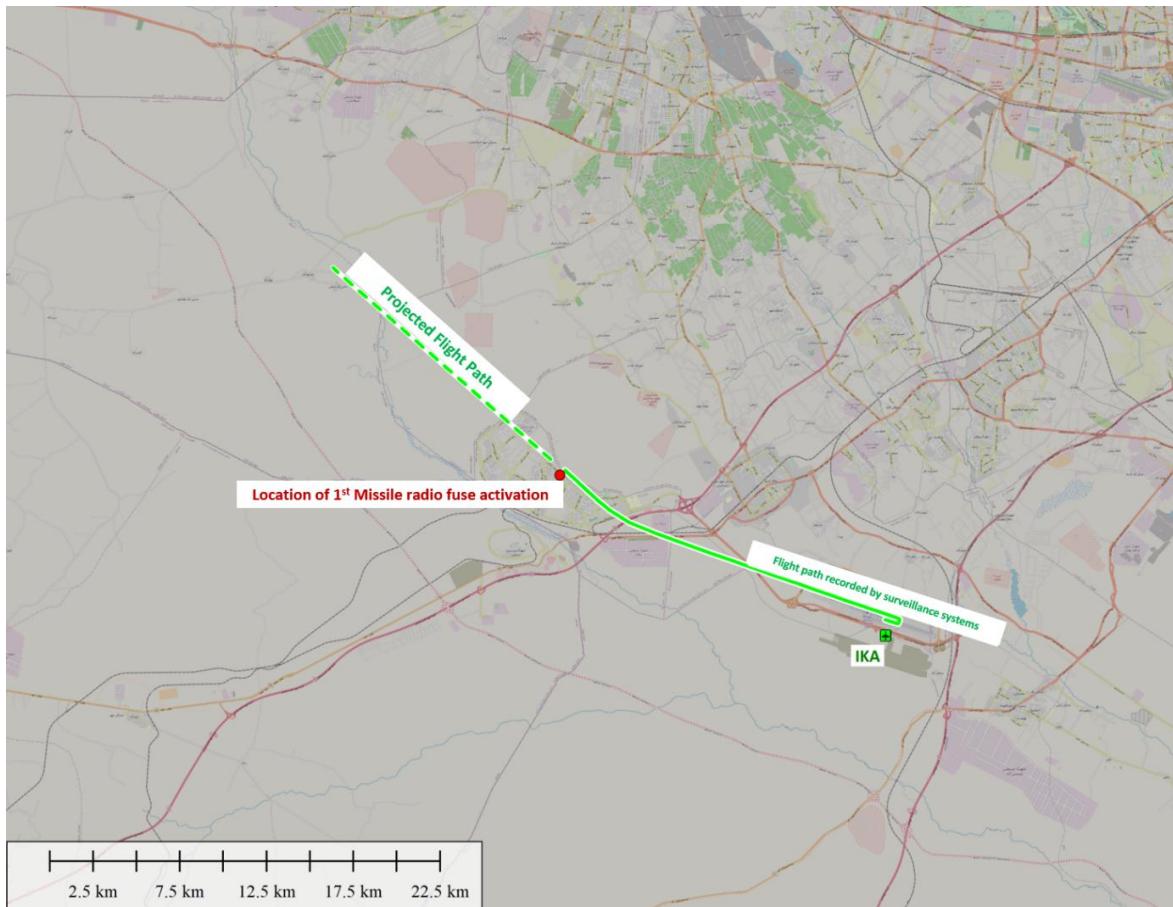
14. The missile radio fuse was activated when the aircraft had reached the last position recorded by the dependent surveillance systems⁶. The activation occurred at 02:44:59. (Figure 3)

Figure 3-The location of the first missile radio fuse activation

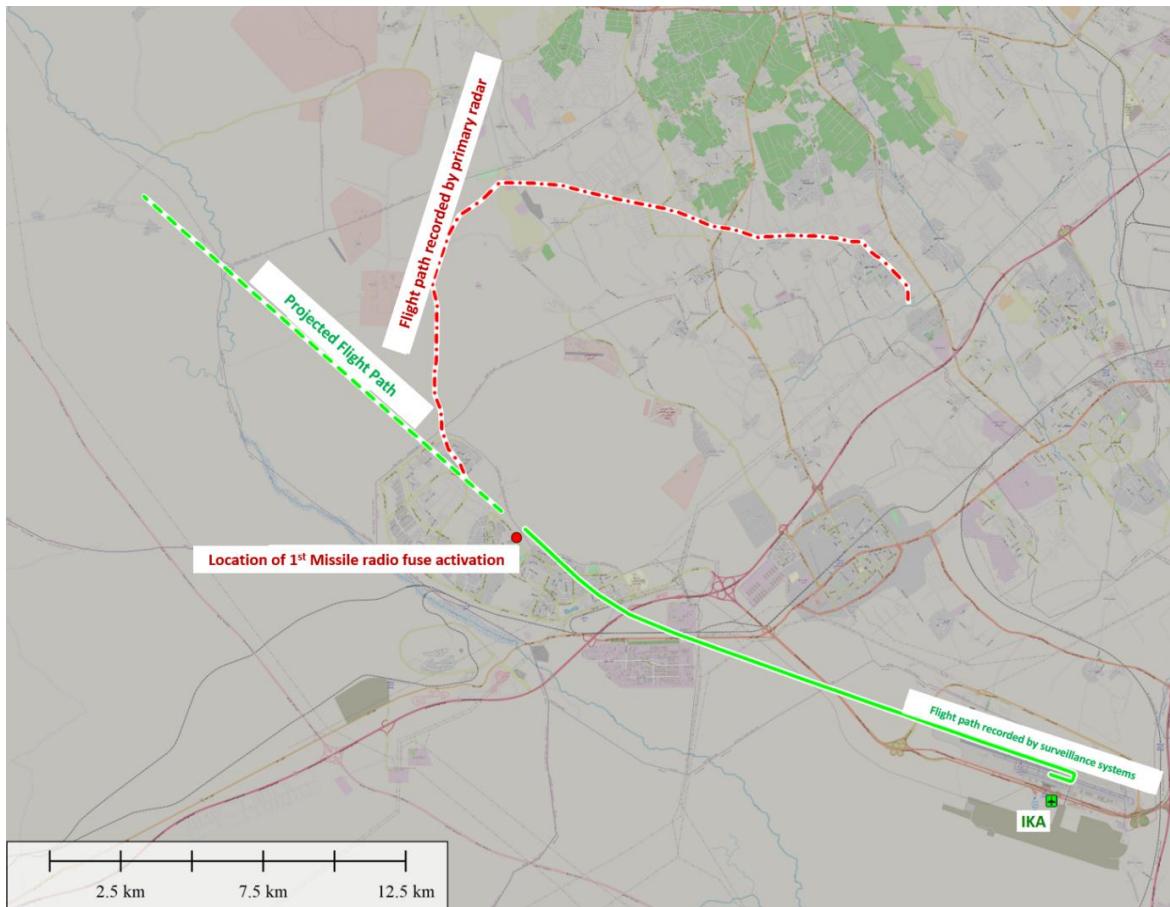
15. At 02:44:58, the last information received from the aircraft included the Secondary Surveillance Radar (SSR) transponder and Automatic Dependent Surveillance-Broadcast (ADS-B), after which the receiving of such signals was terminated. This time corresponds to the first missile radio fuse activation. From then on, the aircraft position was only being recorded by the Primary Surveillance Radar (PSR). (Figure 4)

Figure 4- Termination of SSR/ADS-B signal and recording the remainder of the flight path by PSR

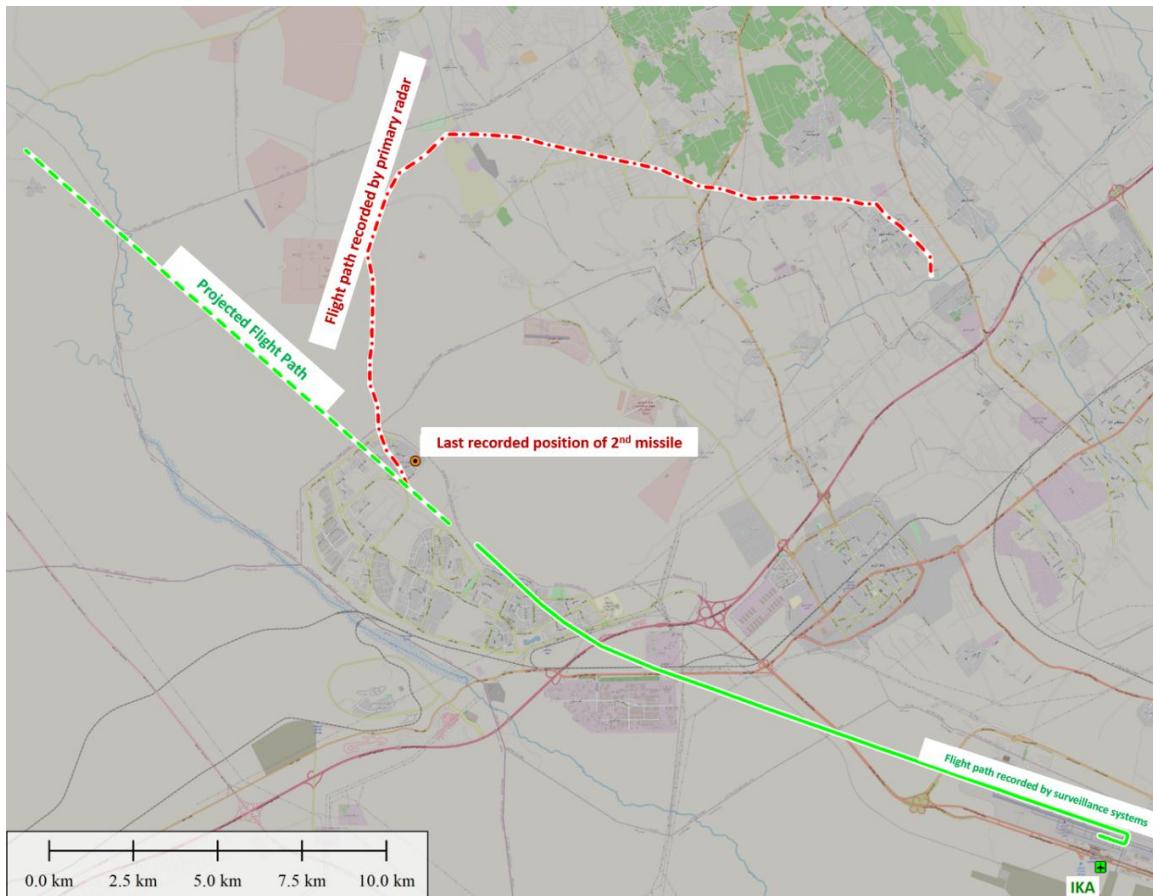
16. After the first missile radio fuse was activated, the air defense unit radar still locked on the target, and the defense system kept detecting and tracking it.
17. By observing the continuity of trajectory of detected target, the second missile was fired at the aircraft by the operator of defense system at 02:45:11.
18. At 02:45:24, the last communication between the missile and the defense system was recorded in a place close to the aircraft route. After that, the defense system showed a message indicating the strike had failed, with the aircraft clearing from the radar lock-on after some time. (Figure 5)

Figure 5- Last position recorded from 2nd missile by air defense unit

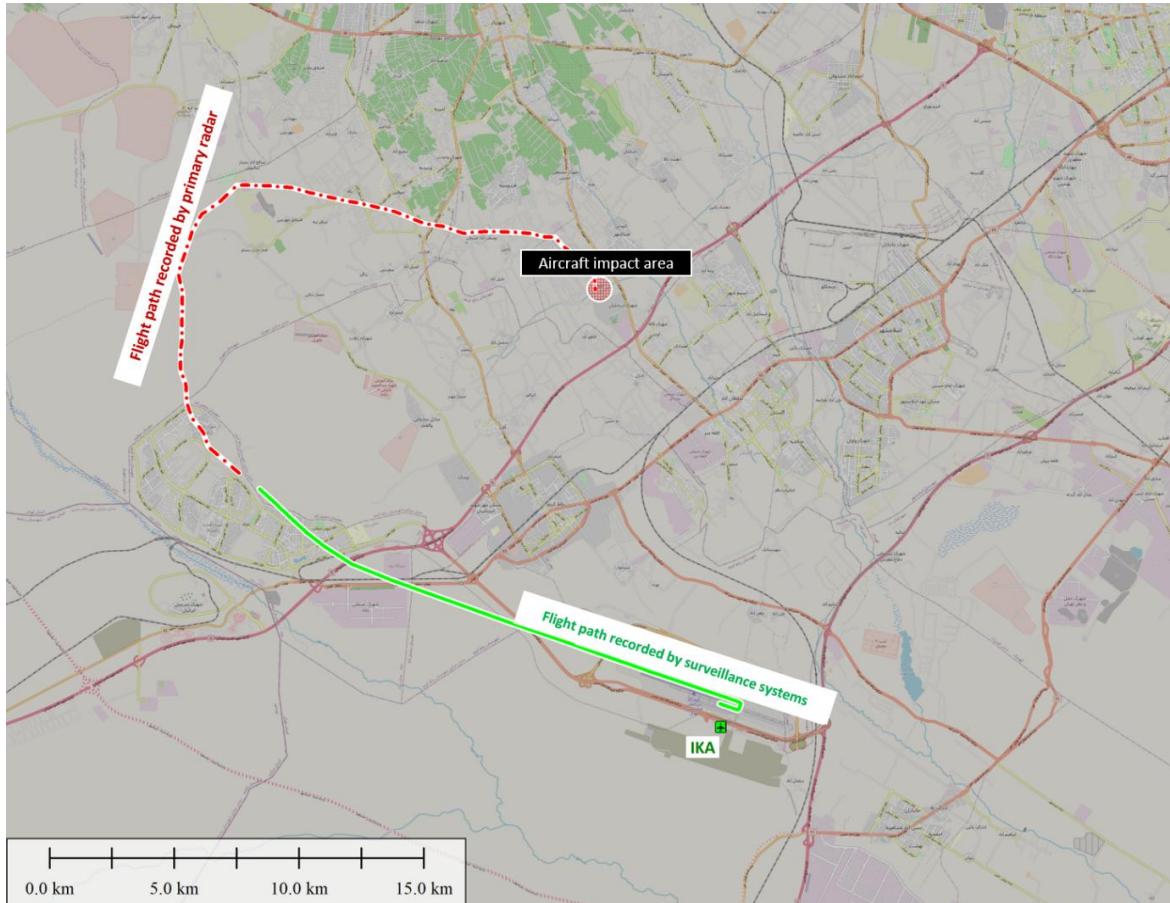
19. The aircraft turned to the right, the route of which can be seen in Figure 6. Due to the radio communication disconnection, there is no information on the aircraft altitude during the time when it was being detected by the Primary Surveillance Radar.
20. The evidence shows that at about 02:46:11, a fire broke out on the aircraft, which was intensifying.
21. At 02:48:23, the aircraft crashed into a playground in Khalajabad near Shahedshahr area at the location marked in Figure 6. An explosion occurred the moment the aircraft impacted the ground. The aircraft then kept hitting the ground and bouncing on a route towards the airport, making the aircraft pieces, victims' properties, objects and body remains disintegrate completely in a vast area near a residential complex, recreational and sports park, gardens and the surrounding agricultural land.

Figure 6- The aircraft impact area

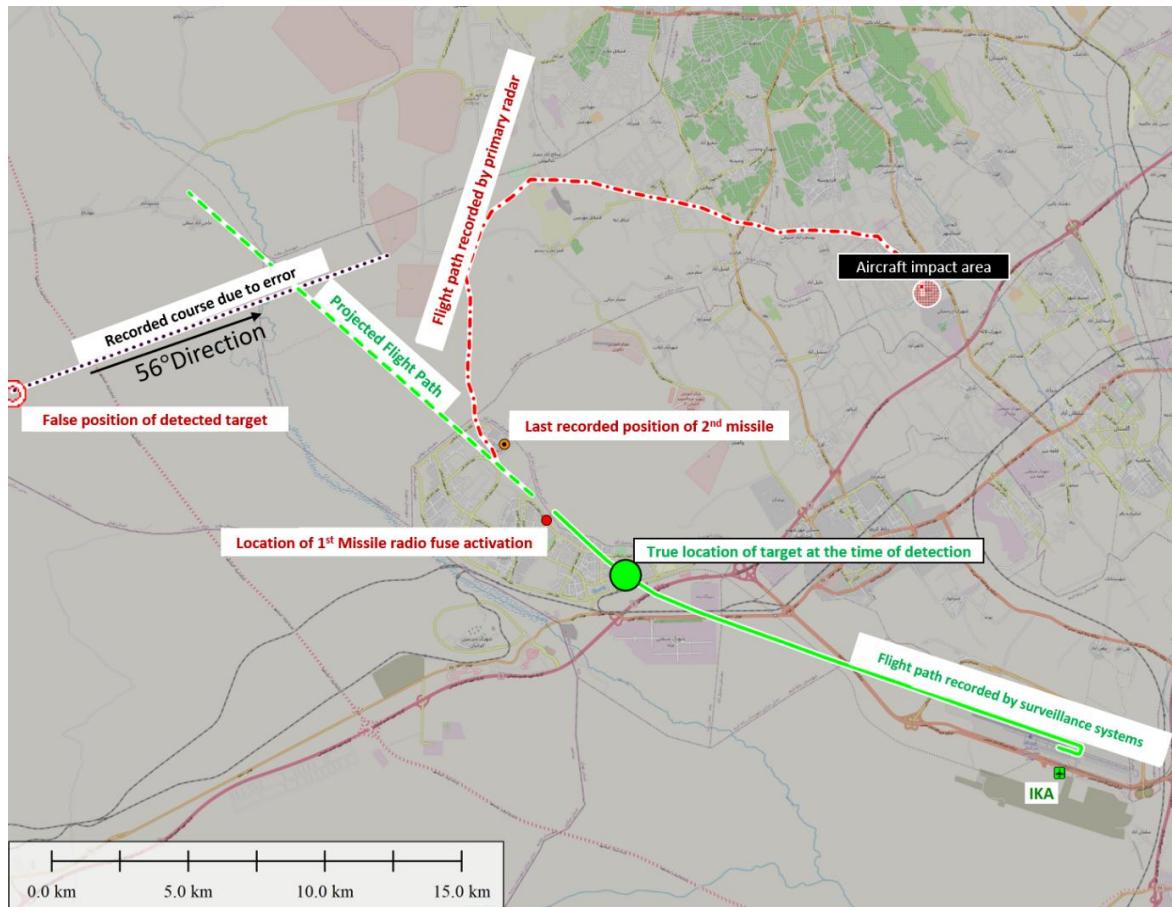
A complete overview of the information, as well as the events on the PS752 flight path are depicted in Figure 7.

Figure 7- Complete overview of available information about the flight route and key events

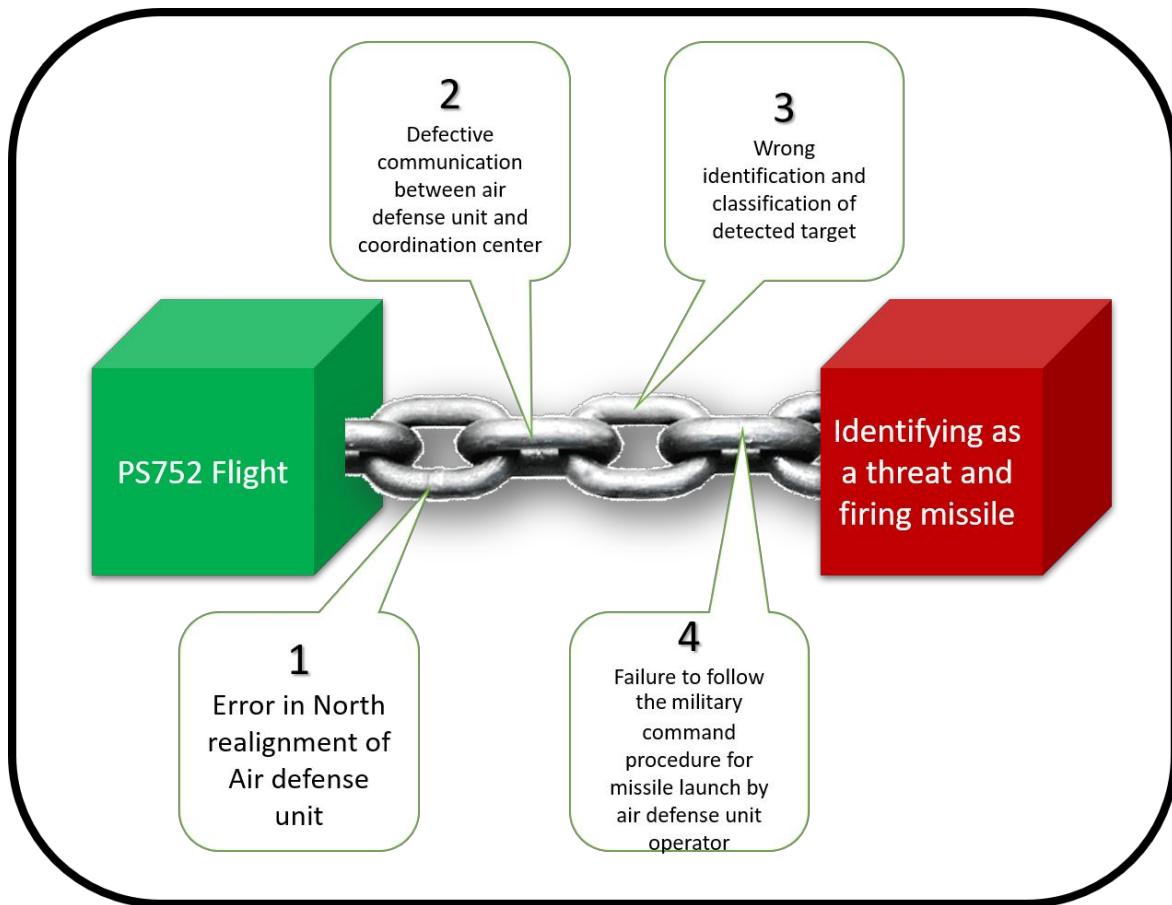
1. The sequence of events clearly shows the occurrence of a chain of events initiated by a human error⁸. Up to this point, some important contributing links in the chain of events have been identified, which have led to targeting the aircraft mistakenly⁹. Figure 8 illustrates the chain of key events identified, that if each had not arisen, the aircraft would not have been targeted. It should be noted that some new links may be found by reading out the flight recorders.

Figure 8- The chain of events leading to targeting the PS752 flight

⁹ - At the time of publishing this report, the measures adopted by Iran's military sector focusing on each one of the links in the accident chain indicate that the likelihood of occurrence of a similar event has been reduced to an improbable level. Therefore, the safety level of airspace for commercial flights from the viewpoint of misidentification is now in normal conditions.
