The Islamic Republic of Iran  
Civil Aviation Organization  
Aircraft Accident Investigation Board

**Preliminary Report #2**

Issue date: January 21, 2020

Aircraft Model: B737-800

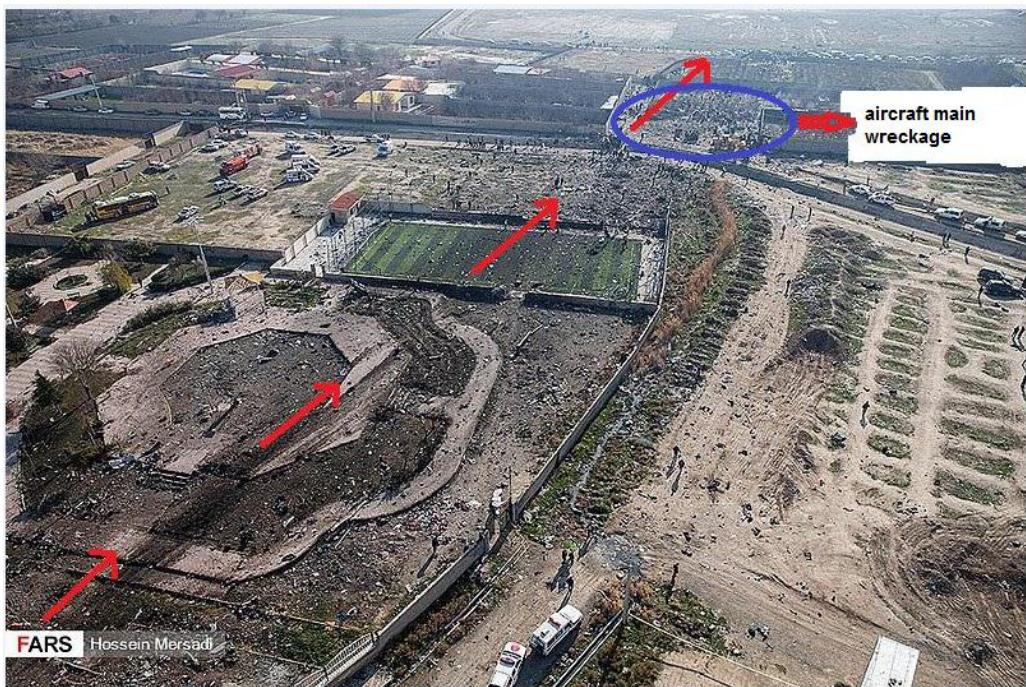
The aircraft lost her altitude and passed by a residential area; ultimately, the aircraft's initial impact point was with a barrier in a recreational park. The aircraft fuselage, subsequently, impacted the ground, disintegrating completely after passing a football pitch, which in turn damaged the surrounding agricultural farms and gardens. Following the initial impact, other impacts were observed along the track at the accident site, wrecking the fuselage and spreading across the entire track.

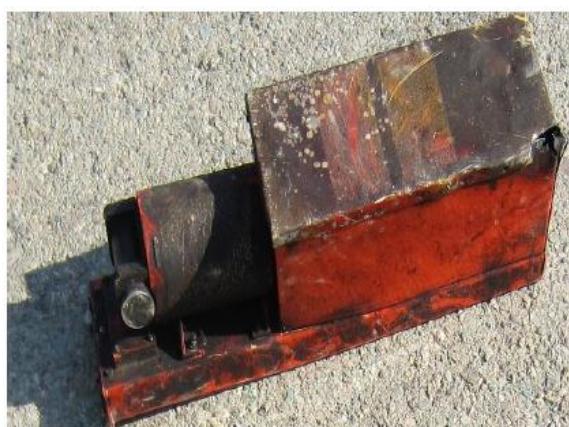
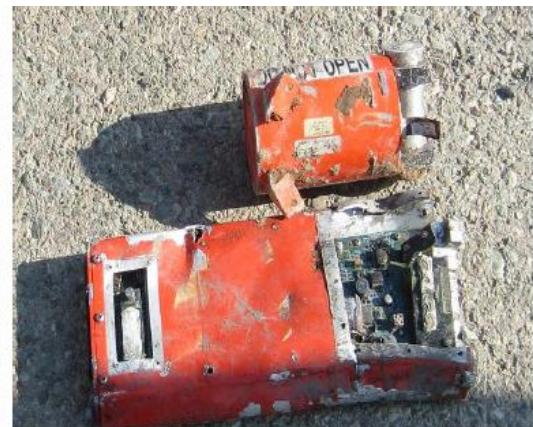
The rescue and search operation team found the aircraft black boxes, including the Flight Data Recorder (FDR) and Cockpit Voice Recorder (CVR), which are currently held by the investigation team of Iran AAIB. Both devices have been damaged as a result of the accident and catching fire. The memory parts of both recorders are in good condition, though the physical damage to their main components is considerable.

The aircraft was equipped with a Solid State Flight Data Recorder (SSFDR) with P/N 980-4750-003, which is capable of recording over 3000 digital and analog parameters as well as a Solid State Cockpit Voice Recorder (SSCVR) with P/N 980-6032-003 capable of recording the last two hours of flight conversations, and also a QAR, but only the SSFDR and SSCVR were found at the accident site. Damage to SSCVR was more serious, whose main memory (CSMU) has been detached. The condition of component indicates that the SSCVR has not been exposed to the fire on the aircraft and was detached as a result of the sever impact with the ground.
