# Report IN-031/2018

Incident involving several aircraft in the  
airspace of the Madrid CTR (control zone) on  
27 May 2018

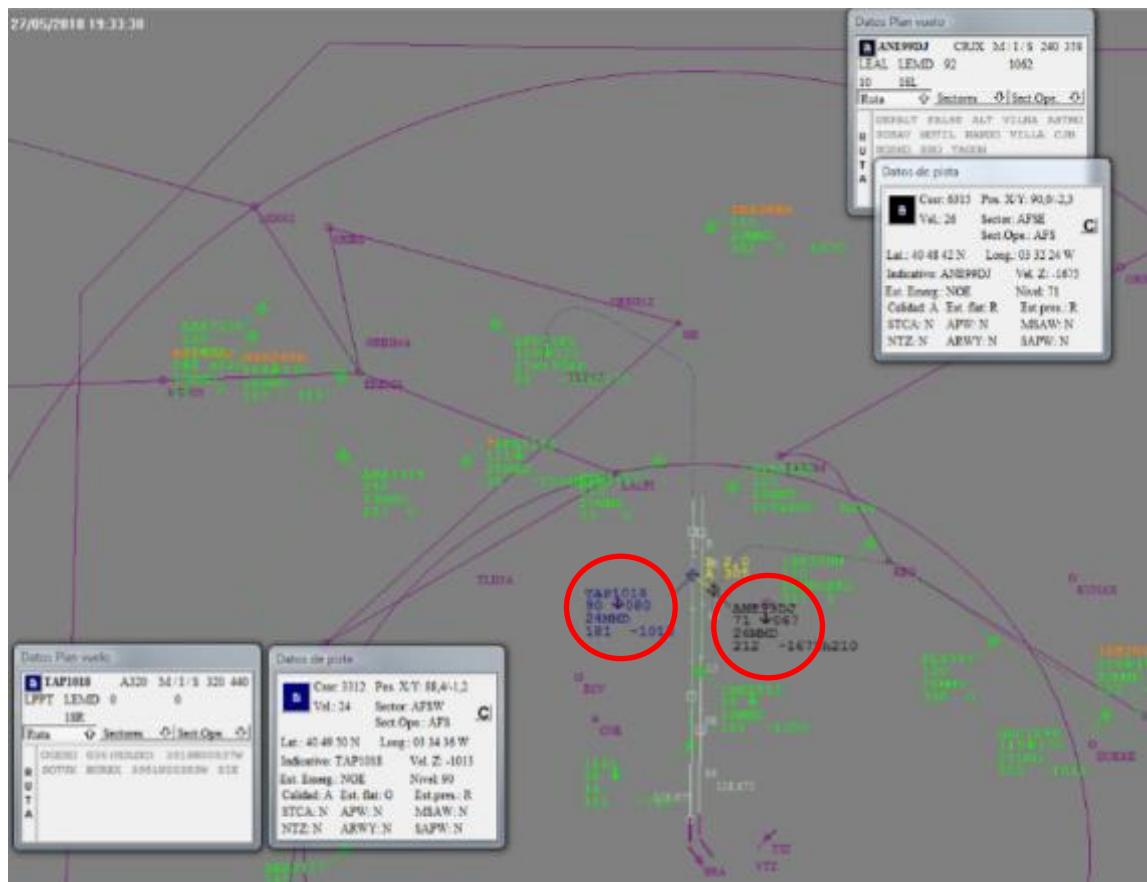
Illustration 2: Positions of the aircraft with callsigns TAP1018 and ANE99DJ at 21:33

The image below shows the position of the two aircraft at 21:33:30. At that time, both aircraft were descending to land, TAP1018 on runway 18R and ANE99DJ on runway 18L.

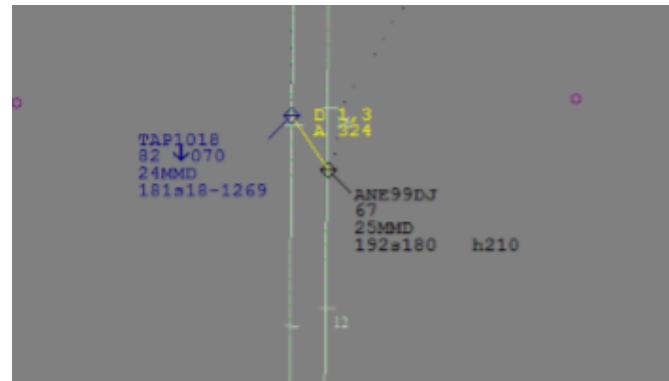
Illustration 3: Positions of the aircraft with callsigns TAP1018 and ANE99DJ at 21:34

At 21:34:06, the aircraft were still descending to land. The horizontal distance between them was 1.3 NM. The aircraft with callsign TAP1018 was flying at a ground speed of 240 knots, and the aircraft with callsign ANE99DJ had a ground speed of 250 knots. Both aircraft had been instructed to reduce their IAS to 180 knots:

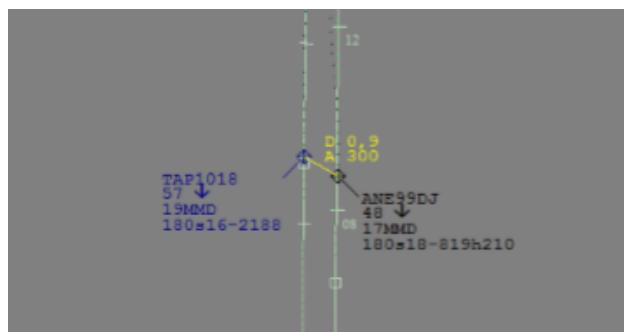
Illustration 4: Positions of the aircraft with callsigns TAP1018 and ANE99DJ at 21:35

By 21:35:58, the horizontal distance between the aircraft had been reduced to 0.9 NM and the vertical distance was 900 feet. The aircraft with callsign TAP1018 had a ground speed of 190 knots and the aircraft with callsign ANE99DJ had a ground speed of 170 knots:

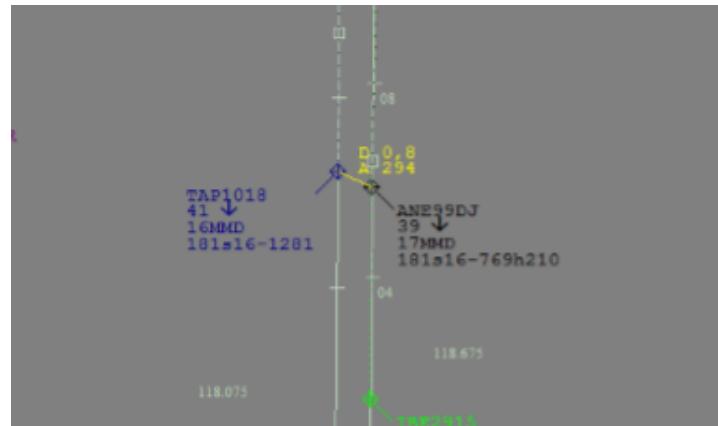
Illustration 5: Positions of the aircraft with callsigns TAP1018 and ANE99DJ at 21:36

At 21:36:59, the horizontal distance between the aircraft was 0.8 NM and the vertical separation was 200 feet. Both aircraft had been instructed to reduce their IAS to 160 knots. The aircraft with callsign TAP1018 had a ground speed of 160 knots and the aircraft with callsign ANE99DJ had a ground speed of 170 knots:

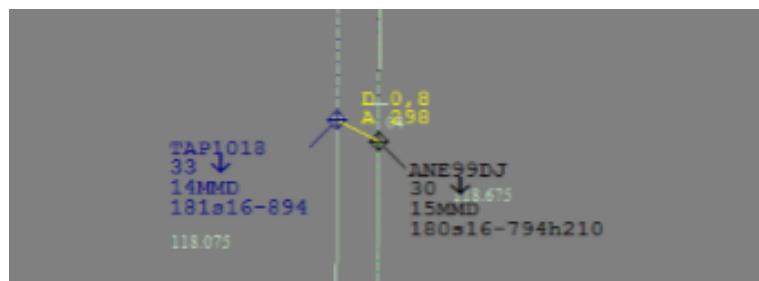
Illustration 6: Positions of the aircraft with callsigns TAP1018 and ANE99DJ at 21:37

Subsequently, the vertical distance between the two increased. At 21:37:58, seconds before landing, the positions of the aircraft were:

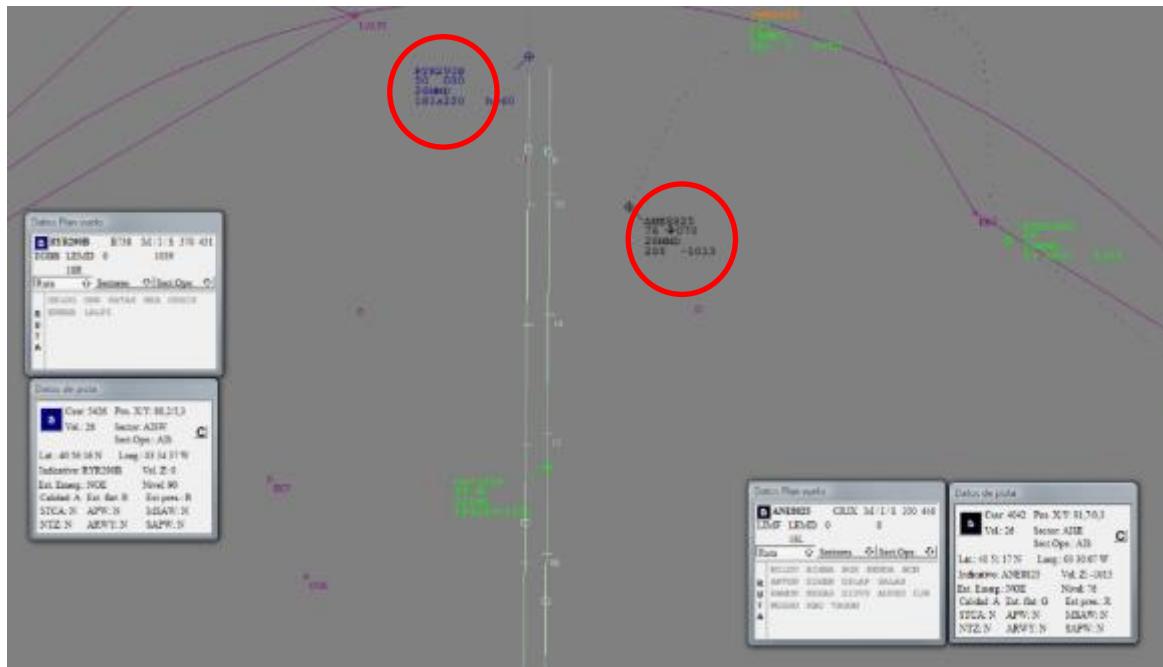
Illustration 7: Positions of the aircraft with callsigns RYR290B and ANE8825 at 21:46:11

The image below shows the position of the two aircraft at 21:46:11. At that time, both aircraft were descending to land, RYR290B on runway 18R and ANE8825 on runway 18L.

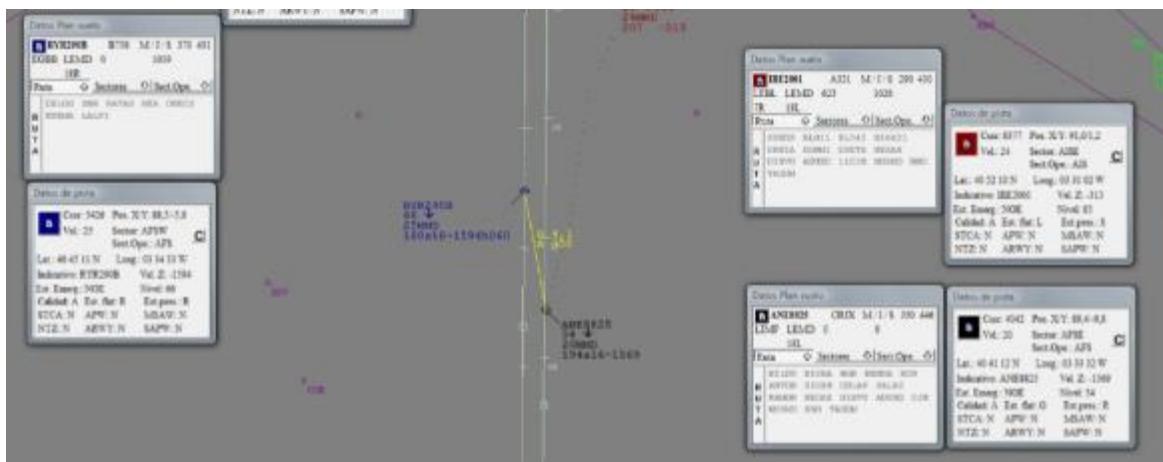
Illustration 8: Positions of the aircraft with callsigns RYR290B and ANE8825 at 21:48:48

At 21:48:48, the aircraft were separated horizontally by 4.1 NM. The ground speed of the aircraft with callsign RYR290B was 250 knots, and the aircraft with callsign ANE8825 had a ground speed of 200 knots.

The aircraft with callsign RYR290B had been instructed to reduce its IAS to 180 knots, and the aircraft with callsign ANE8825 had been instructed to reduce its IAS to 160 knots:

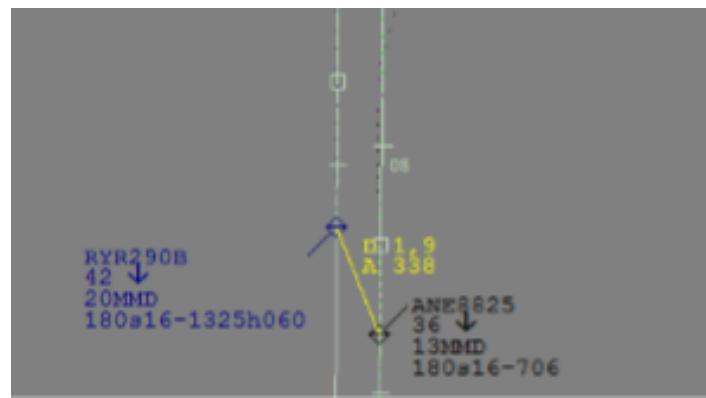
Illustration 9: Positions of the aircraft with callsigns RYR290B and ANE8825 at 21:50:33

Subsequently, by 21:50:33, the horizontal distance between the two aircraft had fallen to 1.9 NM and the vertical distance to 600 feet. The aircraft with callsign RYR290B had been instructed to reduce its IAS to 160 knots:

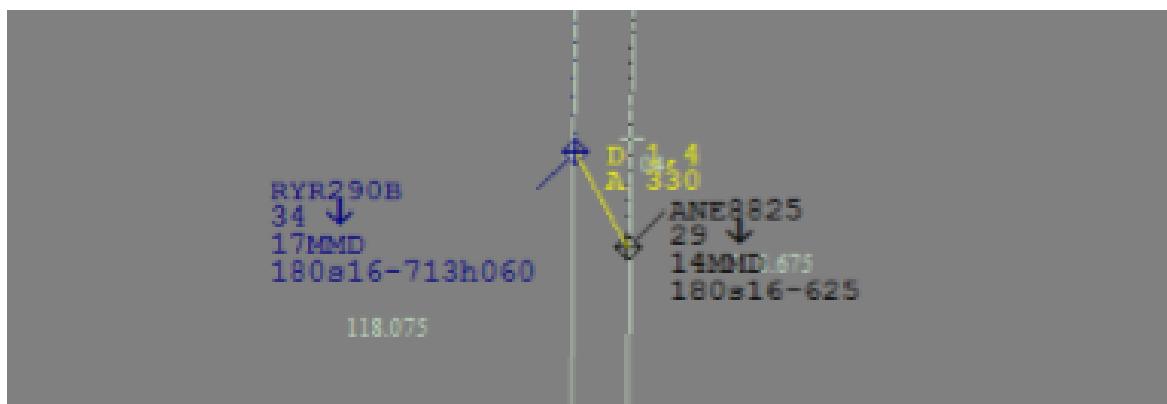
Illustration 10: Positions of the aircraft with callsigns RYR290B and ANE8825 at 21:51:38

At 21:51:38, the horizontal distance between the two aircraft was 1.4 NM and the vertical distance was 500 feet:

The separation between the aircraft continued to fall until seconds before the landing of the aircraft with callsign ANE8825, at which time the horizontal distance was 1.2 NM and the vertical distance was 325 feet.

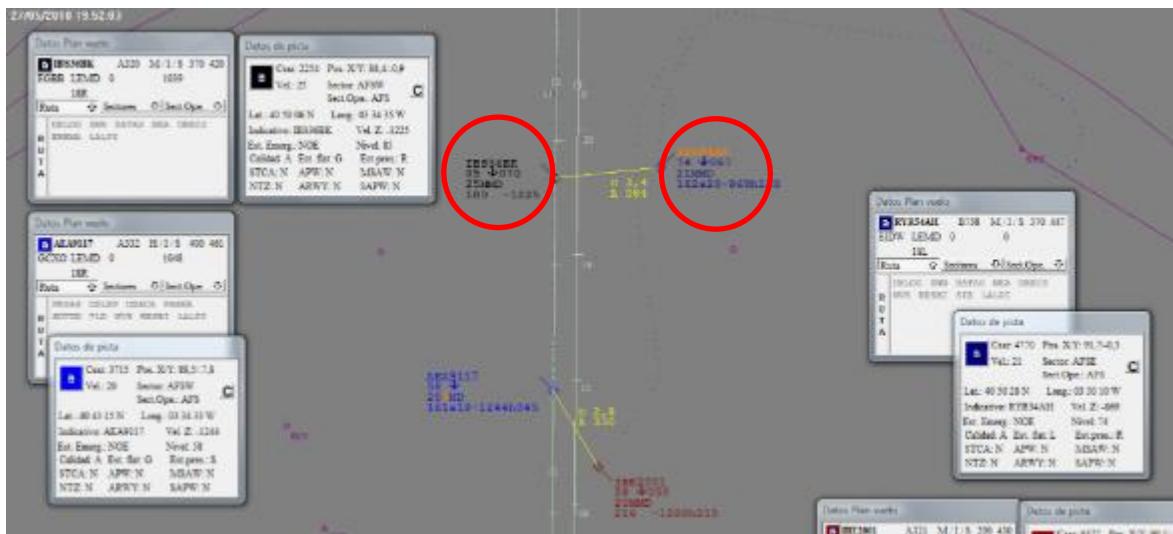
Illustration 11: Positions of the aircraft with callsign RYR54AH and IBS36BK at 21:52:03

The image below shows the position of the two aircraft at 21:52:03. A few seconds later, the aircraft with callsign RYR54AH had requested to change course from  $205^{\circ}$  to  $180^{\circ}$  for 6 NM. Both aircraft had been instructed to maintain an IAS of 180 knots:

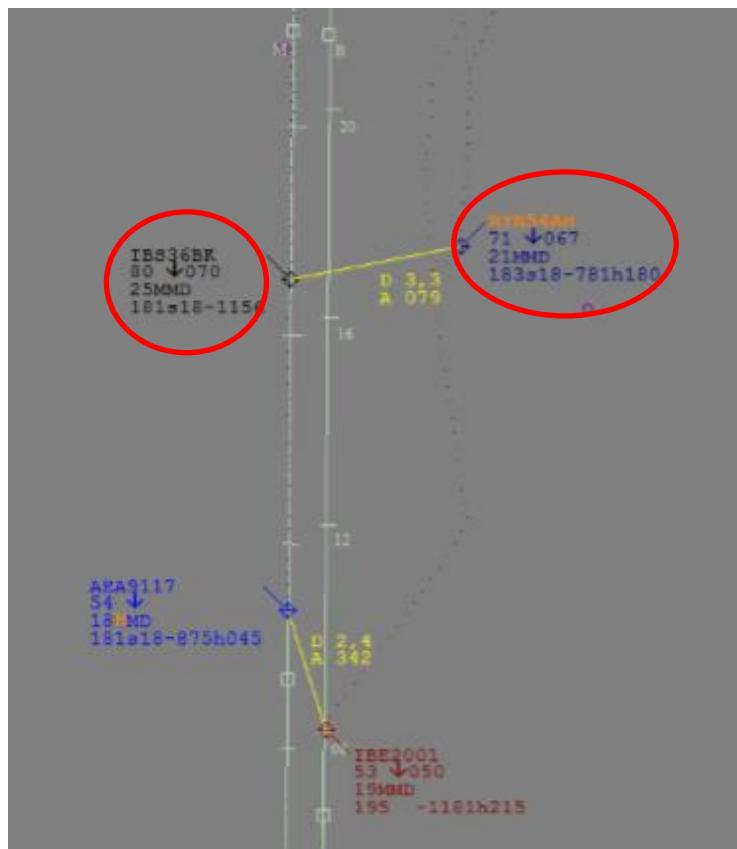
Illustration 12: Positions of the aircraft with callsign RYR54AH and IBS36BK at 21:52:30

At 21:52:30, the positions of the aircraft were as follows:

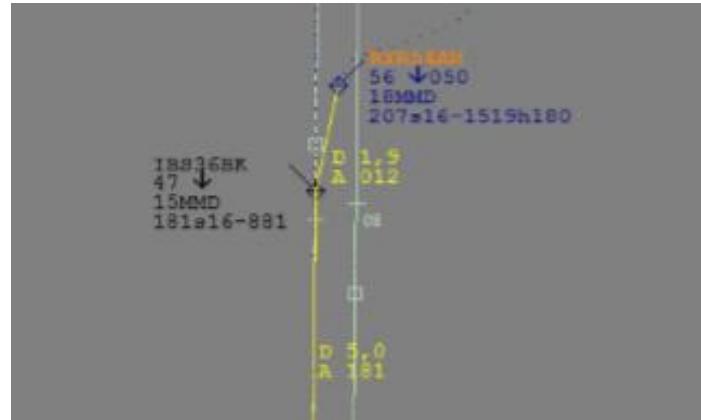
Illustration 13: Positions of the aircraft with callsign RYR54AH and IBS36BK at 21:55:19

At 21:55:19, the aircraft with callsign RYR54H, despite having been cleared to make the ILS-Z approach to 18L, had not yet intercepted the localizer. It was separated horizontally from the other aircraft by 1.9 NM. It had been instructed to reduce its IAS to 165 knots.

The aircraft with callsign IBS36BK had initially been instructed to reduce its IAS to 170 knots, and then to reduce it as much as possible to avoid the loss of separation with the preceding aircraft:

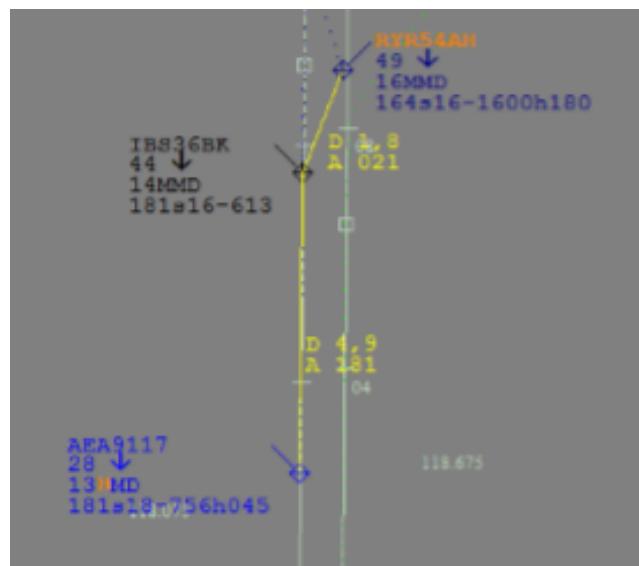
Illustration 14: Positions of the aircraft with callsign RYR54AH and IBS36BK at 21:55:45

By 21:55:45, the aircraft with callsign RYR54AH had intercepted the localizer for the 18L ILS-Z approach. The horizontal distance between the two aircraft had fallen to 1.8 NM.

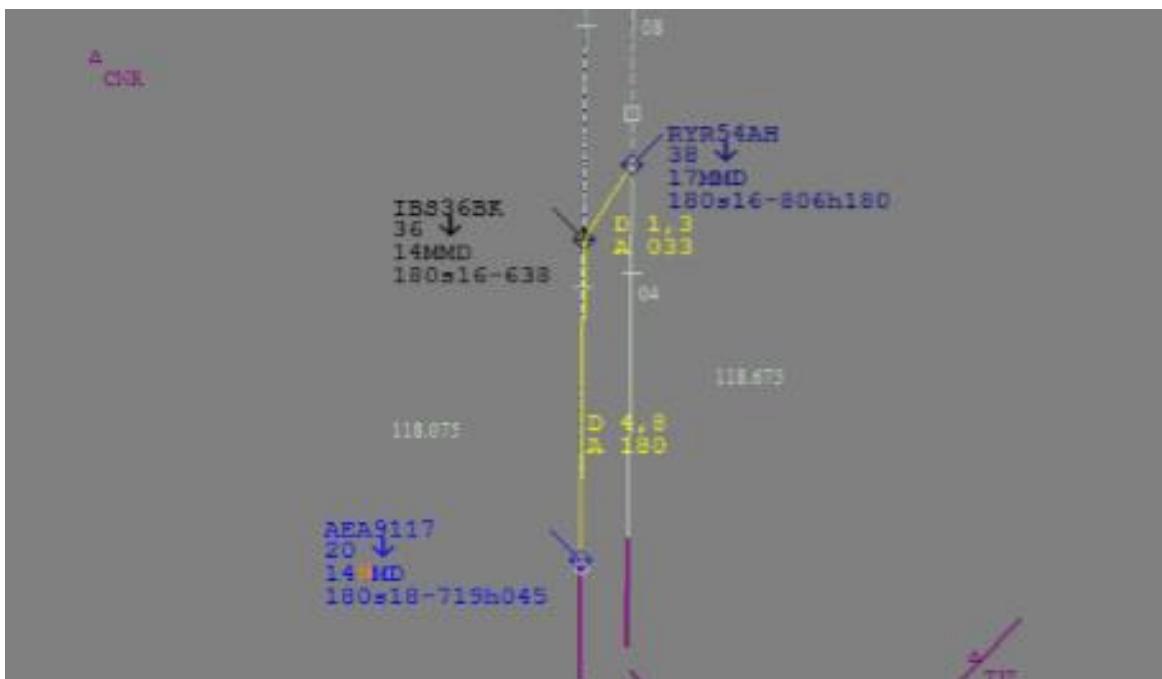
Illustration 15: Positions of the aircraft with callsign RYR54AH and IBS36BK at 21:56:54

By 21:56:54, the horizontal distance between the two aircraft had fallen to 1.3 NM:

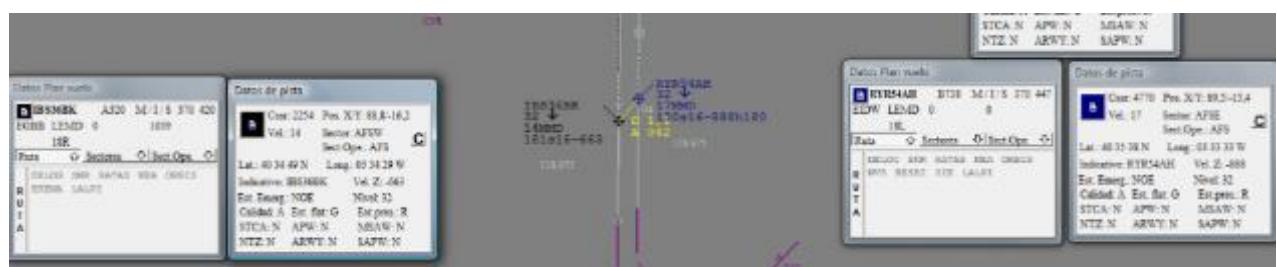
Illustration 16: Positions of the aircraft with callsign RYR54AH and IBS36BK at 21:57:31

By 21:57:31, the horizontal distance between the two aircraft had again fallen, this time to 1.1 NM:

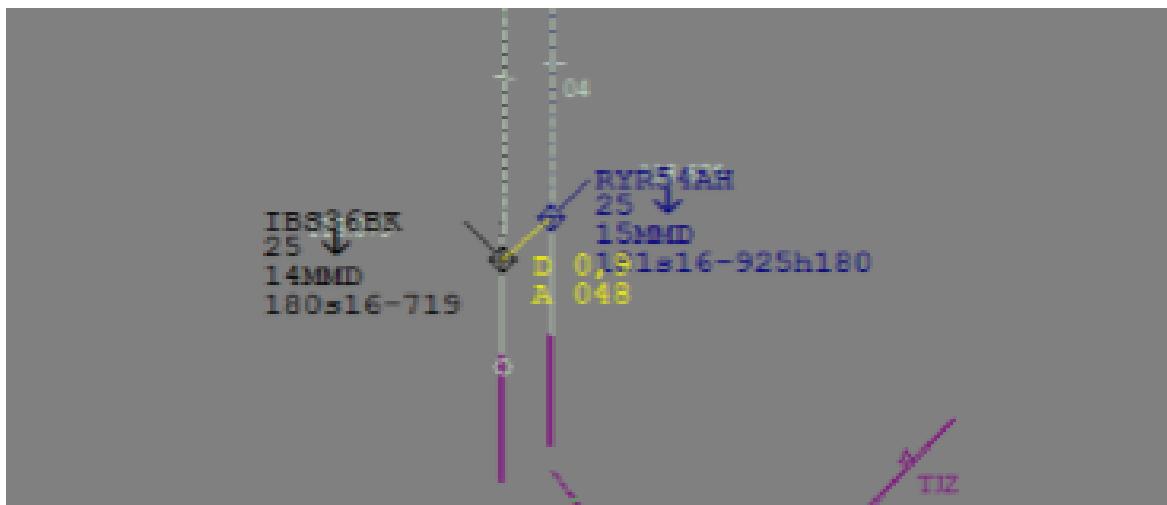
Illustration 17: Positions of the aircraft with callsign RYR54AH and IBS36BK at 21:58:24

Seconds before landing, at 21:58:24, the horizontal distance between the two aircraft was 0.9 NM. Both aircraft were at the same altitude:

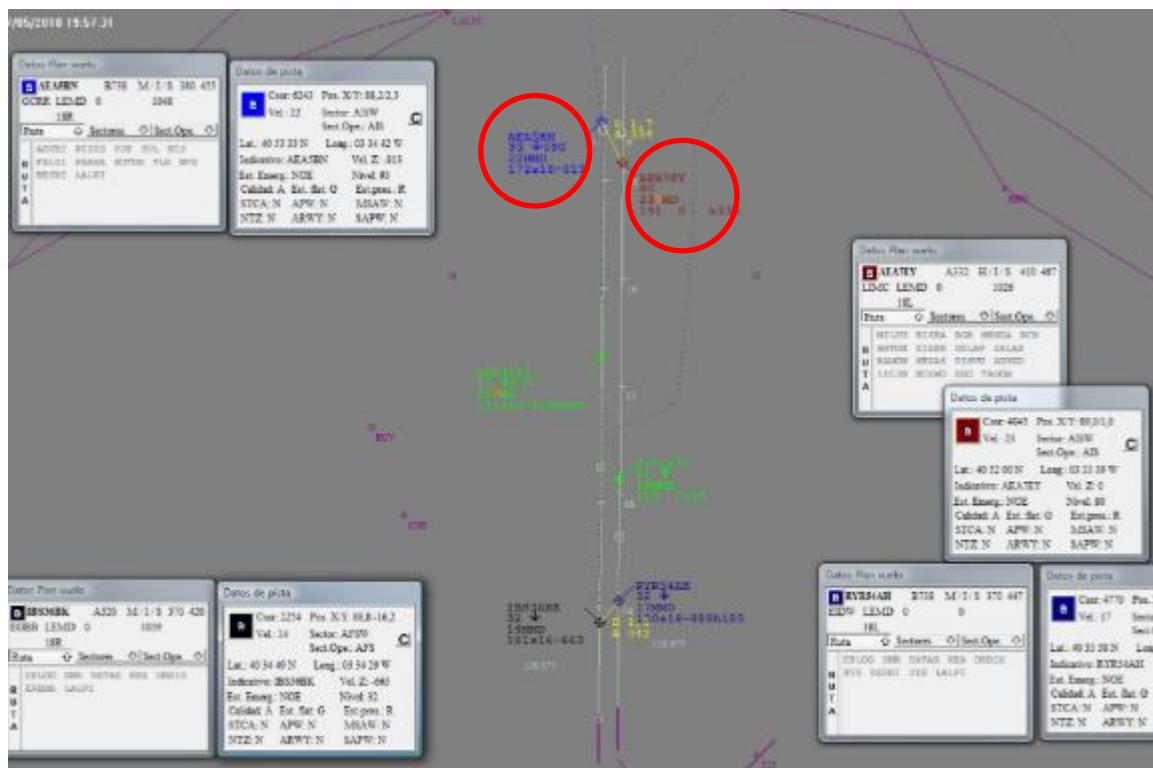
Illustration 18: Positions of the aircraft with callsigns AEA5BN and AEA7EY at 21:57:31

The image below shows the position of the aircraft at 21:57:31. The aircraft with callsign AEA5BN had been instructed to maintain an IAS of 180 knots:

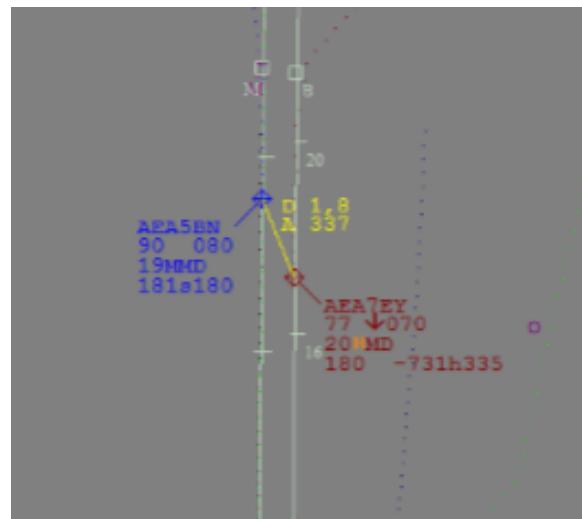
Illustration 19: Positions of the aircraft with callsigns AEA5BN and AEA7EY at 21:58:24

Subsequently, at 21:58:24, the positions of the aircraft were as follows:

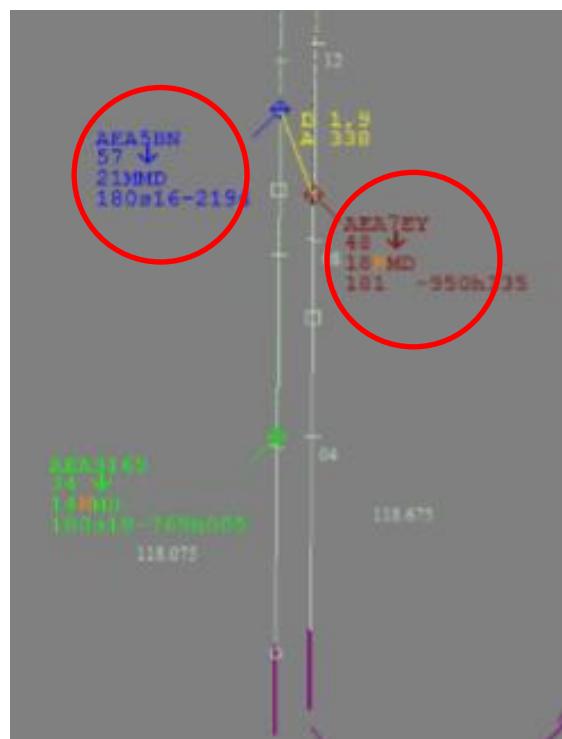
Illustration 20: Positions of the aircraft with callsigns AEA5BN and AEA7EY at 22:00:49

Later, at 22:00:49, the situation was as shown below:

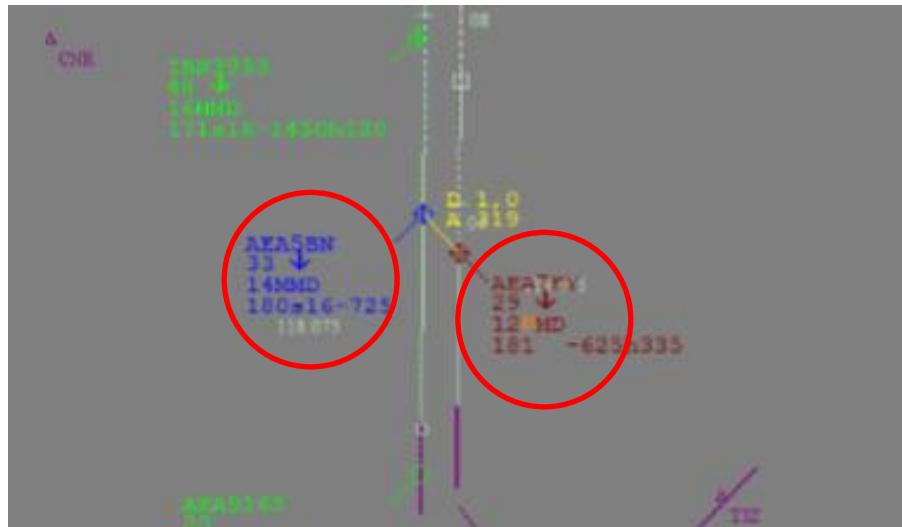
Illustration 21: Positions of the aircraft with callsigns AEA5BN and AEA7EY at 22:03:14

At 22:03:14, the two aircraft were separated by 1.0 NM horizontally and 400 feet vertically.

The separation between the aircraft continued to close until seconds before the landing of the aircraft with callsign AEA7EY.
