# Investigation Report

Type of Occurrence:	Serious incident
Date:	26 June 2017
Location:	Near Stuttgart
Aircraft:	<ul style="list-style-type: none"><li>1) Airplane</li><li>2) Ultralight aircraft</li></ul>
Manufacturer / Model:	<ul style="list-style-type: none"><li>1) Airbus Industry / A319-132</li><li>2) Aerospool / Dynamics WT-9</li></ul>
Injuries to Persons:	No injuries
Damage:	None
Other Damage:	None
State File Number:	BFU17-0804-5X

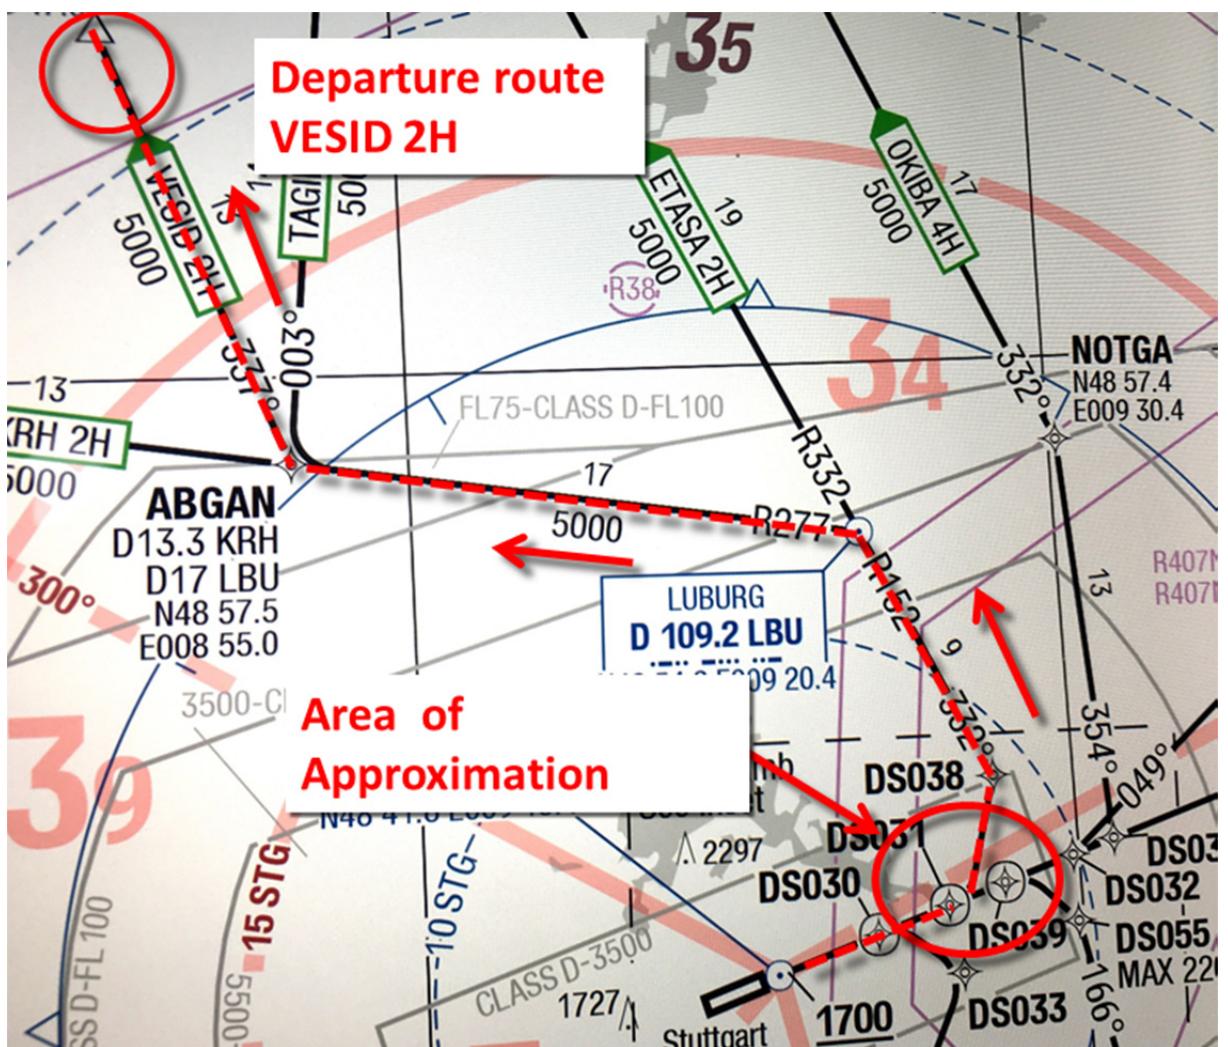
Fig. 1: Standard instrument departure route

Fig. 1 shows the standard instrument departure route including the area of approximation of the two aircraft. The chart is part of the LIDO (Lufthansa Systems GmbH & Co. KG) as of 18 May 2017.

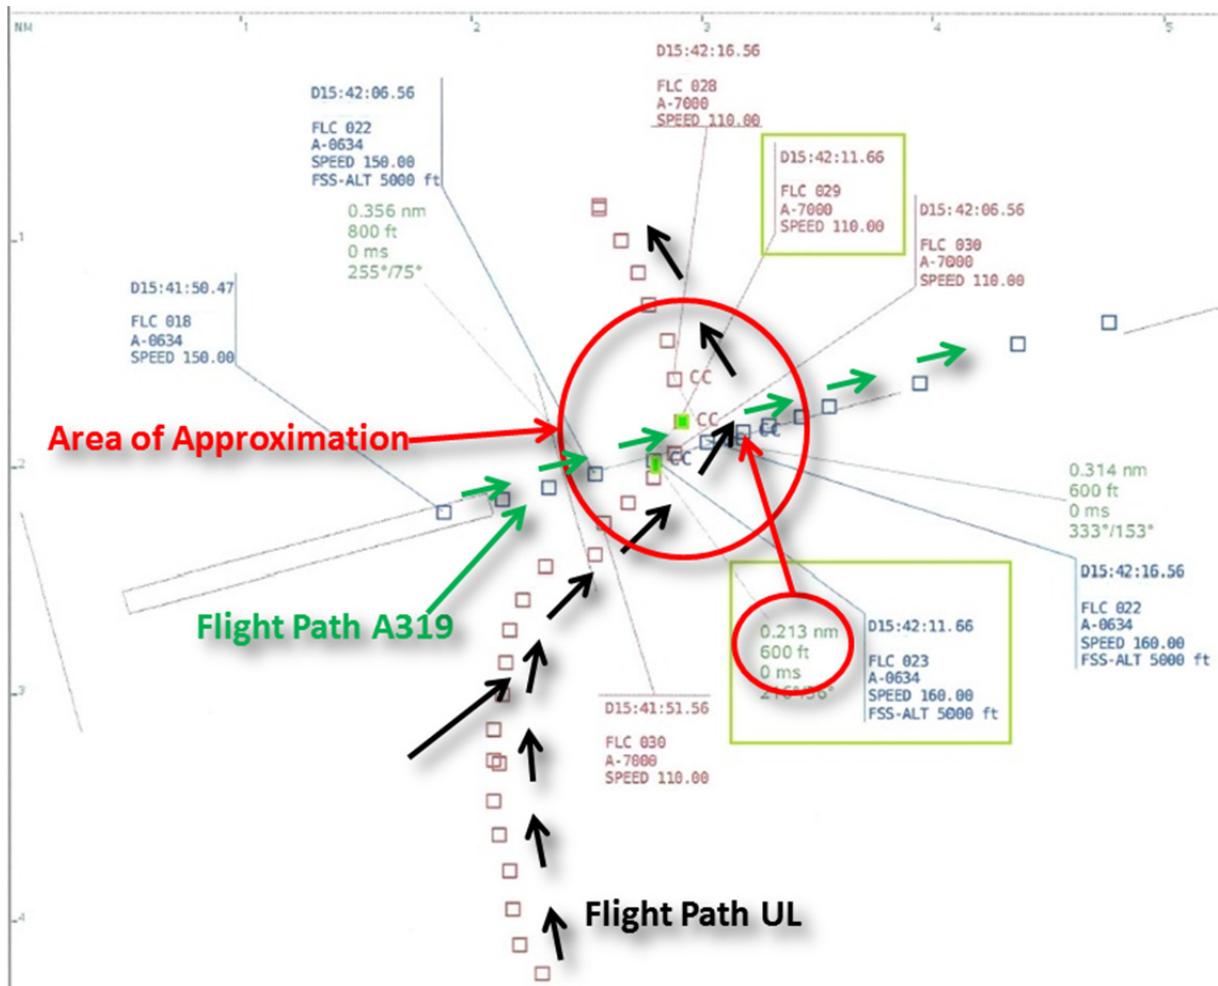
Fig. 2: Flight paths of both aircraft and approximation area

The air navigation services provider provided the BFU with radar data. Fig. 2 depicts the flight paths of the ultralight, the Airbus A319, and the approximation area of the two aircraft in the departure sector. At the time of the closest proximity the two aircraft had a horizontal distance of about 0.213 NM and a vertical of 600 ft. The Airbus A319 had a ground speed of approximately 160 kt and the ultralight of about 110 kt.

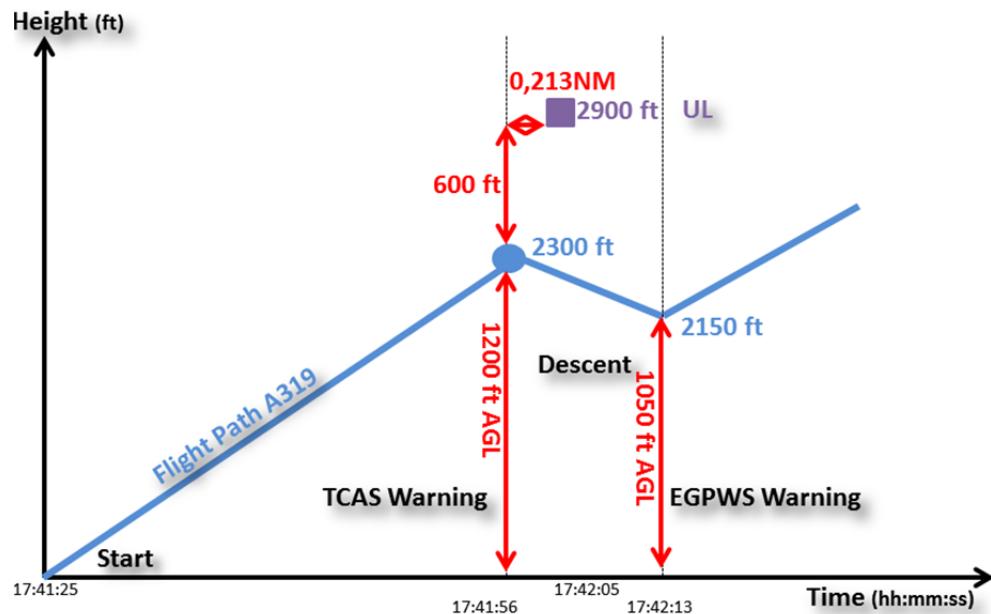
Fig. 3: Flight paths of both aircraft

The following Fig. 3 and Fig. 4 are based on the Quick Access Recorder data of the A319. Fig. 4 shows the lateral view of the approximation of the two aircraft. Fig. 5 shows the diagramm compiled with the software Inflight of relevant parameters.

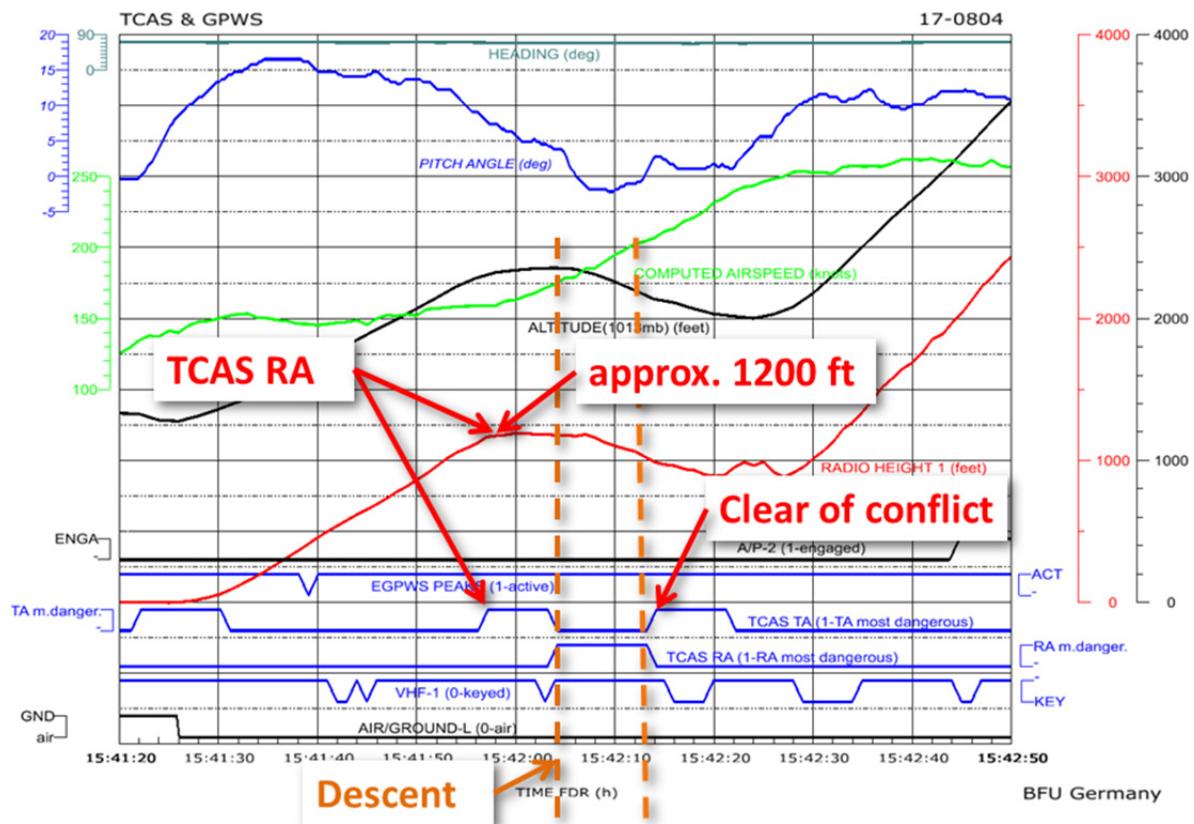
Fig. 4: Parameters of the Quick Access Recorder

The A319 lost approximately 150 ft altitude during the descent. According to the Quick Access Recorder data, the airplane was at about 1,050 ft AGL Radio Altitude (RA). Then the climb was continued.

Heading in degrees; Pitch Angle in degrees; Computed Airspeed in kt; Altitude (1,013 HPa) in ft; A/P - Active/not Active; TCAS TA - Active/not Active; TCAS RA - Active/not Active

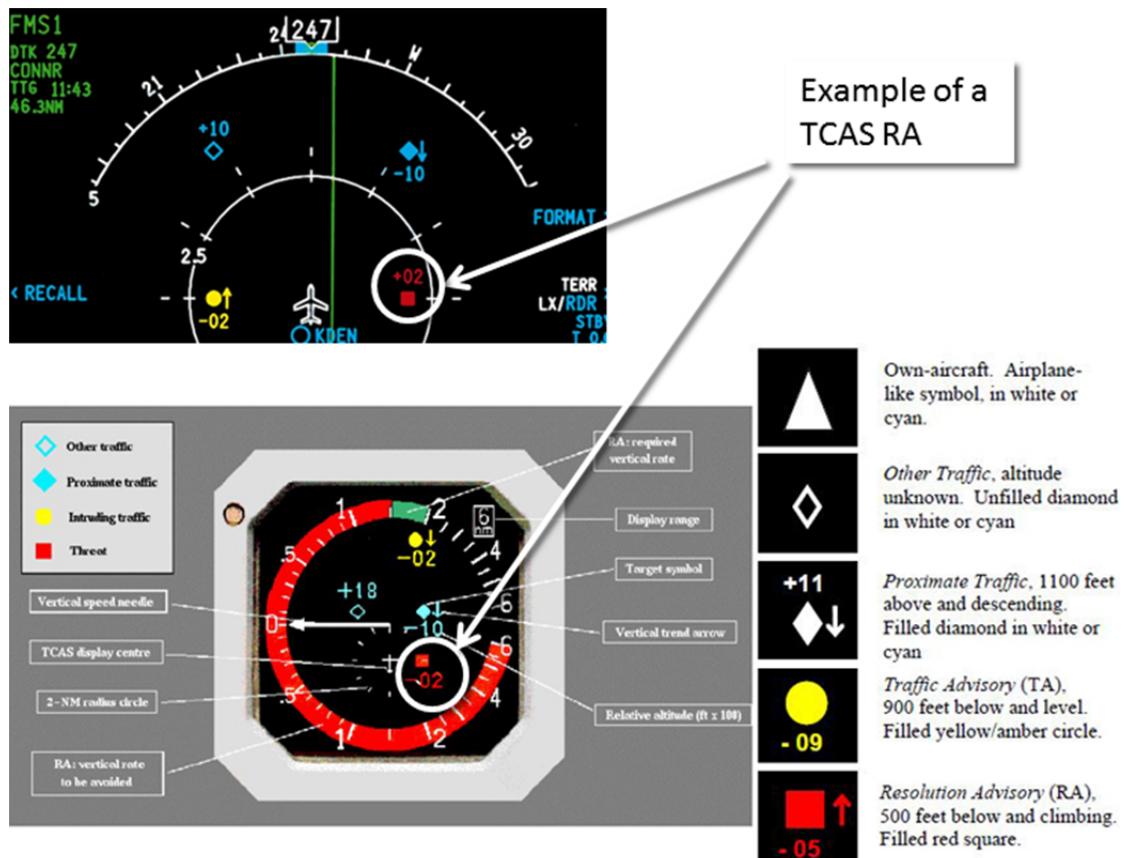
Fig. 5: Various instrument options of TCAS RA depiction

The information is displayed either on navigation displays, or on additionally installed instruments or a combination thereof instead of classical flight instruments. Fig. 5 shows both variants. The display of both instruments depicts the air traffic in the airspace monitored by TCAS. The pilots can observe the relative position, the relative flight altitude, and the trend of the relative flight altitude of other aircraft.
