Report IN-019/2019

Incident involving a Boeing 737-86N,
registration G-GDFS, and a Diamond DA20-C1,
registration EC-KMH, near point E in the Reus
Airport CTR on 12 May 2019

Summary of event:

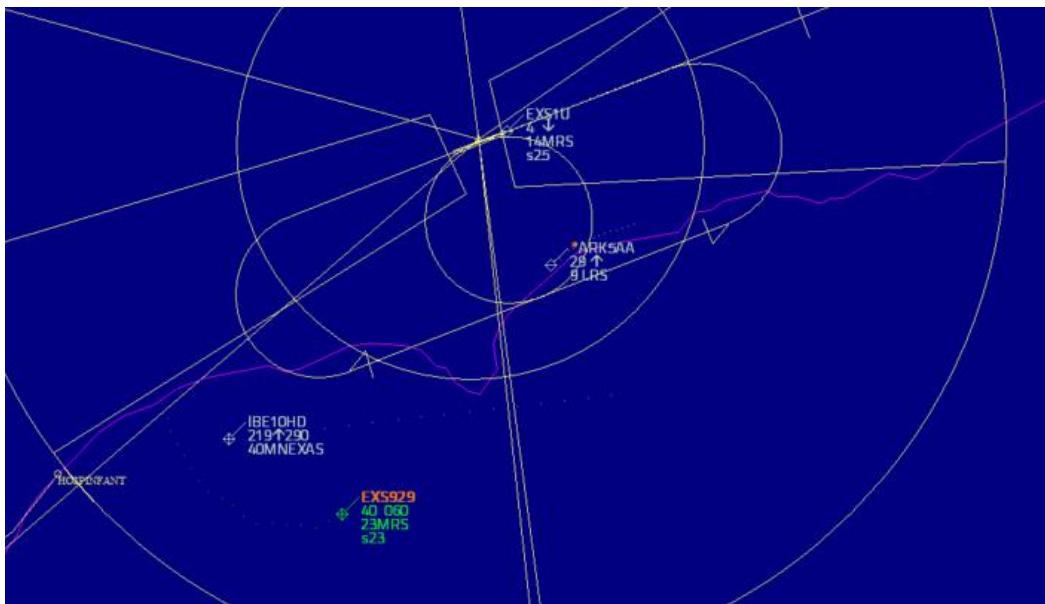
Illustration 1: Position of G-GDFS at 10:32:26

At 10:32:26, G-GDFS, whose callsign was EXS929, after missing its approach due to not being stabilized, was on the outbound leg to try a new ILS Y approach based on the RUS NDB. The instrument approach chart published in the AIP specifies that the outbound leg is to be flown descending from an altitude of 5000 ft to 3800 ft by DME mile 13 on the ILS; however, the aircraft was flying at an altitude of 4000 ft, as it had been cleared to do so by the air traffic controller.

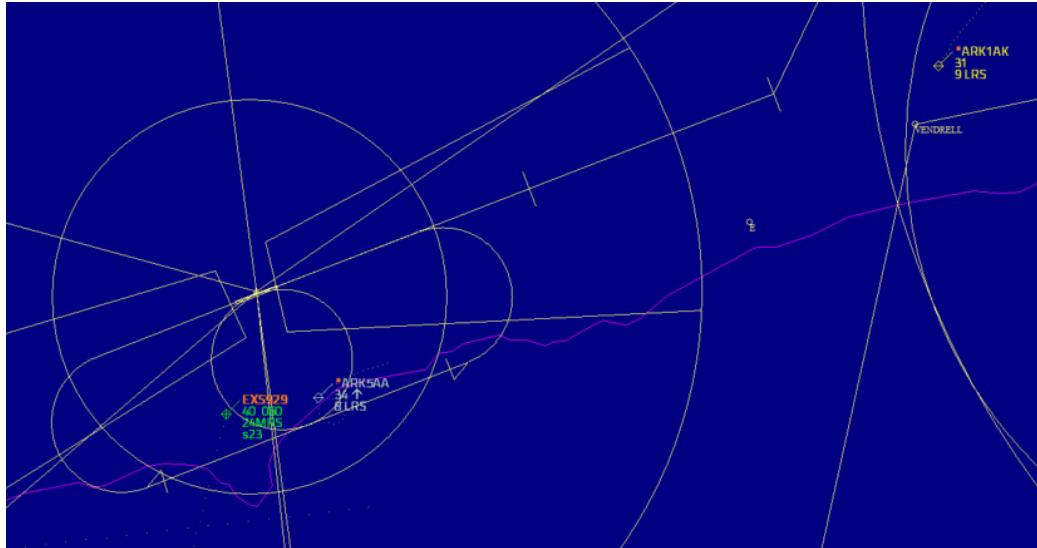
Illustration 2: Position of the aircraft at 10:34:40

At 10:34:40, EC-KMH, whose callsign was ARK1AK, was preparing to enter the Reus Airport CTR via reporting point E. At that time, it was at an altitude of 3100 ft. This aircraft had been instructed by the controller to maintain 3,500 ft or higher due to an aerobatic show that was taking place over Tarragona.

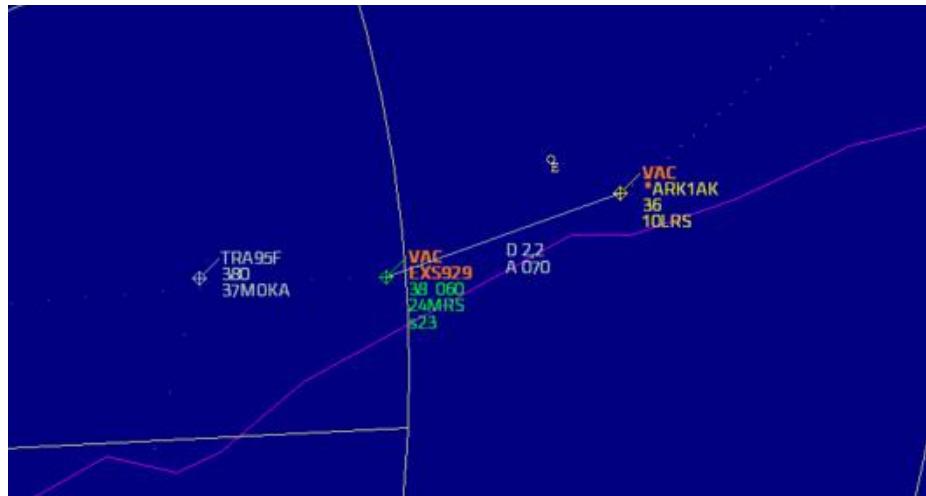
Illustration 3: Position of the aircraft at 10:37:41

At 10:37:41, G-GDFS was on the outbound leg, approaching mile 13 on the ILS DME at an altitude of 3800 ft, and EC-KMH was near reporting point E in the CTR at an altitude of 3600 ft. (On the outbound leg, mile 13 on the ILS DME practically coincides with reporting point E). At this time, the two aircraft were separated by 2.2 nautical miles horizontally and 200 ft vertically.

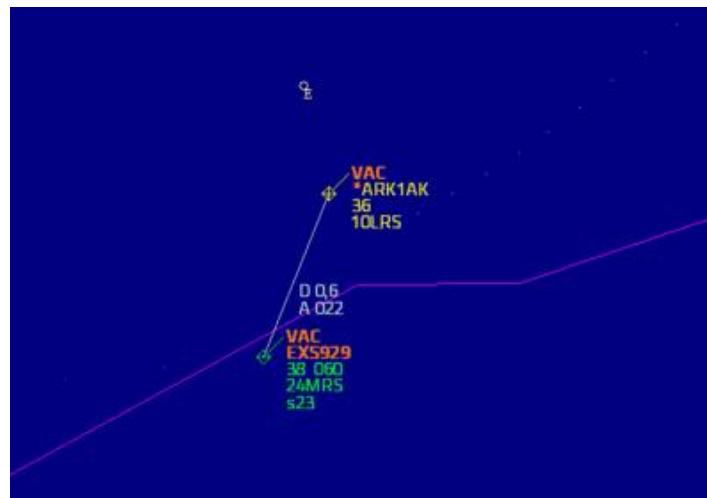
Illustration 4: Position of the aircraft at 10:38:05

The minimum separation between the aircraft occurred at 10:38:05, after which G-GDFS began to climb and separate from EC-KMH after receiving a TCAS resolution advisory.

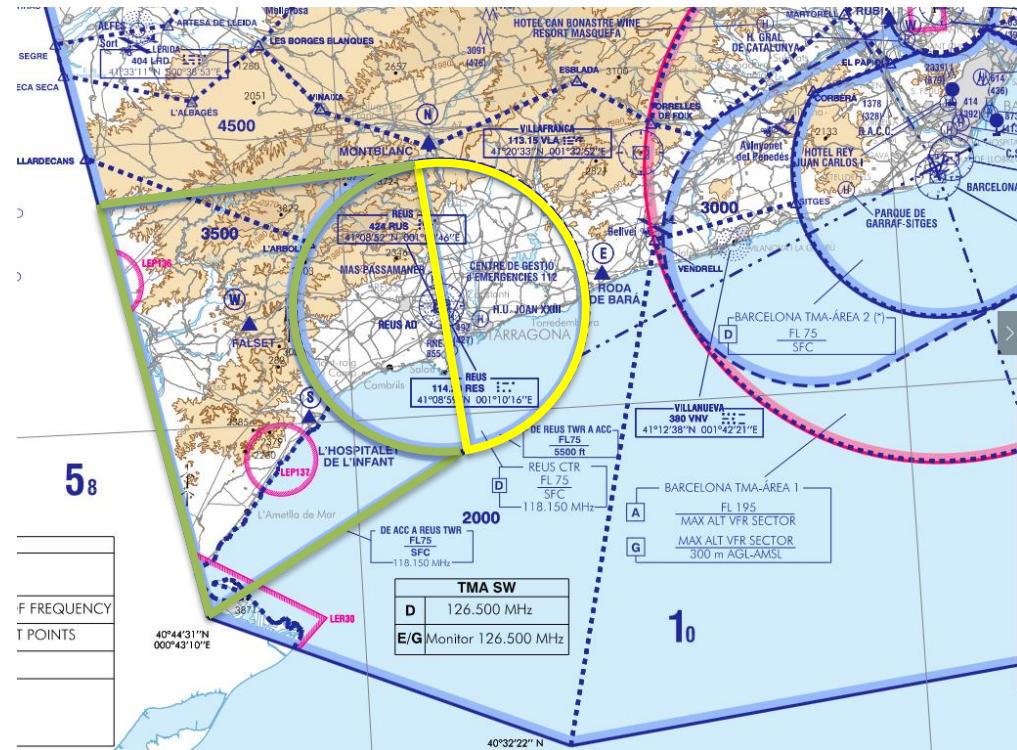
Illustration 5: Airspace where approach control services are provided

The approach control service provided by the control tower at the Reus Airport in the Reus CTR airspace is conventional, meaning it is procedural. The service is provided in the Reus CTR airspace and in an airspace delegated by the Barcelona TMA (highlighted in green in the chart below) up to FL75. Reus also delegates to the Barcelona TMA a semicircular segment (highlighted in yellow) between FL75 and 5500 ft AMSL.

ENAIRO stated that, at the time of this incident, there was no specific report⁵ on the radar coverage at Reus, although there was a report on the coverage of the Barcelona TMA, which spans the airspace that falls under the responsibility of the control tower at the Reus Airport. According to this ENAIRO report, the radar at BEGAS provides full coverage above “about” 5000 ft in the Reus CTR airspace.

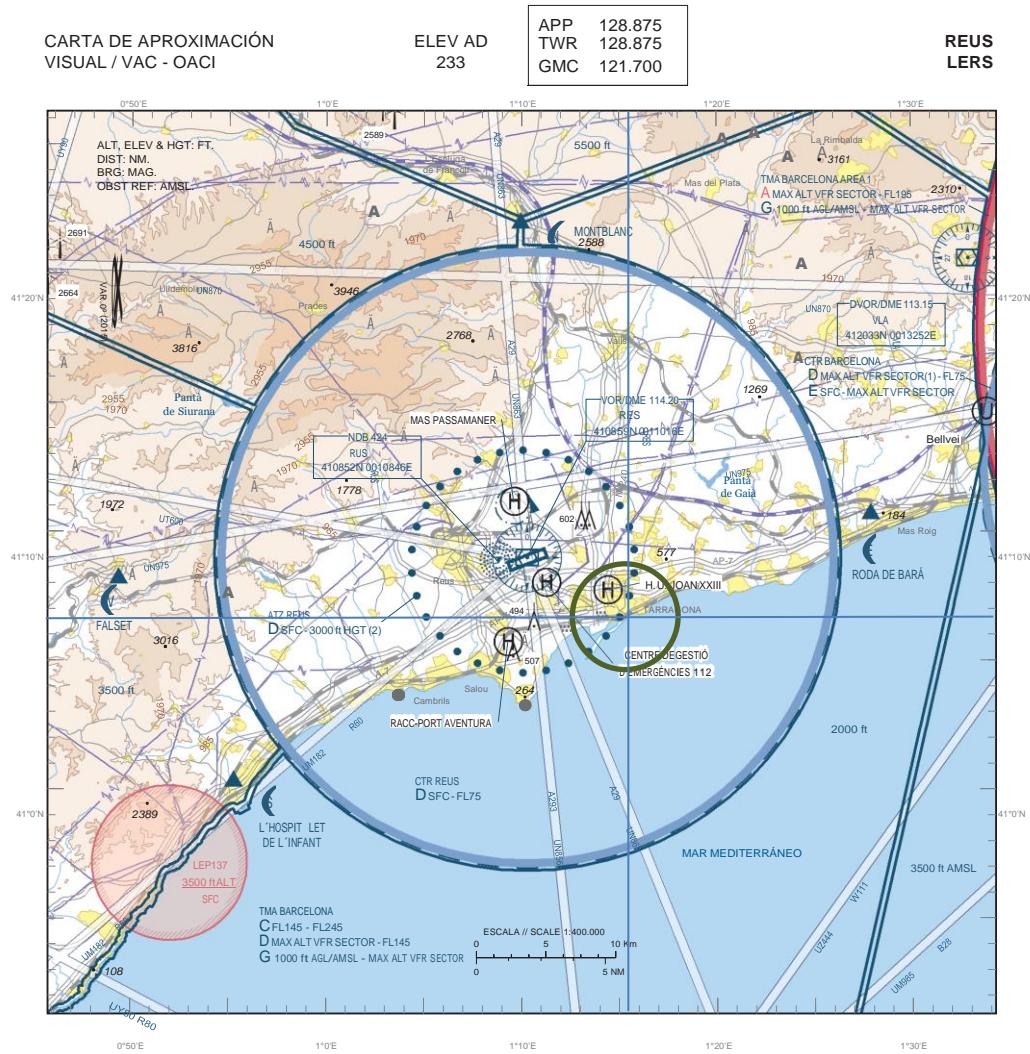
Illustration 6: Close-up of the airspace where the air show was taking place (in green)

As the chart shows, a small part of this airspace was within the Reus ATZ, and was thus monitored on radar by the air traffic controllers; however, the majority of this area was inside the Reus CTR, and the controllers were not aware of the aircraft in this area:

Although the aerobatic flight exhibition was coordinated between AESA and ENAIRE's Department of Operational Coordination, following the usual procedure, and after which AESA published a Resolution regarding the aeronautical compliance required by these exhibits, it is considered that the evaluation of the safety risks was not adequate. The publication of a NOTAM advising of the exhibition of acrobatic flights in front of the Miracle beach in Tarragona is not a sufficient safety measure and therefore a safety recommendation will be made to ENAIRE so that it establishes more safety measures when assign aerobatic flight areas near airfields. It should also be noted that, during the comment phase, the operator of the G-GDFS aircraft indicated that this NOTAM was not among the information given to the crew prior to departure. Therefore, the aircraft crew was not aware of this situation.

REC 02/20. It is recommended that ENAIRE establish more safety measures when aerobatic flights are near an aerodrome.
