**Islamic Republic Of Iran**  
**Civil Aviation Organization**  
**Aircraft Accident Investigation Board**

**Final Report**

Aircraft Model: Bombardier CL604 Challenger

Registration: TC-TRB

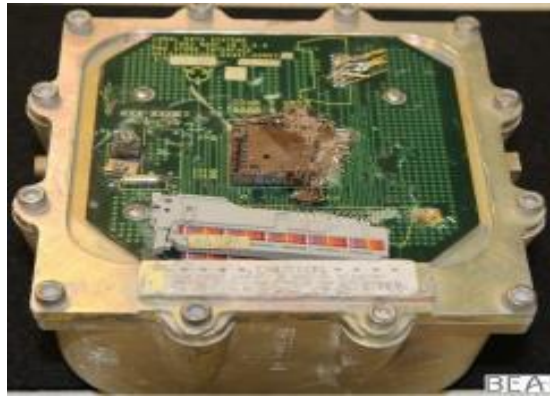
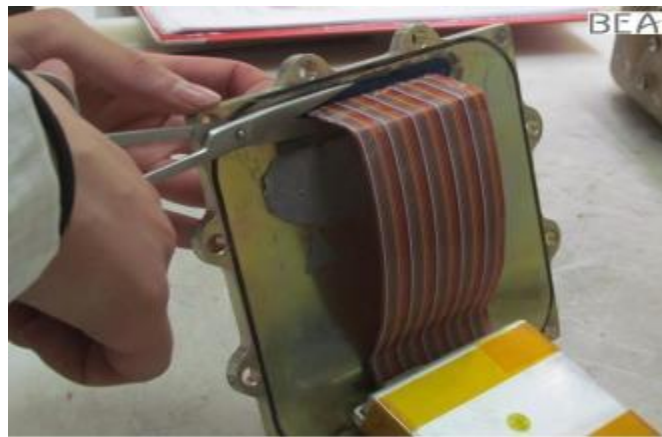
The FDR FCSSU was visually checked. The connector of the memory board was damaged.

The FCSSU was opened, the metallic casing of the memory board was extracted and the ribbon cable was cut close to the cover of the FCSSU.

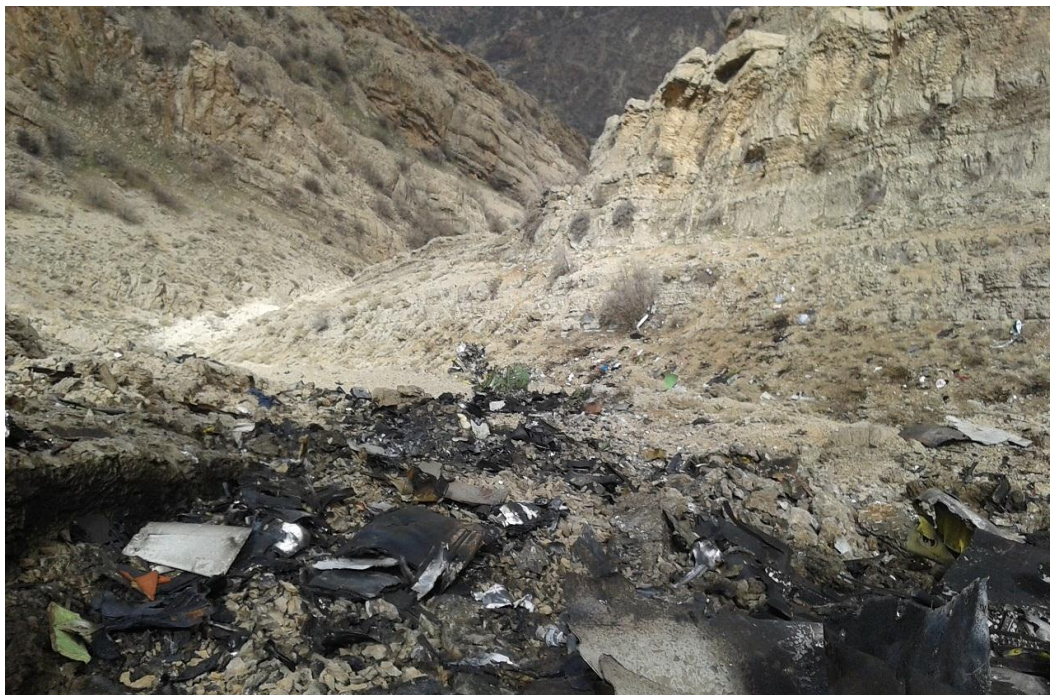
The investigation carried on Helen Mountain area along with the wreckage distribution pattern revealed that the initial contact with terrain has happened at an elevation of 7500 ft elevation, with the nose impacted first. As shown in the figures, the wreckage was scattered in an area of about 500 m long and 200 m wide on mountain slope. At the point of impact, there was a burned black hole about 3 m wide, 5 m long and 2 m deep. There was evidence of severe impact at this point with scattered parts from the cockpit, and nose section equipment of the aircraft. After the impact of the aircraft with the terrain, both engines were separated. Both engines were available at accident site and the condition of their rotating parts showed minimum engine rotation speed impact. The right and left wings as well as the forward fuselage including the cockpit, completely burned in the post-impact fire. It seemed that the aircraft had integrity before impact to mountain area.

Impact point and the wreckage of the aircraft

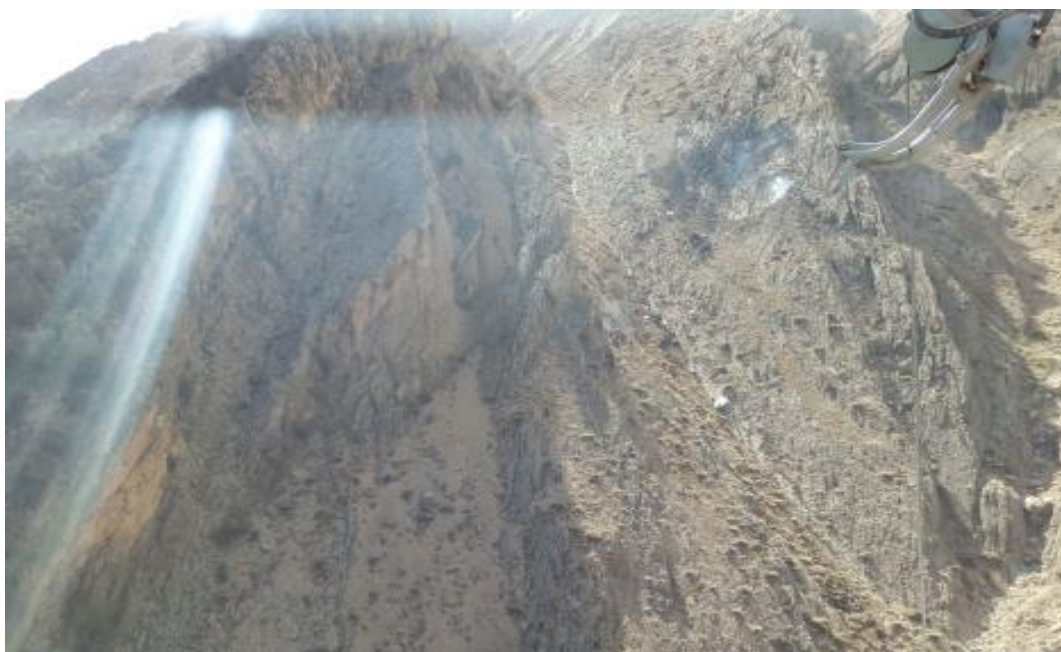
Impact point of the aircraft

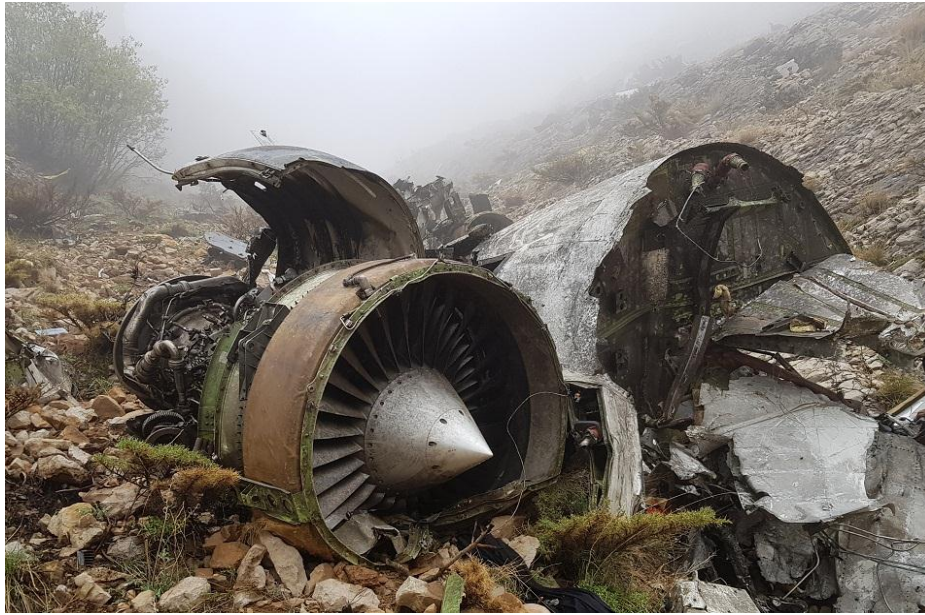
Engine #2

The data shows an eventual and progressive deterioration of engine performance parameters until shutdown of both engines. It is likely that the disturbed airflow caused by the rapid and repeated pitch oscillations eventually caused internal damage to the engines, resulting finally

in the inability of the engines to continue to operate. It is likely that the engines were sufficiently damaged as a result, such that it would have been impossible to re-start them following the shutdown.

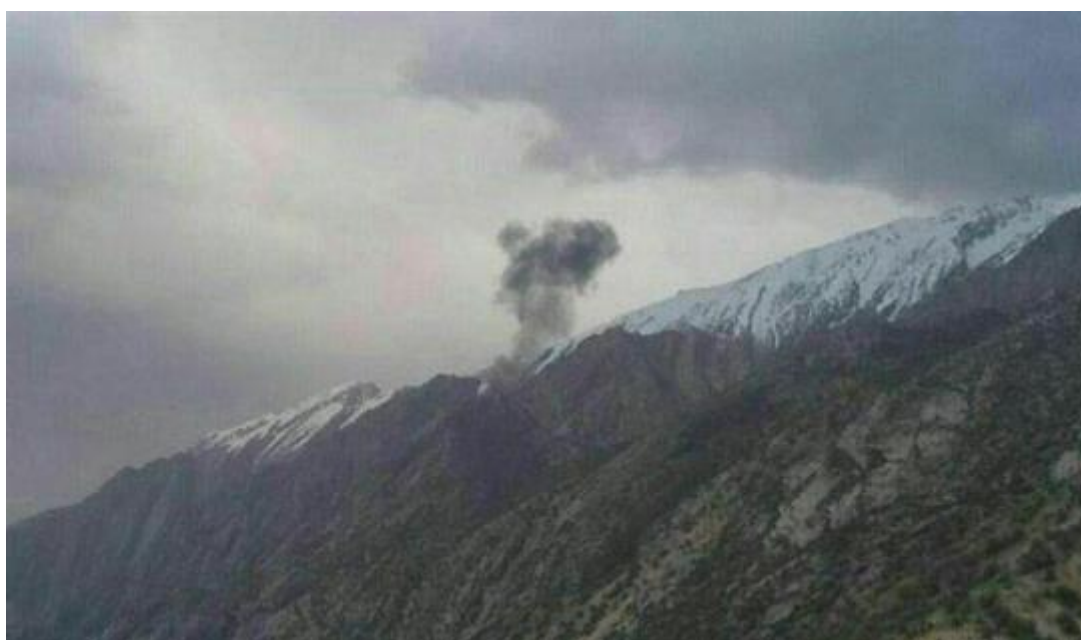
The first picture from crash site

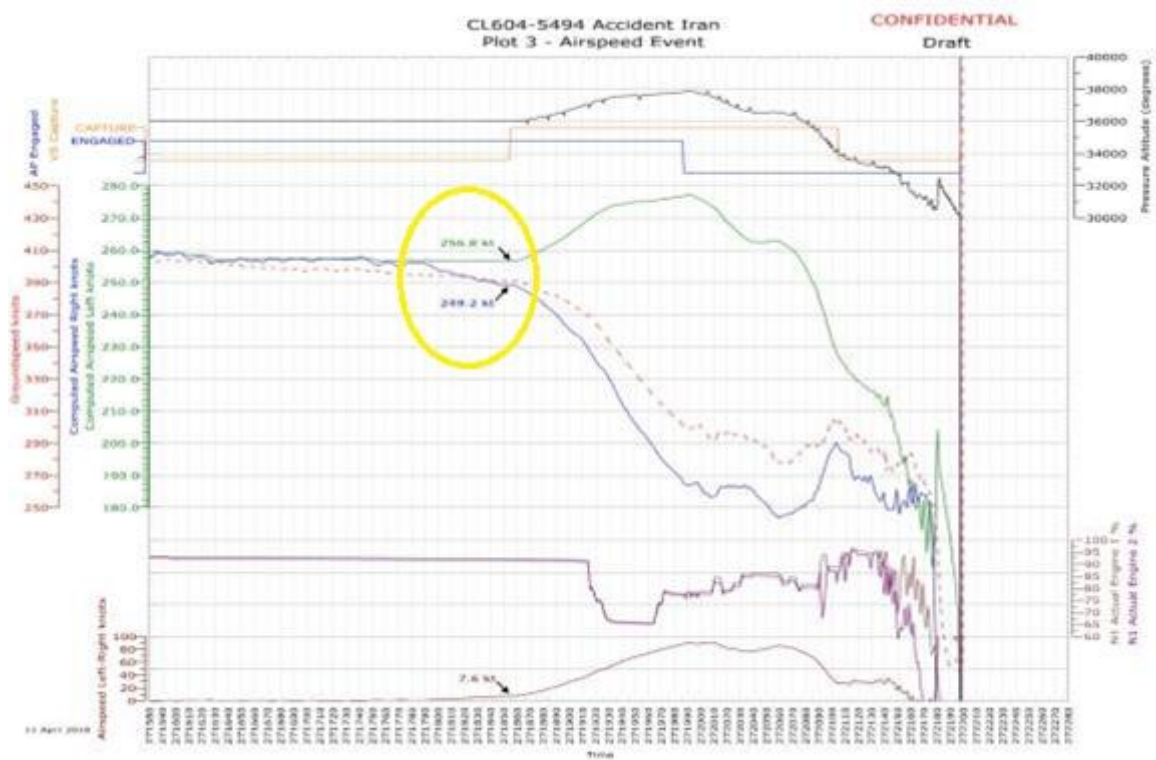
Accident flight

At 14:32on FL360 the speeds of both side indicators began to diverge about 5 kt.

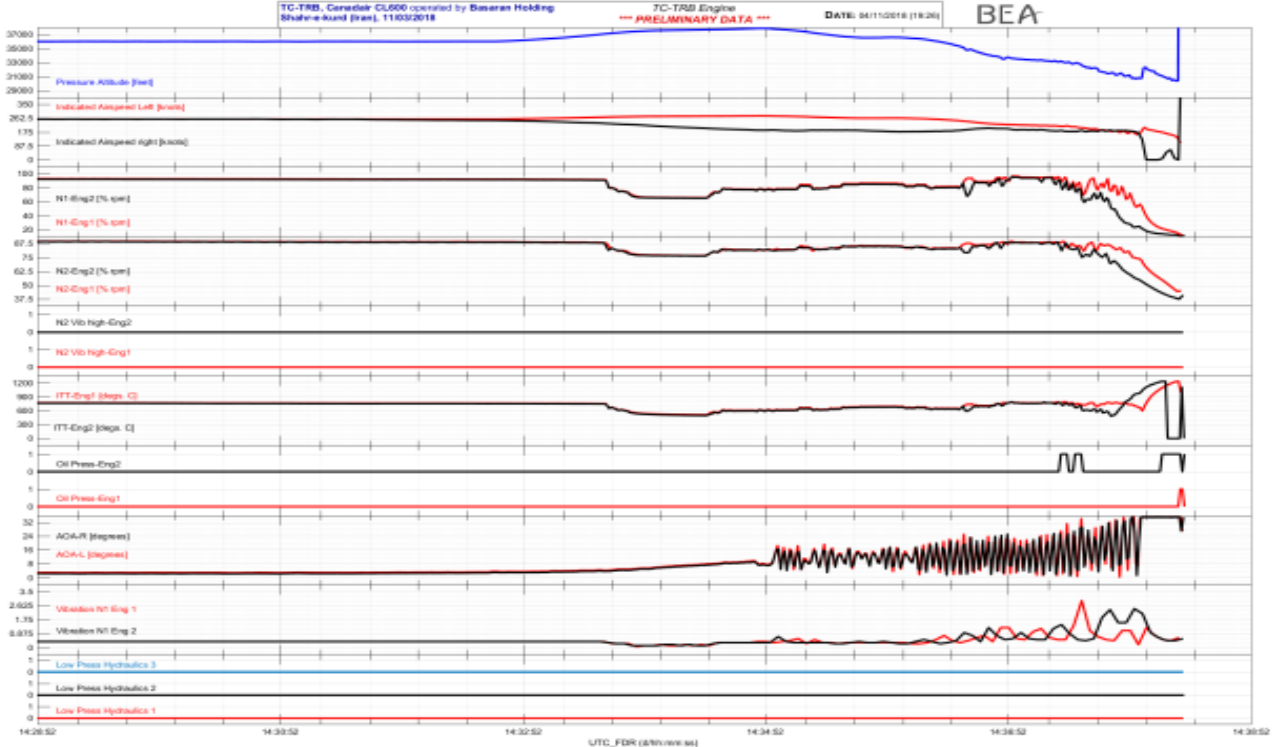
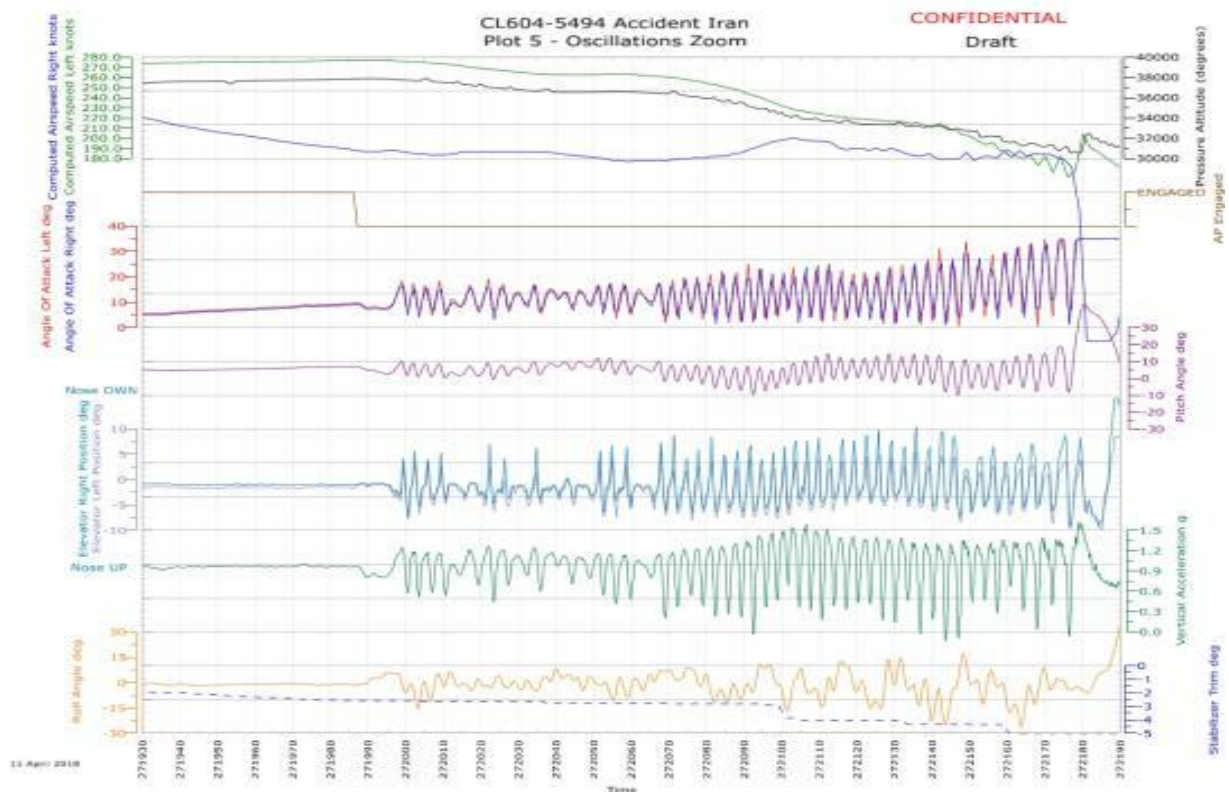
While aircraft was descending through FL370, the engine power and actual aircraft speed had reduced to stall speed but overspeed clacker was activated due to failure on indication system. The pilot never followed stall recovery procedures because she had a mind of overspeed by clacker warning [MMO over speed] on the cockpit. The stick pusher acted to pitch down aircraft to prevent stall condition but the captain's reaction on the control column just was in the opposite direction. During this time, the aircraft entered a series of pitch and roll oscillations.

The autopilot was disengaged by the crew before stall warning, which ended in oscillation of control surfaces based on FDR information. Engine power began to decrease on both sides until both engines flamed out in stall condition and FDR data recording was lost at this point. Data from the FDR shows that the aircraft experienced close to about 50 rapid pitch cycles following the activation of the stall protection systems, the result of the crew actively fighting against the pusher system.
