**Islamic Republic Of Iran**  
**Civil Aviation Organization**  
**Aircraft Accident Investigation Board**

**Final Report**

Aircraft Model: IL-76TD

Registration: EP-PUS

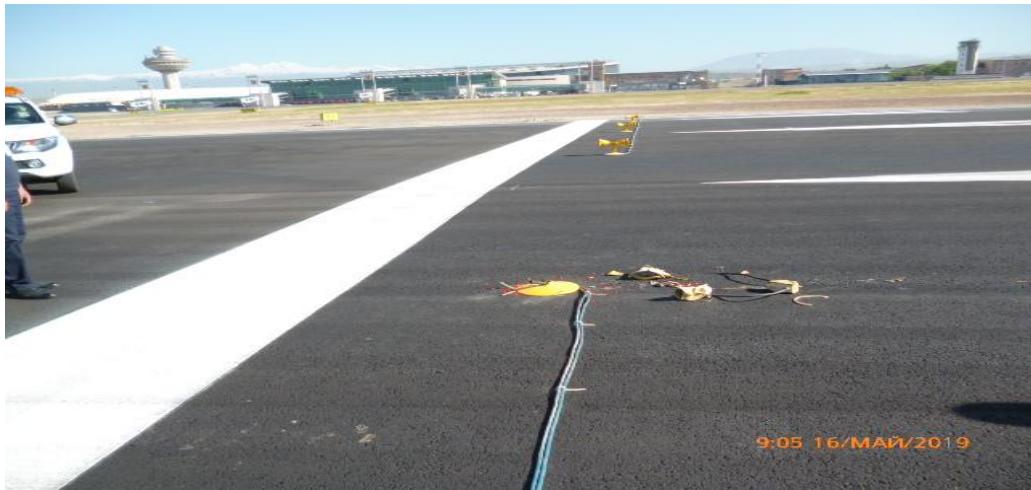
At 04:25 about 6 NM on the final, the flight was cleared to land by the tower controller. The aircraft landed on RWY 09 and crossed defined new temporary RWY END marking so aircraft main wheels have collided with the runway end lights.

At 04:29 UTC tower controller instructed the pilot to stop, and in his response, the pilot acknowledged" Stopping".
