ZKM KHAIA 002/R

AIRCRAFT INCIDENT REPORT ZKM KHAIA 002/R

**Komisioni për Hetimin e Aksidenteve dhe Incidenteve Aeronautike
/Vazduhoplovna Komisija za Istraživanje Nesreća i Incidenata/Aeronautical
Accidents and Incidents Investigation Commission**

**Report on Serious Incident of aircraft Airbus A320-232, Orange2Fly, SX-ORG at
the International Airport of Pristina, on 1st December 2017**

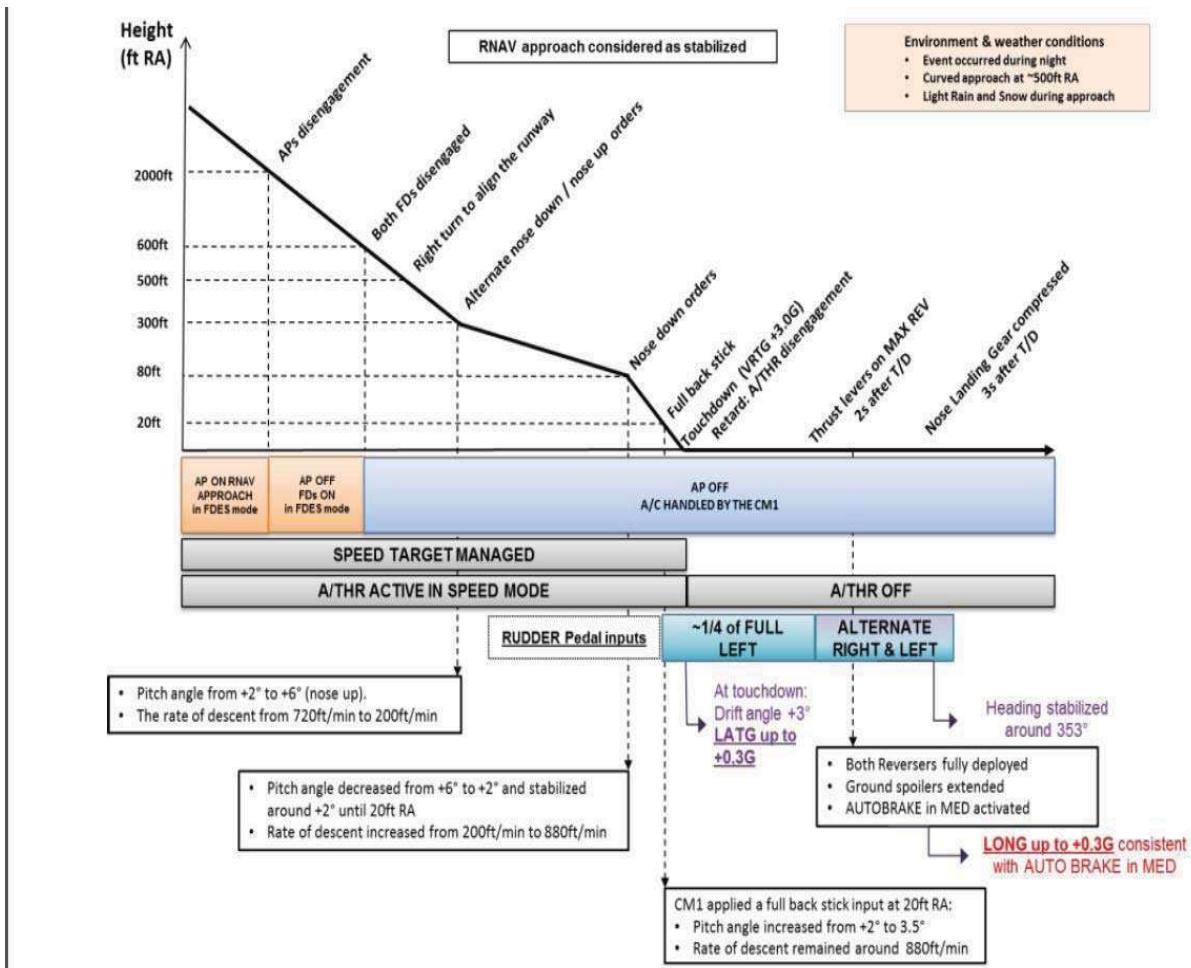
Figure 8: The approach sequence and touch down

- 350° of heading (QFU 353°).
- $+3^\circ$ of drift angle (aircraft nose toward the left of the track).
- Lateral load factor was at $+0.3G$ (consistent with drift angle).

The above mentioned are graphically illustrated in the figure below.

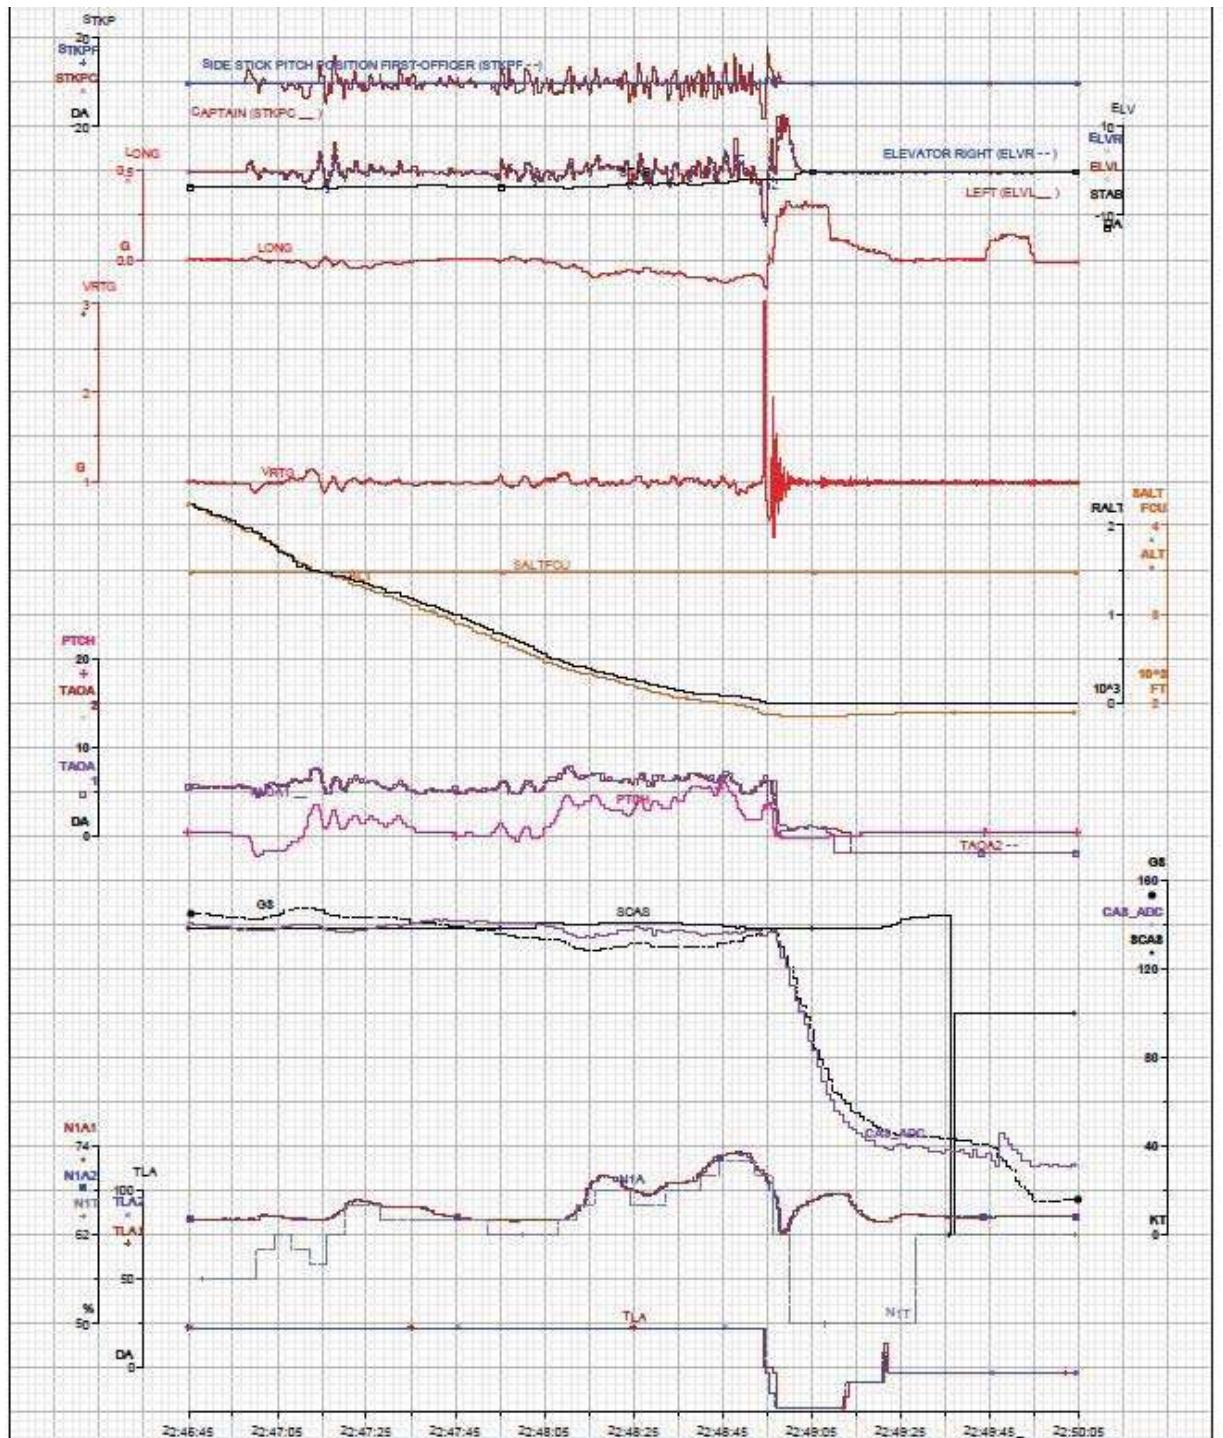
Figure 9: FDR parameters of the approach phase

The figure shows the approach phase on the longitudinal axis.

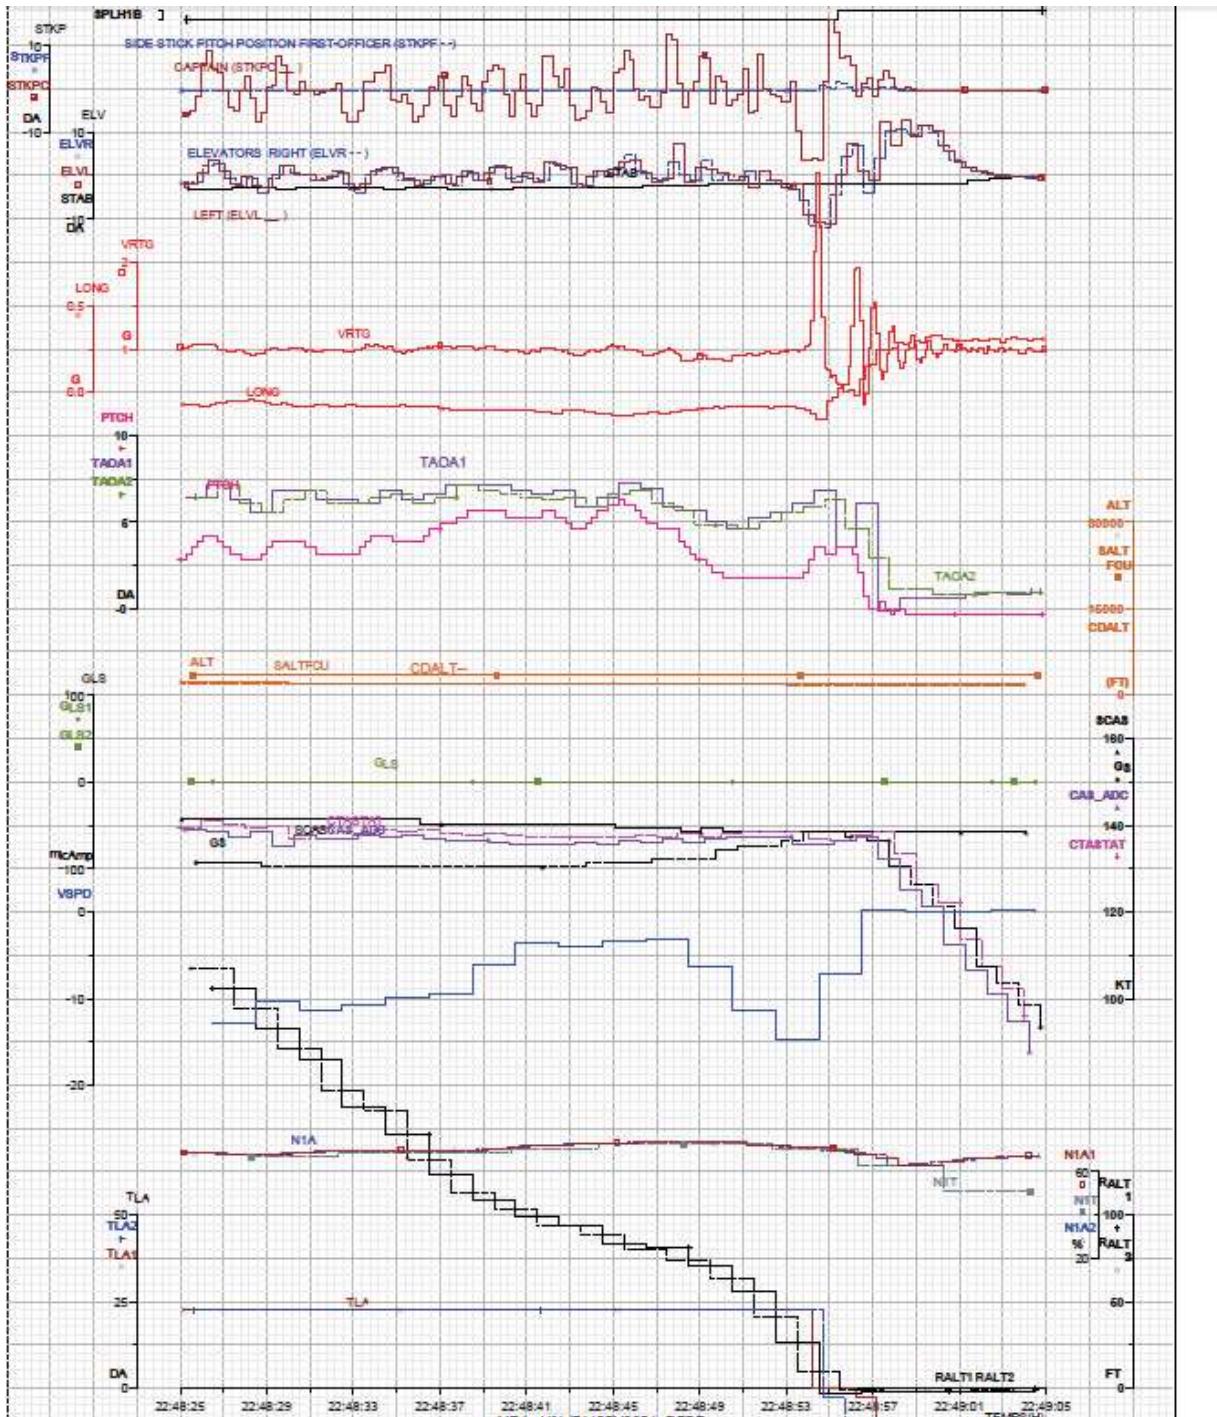
Figure 10: FDR parameters of the landing phase

The figure shows the landing phase on longitudinal axis.

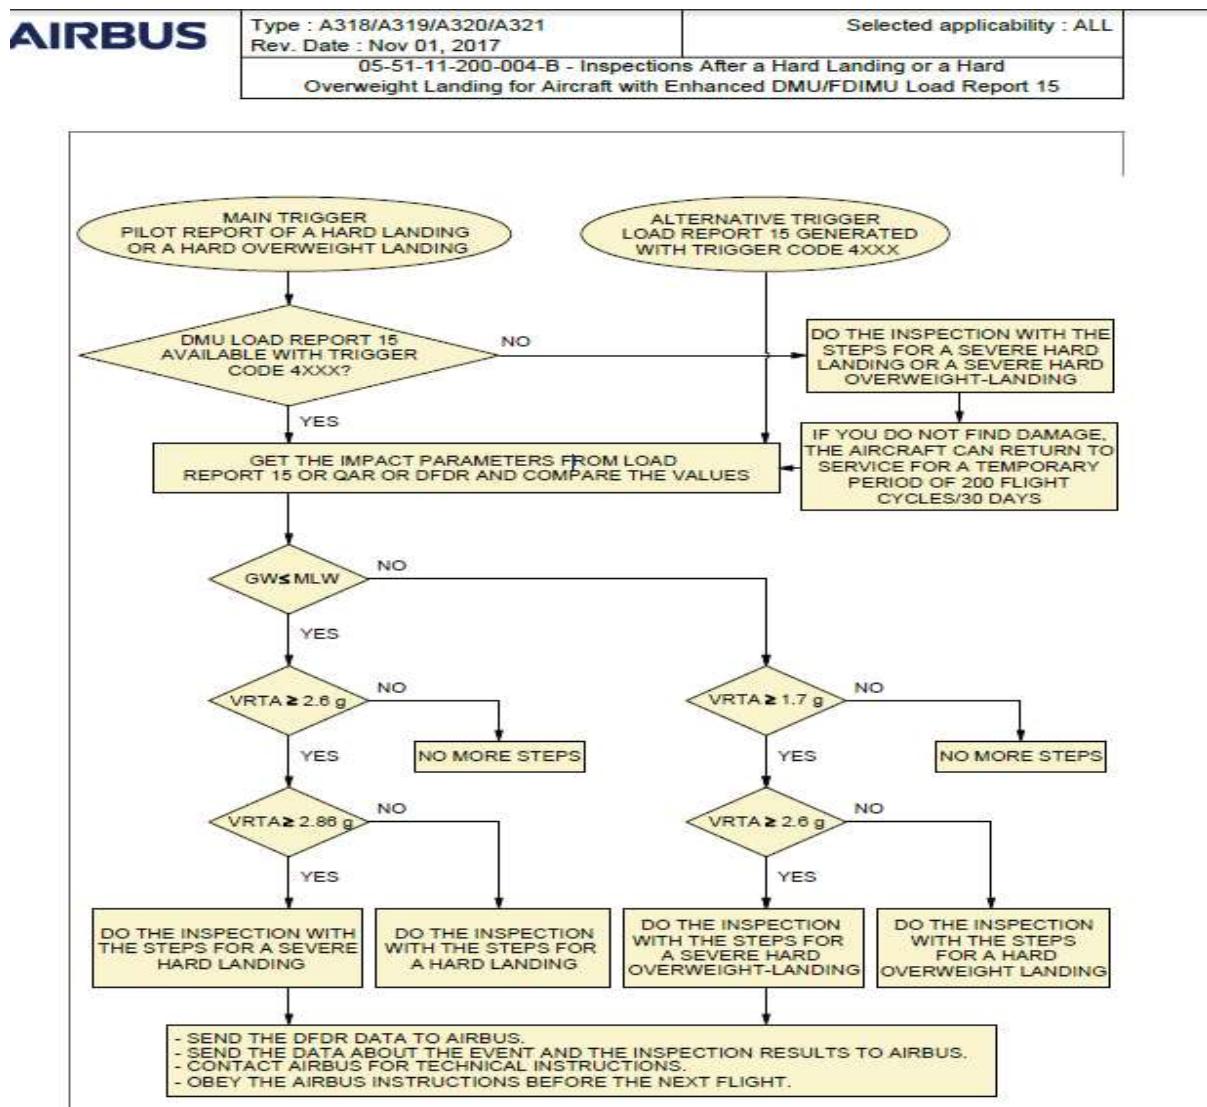
Figure 22: Hard Landing Inspections Chart

" after a crew report of a hard/overweight landing, you must confirm the impact parameters to know the category of the landing. To know this, refer to: - the DMU load report 15 or - the FDRS read out."

The specific inspections with the steps for a severe hard landing need to be carried out to the aircraft by the engineers after the exceedance of parameters.
