Islamic Republic of IRAN
Civil Aviation Organization
Aircraft Accident Investigation Board

Incident Report

State File Number: S961101URCQC
Type of Occurrence: Serious Incident
Date of Occurrence: Jan 21st 2018
Place of Occurrence: Isfahan Airport, IR of Iran
Aircraft Type: MD-83
Registration: UR-CQC
Operator: **Bukovyna Airlines**
On behalf of ATA Airline

INCIDENT REPORT
TBZ5704 - MD83 - UR-CQC

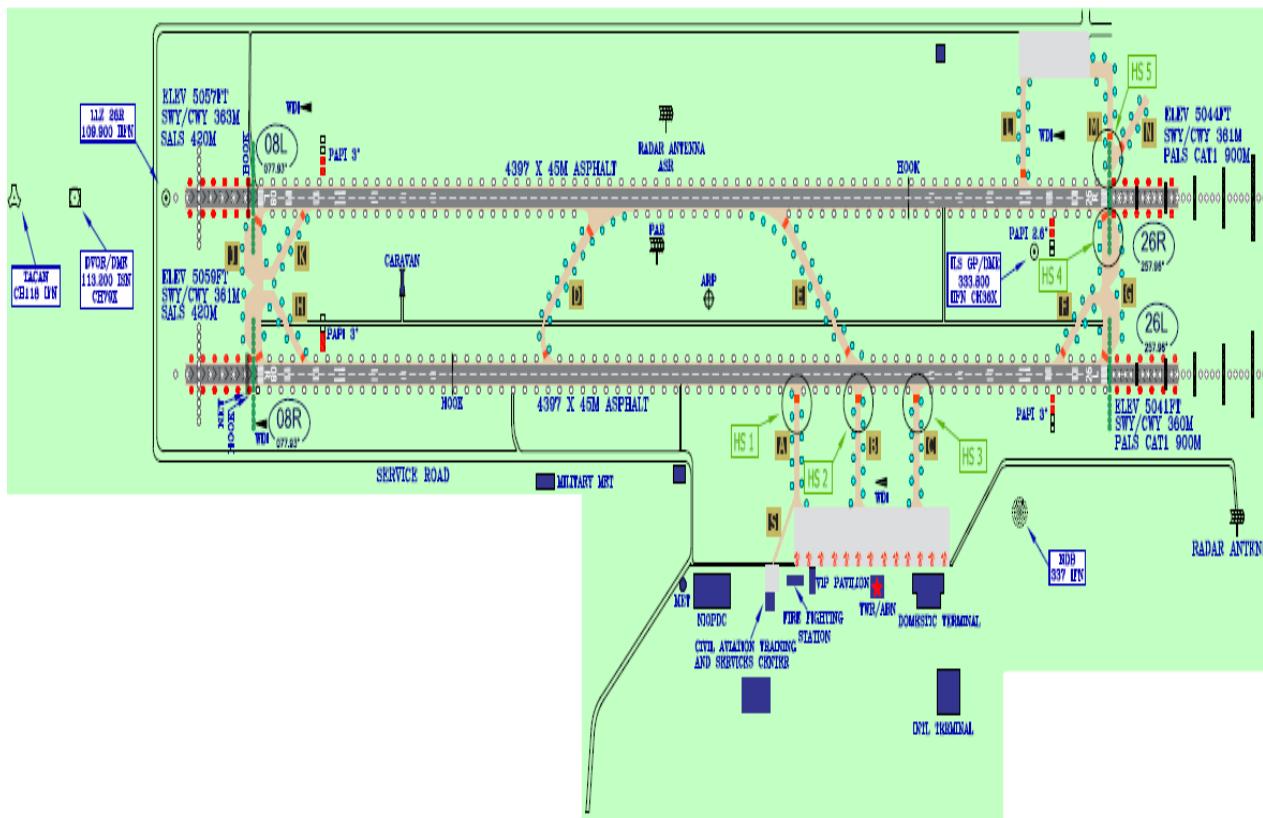
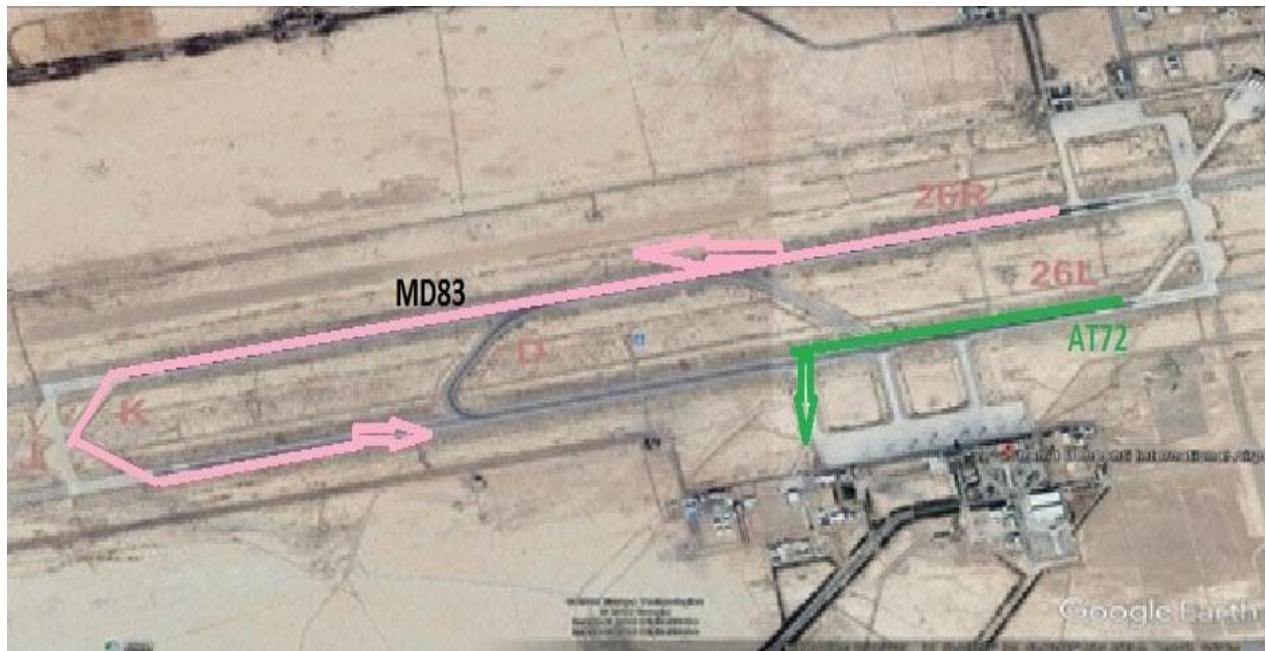
At 10:15 UTC (13:45 local time) on 21.Jan,2018, ATA Airlines McDonnell Douglas MD83, registration UR-CQC under property of Bukavyna (Ukraine) performing flight TBZ.5704 from Mashhad to Isfahan, had landed on Isfahan's runway 26R and were instructed to vacate the runway via taxiway D and hold short of runway 26L. The crew requested taxi via taxiway K and entered runway 26L via TXY J.

At 10:21UTC the pilot of TBZ5704 reported backtracking on RWY26L immediately the controller instructed him to hold short RWY26L. After confirmation of flight No;TBZ5704 regarding his position the controller informed arriving aircraft, ATR72 about the position of MD-83 which was back tracking at the end of RWY26L.

At 10:22:00 UTC An Iran Air ATR-72 registration EP-ITH performing flight IR-3366 from Ahwaz to Isfahan, was just approaching to touch down on Isfahan's runway 26L when the MD-83 entered the runway.

At 10:22:33UTC flight No; IRA3366 landed on RWY26L without receiving any instruction from ATC for go around and left RWY via TWY A.
