National Transportation Safety Board

Aviation Accident Final Report

Location:	Pensacola, FL	Accident Number:	DCA16FA217
Date & Time:	08/27/2016, 0930 CDT	Registration:	N766SW
Aircraft:	BOEING 737-700	Aircraft Damage:	Substantial
Defining Event:	Uncontained engine failure	Injuries:	104 None
Flight Conducted Under:	Part 121: Air Carrier - Scheduled

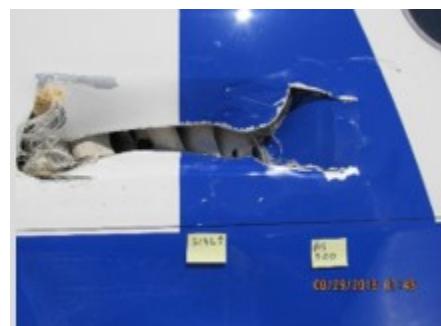
Postaccident examination of the airplane revealed a 16-by-5-inch through-puncture on the left side of the fuselage, as shown in figure 4. The through-puncture was just below the cabin windows by rows 11 and 12, as indicated by the yellow tape in figure 5, with no corresponding damage on the interior cabin sidewall. Numerous impacts were observed along the left side of the fuselage, the left wing, and the left horizontal stabilizer, and the left winglet front spar was partially severed.

Figure 4. Close-up view of through-puncture on left side of fuselage.

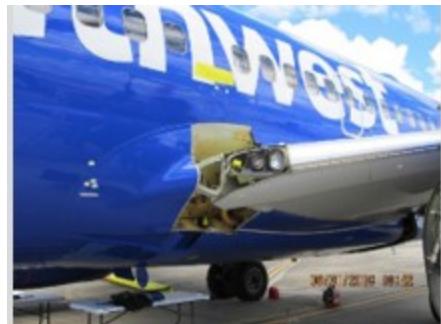
Figure 5. Location of fuselage skin puncture (as indicated by yellow tape).

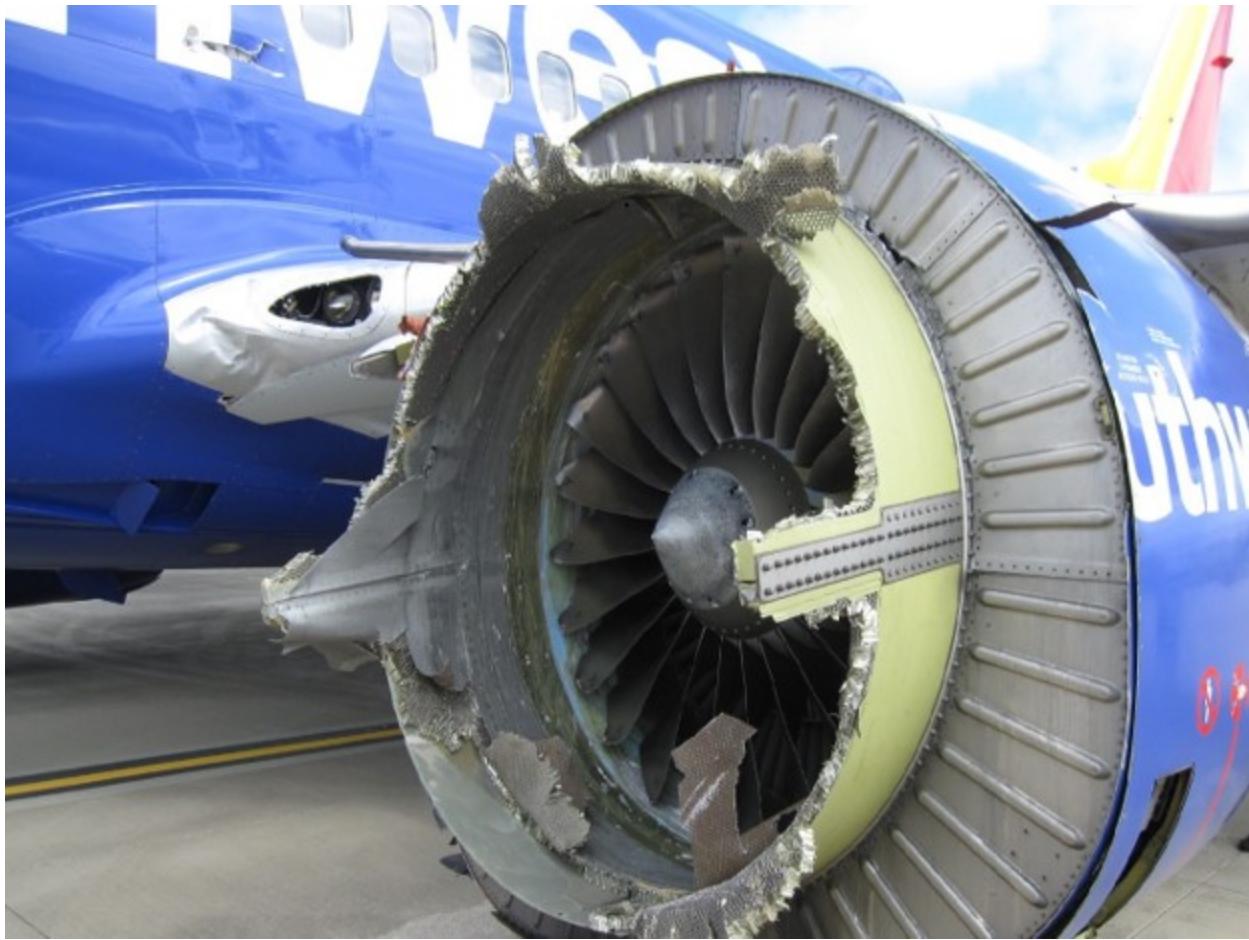
Almost all of the left engine inlet was missing, including the outer barrel, the inlet lip, the forward bulkhead, and the inner barrel forward of the containment shield. The part of the inlet that remained was severely damaged, as shown in figure 6. The aft bulkhead remained in place, but rivets connecting it to the attach ring were sheared 360° around the ring. A 360° section of the inlet inner barrel forward of the containment shield separated from the rest of the inlet about 17 inches forward of the A1 flange. Although both inner barrel splice plates (located at the three and nine o'clock positions) remained intact, the splice plate at the nine o'clock position exhibited impact damage and outward deformation. The inner barrel honeycomb core and the inner skin that remained were torn and flared outward. Gaps between the inlet attach ring and the fan case A1 flange were observed at several locations around the circumference of the interface between the two parts.

Figure 6. Inlet damage.

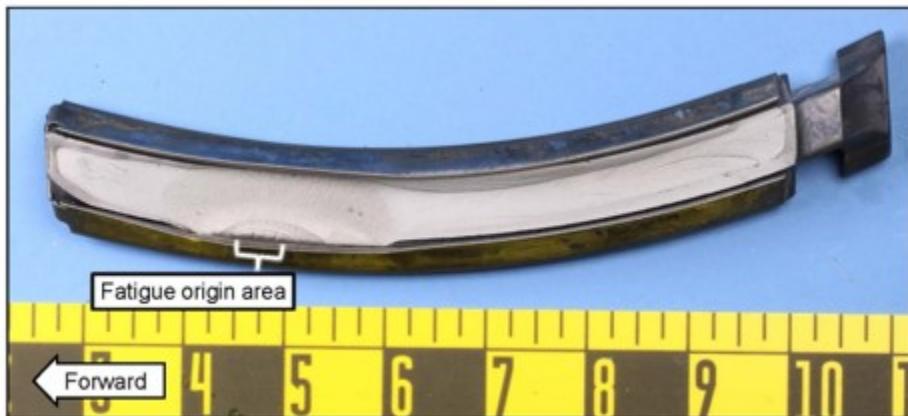
All of the fan blades were found in their as-installed (full length) positions in the fan disk except for fan blade No. 23, which had fractured at the blade root with the dovetail remaining in the fan disk. The blade dovetail is shown in figure 7; the blade airfoil was missing and was not subsequently recovered. All of the intact fan blades exhibited hard-body impact damage, tears, missing material, and airfoil curling or distortion. Most of the blade platform for fan blade No. 22 (which was adjacent to fan blade No. 23 in the counterclockwise direction) was missing.

Figure 7. Fan blade No. 23 fracture surface.

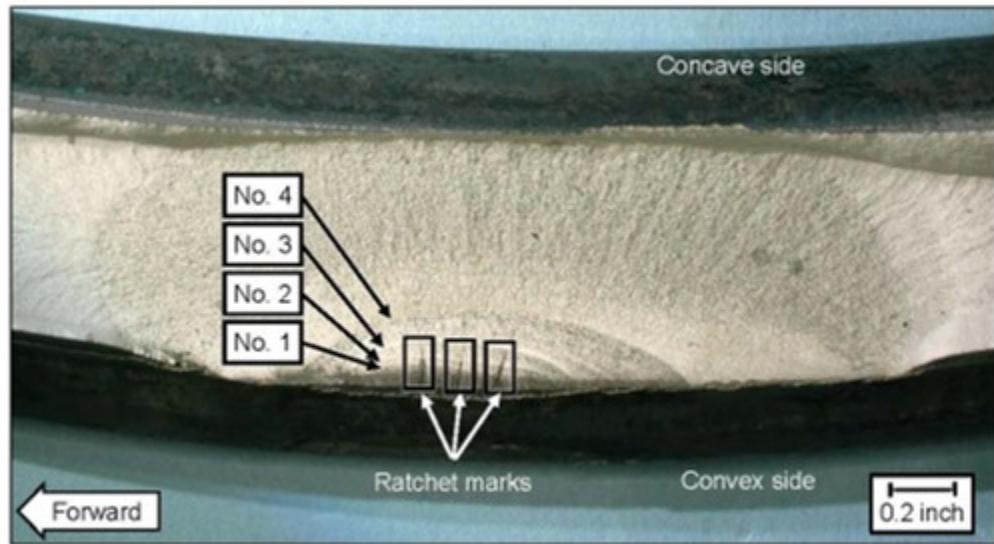
Part of the fracture surface on fan blade No. 23 was relatively smooth with well-defined curving crack arrest lines, which were consistent with fatigue, as shown in figure 8. (Crack arrest lines generally represent changes in the stress state, environment, or time interval associated with fatigue crack growth.) Fracture features emanated from an origin area centered about 2.1 inches from the leading edge face on the convex side of the blade. Ratchet marks (which are formed when two adjacent fatigue cracks originate on slightly offset planes) were observed in the origin area, consistent with multiple fatigue origins. The fracture had initiated at the contact face just inboard of the outboard edge (relative to the fan disk rotational axis) of the dovetail coating. The coating was missing and spalled in several locations on the convex side of the blade, including an area adjacent to the fracture and a larger area directly inboard from the fracture origin.

Figure 8. Fatigue region and crack arrest lines.

The progressive crack growth region extended up to 2.277 inches axially and was 0.695 inch deep. Beyond the boundary of the progressive crack growth region, the fracture surface had a lighter gray appearance with prominent shear lips, which was consistent with ductile overstress fracture.

The fan blade No. 23 fracture surface was further examined using a SEM. The four crack arrest lines found during the visual and optical examination (shown in figure 8) were observed on the fracture surface. The depths of crack arrest lines Nos. 1 through 4 were 0.072 inch, 0.093 inch, 0.139 inch, and 0.228 inch, respectively. A possible crack arrest line was observed between arrest lines Nos. 3 and 4, especially near the aft side of the fatigue region, but there was no distinct boundary around the entire front of the crack.

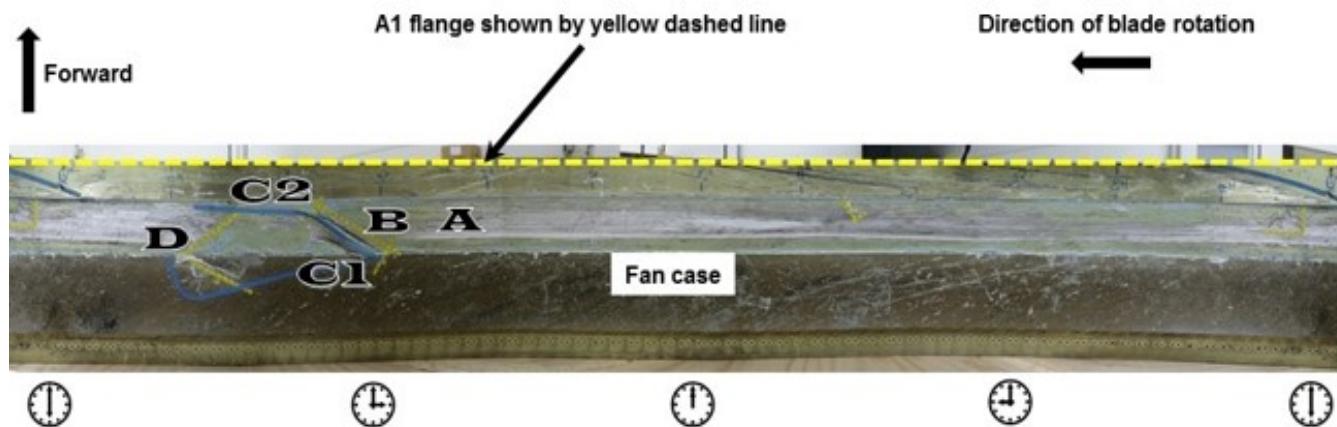
Figure 9. Fan case impact damage.

The first fan case impact, labeled impact mark A in figure 9, was a shallow blade tip scuff mark located near the two o'clock position. According to CFM, this initial fan blade impact caused the blade tip to bend, snap off, and travel forward and out of the engine. CFM considered this initial impact to be a "low energy" event due to the small radial clearance between the blade tip and fan case (resulting in a low radial release velocity) and the lack of a deep gouge or any related distortion of the fan case in this area.

According to CFM, after the blade tip fractured, the remaining fan blade continued to travel and created two "high energy" crescent-shaped impact marks (labeled B and C1) located between the three and four o'clock positions on the fan case. The impact marks coincided with observed fan case distortion and tears and was near the largest A1 flange distortion. CFM determined that the blade airfoil fractured at these locations, indicating that the impact was created by a different fan blade fracture surface. CFM also determined that the deep scuffing damage by impact mark C1 (labeled C2) could have been the result of an additional impact and airfoil fracture.

Another "high energy" impact mark (labeled D) was located at the five o'clock position on the fan case. This impact mark appeared to have the outline/imprint of the blade root trailing edge (profile view). The impact mark coincided with the observed fan case distortion and tears.
