# REPORT

## REPORT ON SERIOUS INCIDENT

Type of aircraft:	Aerospatiale SNI ATR 42-320
Nationality and registration:	Norwegian, LN-FAO
Owner:	Kystfly AS, Norway
Operator:	Coast Air AS, Norway
Crew	2 pilots and 1 member of cabin crew, no injuries
Passengers	24 passengers, no injuries
Place of incident:	Southeast of the glacier Folgefonna, Norway (59°55'N 006°31'E) at approx. 14,000 ft
Date and time:	Wednesday 14 September 2005, at 0720

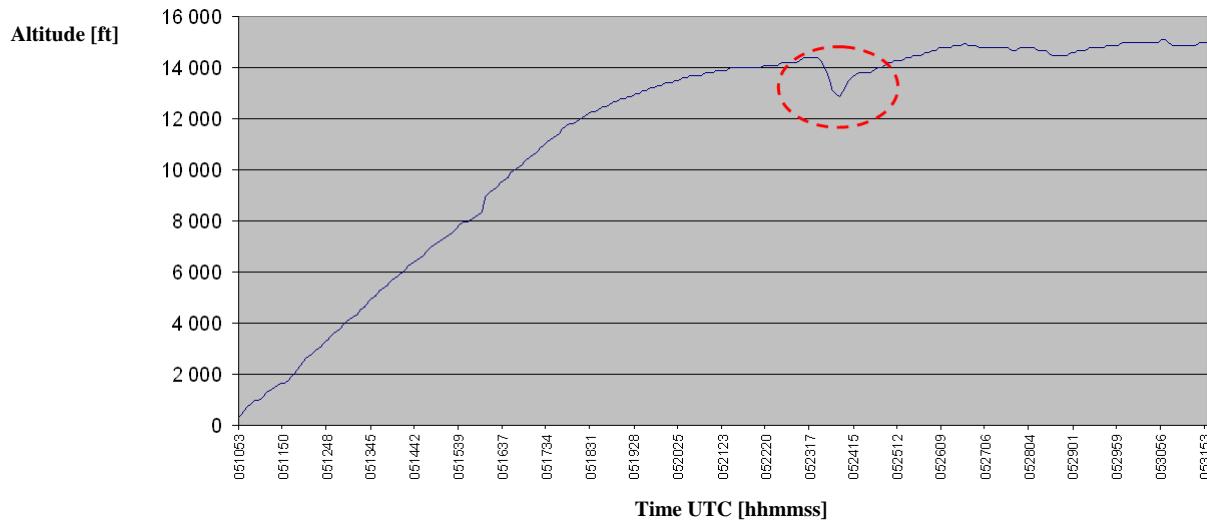
1.1.17 Radar data shows that, on the first occasion, the aircraft lost 1500 ft of altitude before beginning to climb again 28 seconds later (Figure 2: The flight profile for CST602 from take-off until the aircraft was established at cruising altitude (based on Mode C every 5 seconds). The period during which the incident lasted has been circled. See also figure 3.). The second loss of control is not shown quite so clearly.

Figure 2: The flight profile for CST602 from take-off until the aircraft was established at cruising altitude (based on Mode C every 5 seconds). The period during which the incident lasted has been circled. See also figure 3.

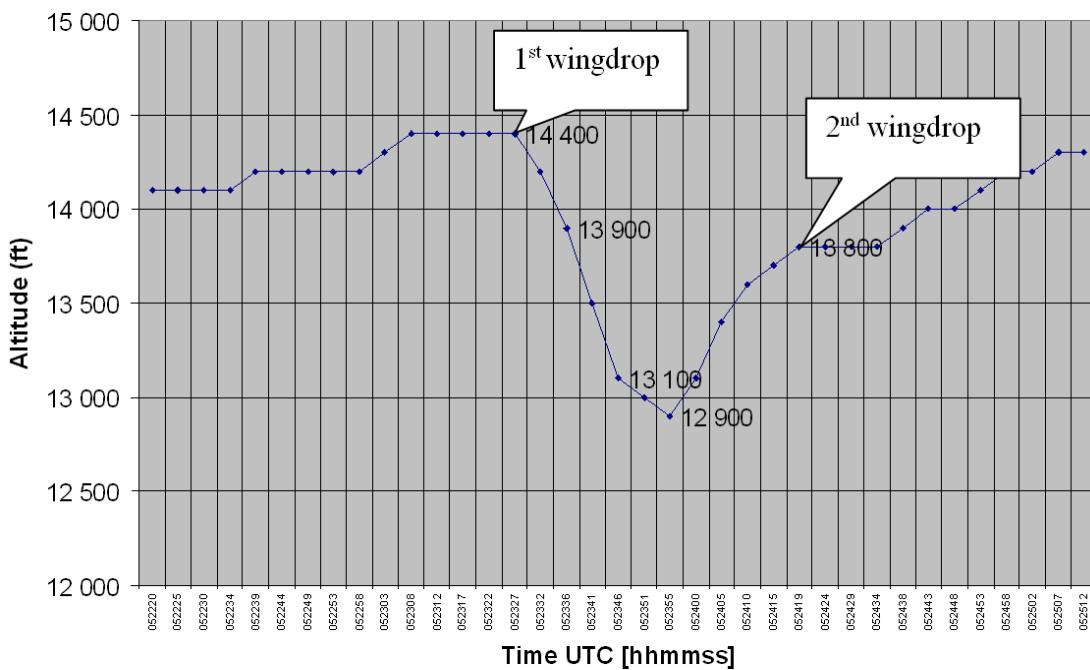
1.1.18 An extract of the period when the incident occurred is shown in the figure below. Combined with the crew's explanation it is possible to establish that the aircraft lost approx. 1500 ft in height the first time the wing dropped. It is equivalent to an average descent speed of approx. 3200 ft/min for the 28 seconds that passed before the aircraft again commenced climbing. At its steepest, the descent was around 5000 ft/min.

Figure 3: The flight profile for CST602 during the period 07:22:20 to 07:25:12 (based on Mode C every 5 seconds).

1.1.19 Once the descent stopped, the radar plot shows that the aircraft went into a relatively steep climb. According to the radar readings, it climbed 700 ft in the first 15 seconds, which corresponds to 2800 ft/min. Then the radar plot shows that the climb decreased somewhat during the following 10 seconds, before the aircraft maintained a constant altitude of approx. 15 seconds. Once it began to climb again, the climb rates were approx. 900 ft/min.

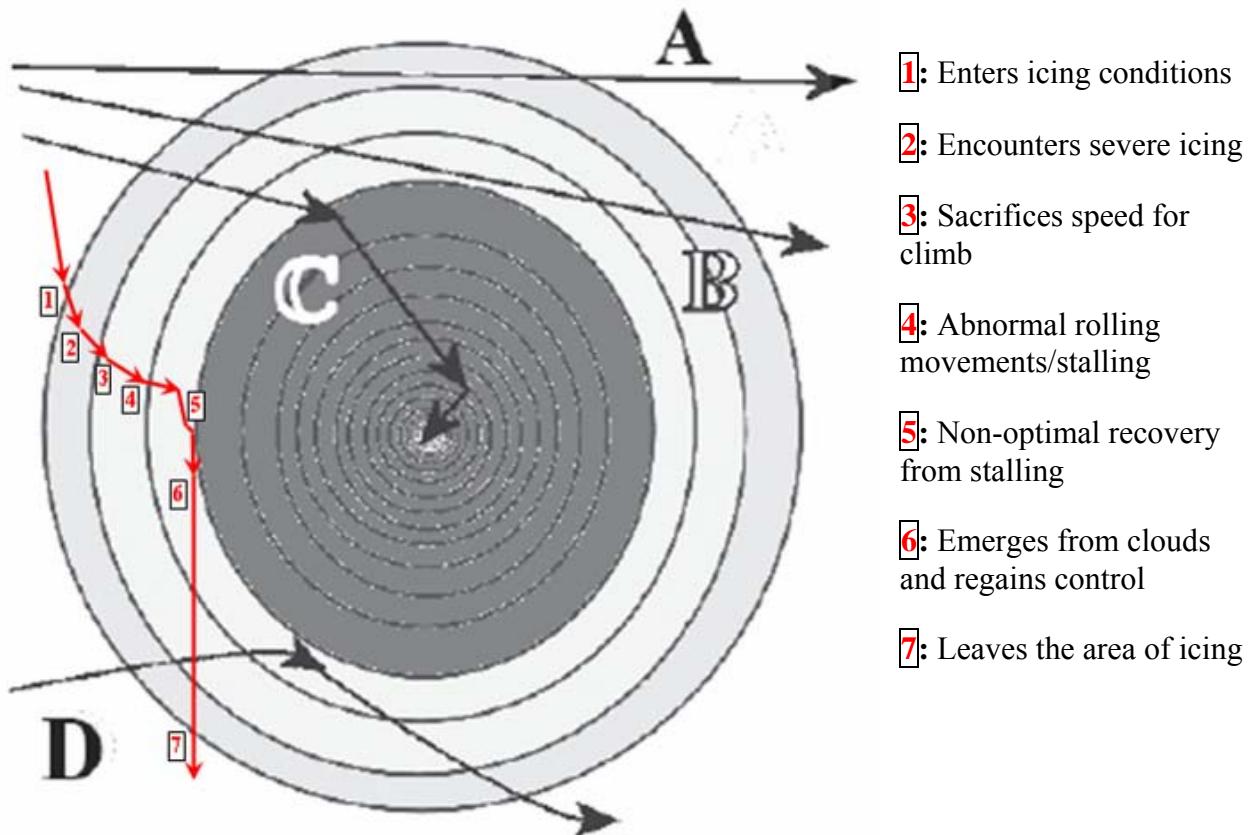
2.1.5 The AIBN believes that this "black hole model" can be used to illustrate what happened to the CST602 when the aircraft flew into an area of severe icing. The path is indicated with red arrows in the following figure:

Figure 10: Plotting the course of the CST602 relative to the “black hole model”
