SERIOUS INCIDENT

Aircraft Type and Registration:	Airbus A320-216, EC-KLT	
No & Type of Engines:	2 CFM56-5B6 turbofan engines	
Year of Manufacture:	2007 (Serial no: 3376)	
Date & Time (UTC):	26 August 2019 at 1205 hrs	
Location:	On approach to Birmingham Airport	
Type of Flight:	Commercial Air Transport (Passenger)	
Persons on Board:	Crew - 6	Passengers - 189
Injuries:	Crew - None	Passengers - None
Nature of Damage:	None	
Commander's Licence:	Airline Transport Pilot's Licence	
Commander's Age:	40 years	
Commander's Flying Experience:	9,700 hours (of which 8,080 were on type) Last 90 days - 150 hours Last 28 days - 61 hours	
Information Source:	AAIB Field Investigation

Synopsis

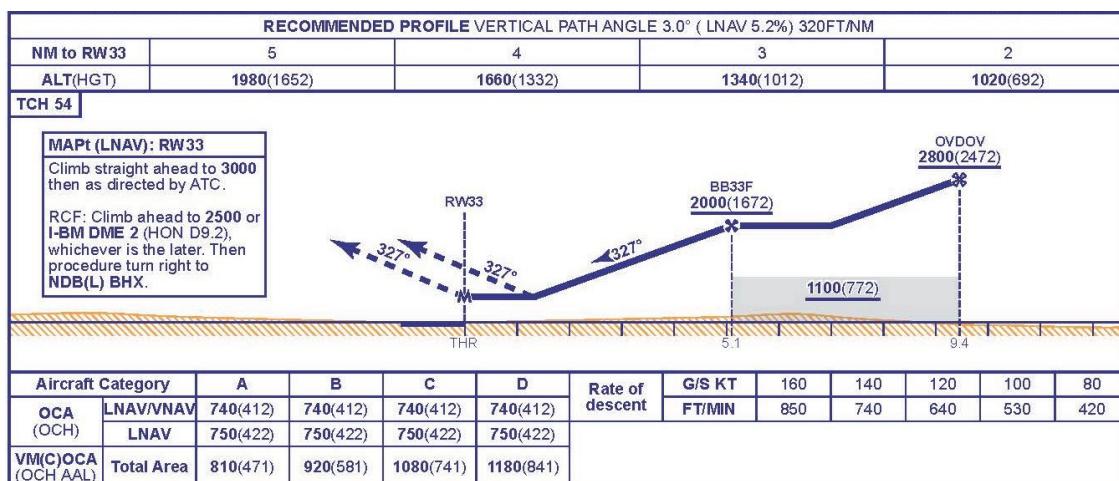
Figure 1

The aircraft was at 4,000 ft approximately 11 nm south of the airport when ATC cleared it to descend to 2,000 ft and carry out the RNAV approach (Figure 1). The pilots read back the clearance correctly but, thirty seconds later, the aircraft had not changed altitude and they contacted ATC to request descent. ATC again cleared the aircraft to descend to 2,000 ft and to carry out the approach. The aircraft was 10.5 nm from the runway when it started descending. At 9.4 nm it was at 3,800 ft, 1,000 ft above the correct profile.

Vertical profile of RNAV approach to Runway 33 at Birmingham Airport
(Extract from UK Aeronautical Information Publication)

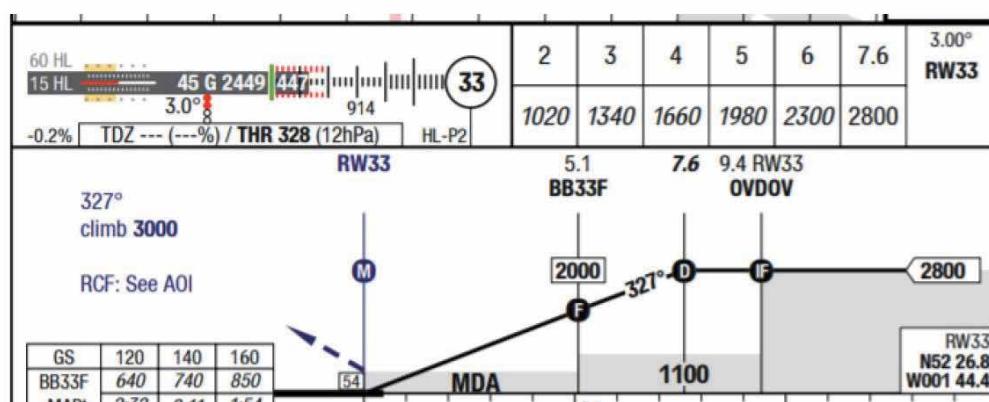
Figure 2

The investigation also highlighted a difference between the descent profile for the RNAV approach published in the UK AIP⁵ and that published by the operator's chart provider⁶. Whilst the former had a platform altitude for the approach of 2,000 ft with final descent starting at 5.1 nm from the threshold, the operator's approach charts showed a continuous descent starting from 2,800 ft at 7.6 nm (Figure 2). This led to confusion by the pilots when initially they were cleared to 2,000 ft on the first approach, causing them to delay their descent and to ask ATC again for the descent instructions. This had served to compound the issue of the late configuration of the aircraft for the approach whilst trying to slow down, resulting in the aircraft not establishing on the correct approach profile and leading to the missed approach.

Extract from operator's chart for RNAV approach to Runway 33 at Birmingham

Different chart providers have different ways of depicting approach profiles. However, the AIP remains the source document and ATC will naturally rely on this, rather than individual operator's charts, when managing air traffic. Where differences exist, it is desirable for operators and ATC to ensure their effect is understood.

The aircraft did not maintain the correct vertical profile because the pilots were not sure when to commence the final descent. The depiction of the descent profile on charts provided by the operator may have contributed to this uncertainty.

- the inclusion of high energy approaches and go-arounds in future company simulator training;
- a review of approach intercept procedures to ensure they make adequate provision for approaches without a glideslope;
- the introduction of procedures to assist pilots in estimating distance to run during an approach; and
- procedures to deal more effectively with a loss of situational awareness.

The operator and air traffic services provider are working to gain a better understanding of each other's approach requirements.
