DUTCH SAFETY BOARD : SHORTENED SERIOUS INCIDENT INVESTIGATION

Clearance for take-off on occupied runway, Embraer ERJ 190-100 STD, PH-EXV, Boeing 737-800, PH-BXI, Amsterdam Airport Schiphol, 27 July 2018

Reference: 2018077

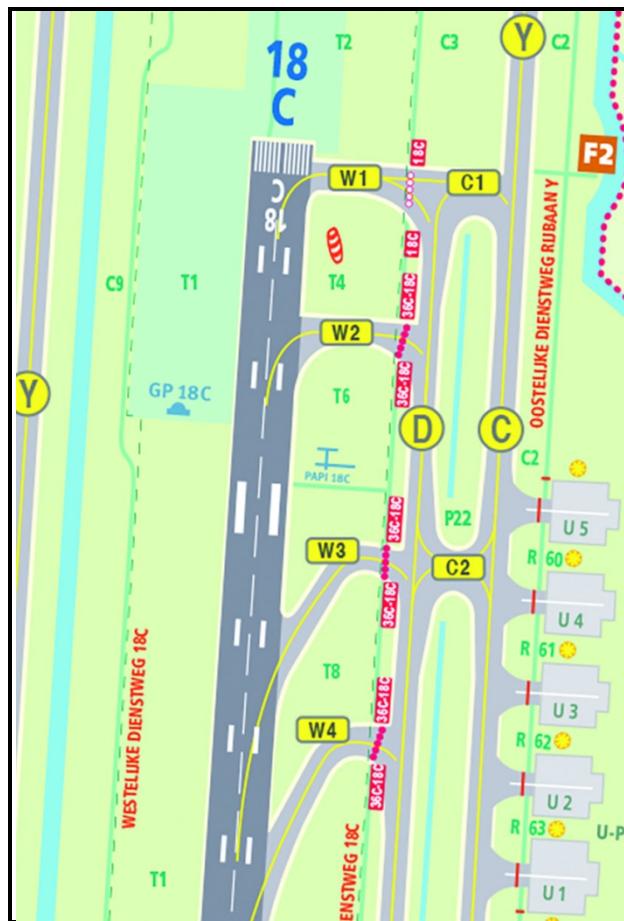
An Embraer ERJ 190-100 STD (hereinafter: E190) stationary at the start of runway 18C was given take-off clearance while a Boeing 737-800 (hereinafter: B737) had also been given clearance to line up for an intersection take-off on the same runway, via high speed exit W4. After hearing the take-off clearance issued to the E190, the crew of the B737 stopped past the hold short line and reported via the radio that they were located 'on the runway'. The runway controller then also issued a take-off clearance to the B737. The crew of the E190 had started the take-off roll when they saw that the B737 was clear of the runway, but broke off their take-off when they heard that the B737 had also been given clearance to take off. Shortly afterwards, the Runway Incursion Alerting System Schiphol (RIASS) sounded a warning in the air traffic control tower and the runway controller withdrew the clearance to the E190. The E190 passed the B737 that was stood stationary at the boundary line of the intersection and the runway, at a speed of approximately 85 knots and a separation of approximately 19 metres.

Previous investigations have shown that the use of intersection starts can engender increased risks. These risks are further increased by using a (non-rightangled) high speed exit as an access to the runway, a situation which is advised against, internationally. As a consequence, once they have passed the hold short line approaching the runway, the aircraft crew experience difficulty in seeing other approaching traffic taking off from the start of the runway.
