**SERIOUS INCIDENT**

<b>Aircraft Type and Registration:</b>	Boeing 737-8B6, CN-RGJ	
<b>No &amp; Type of Engines:</b>	2 CFMI CFM56-7B26 turbofan engines	
<b>Year of Manufacture:</b>	2012 (Serial no: 33072)	
<b>Date &amp; Time (UTC):</b>	28 February 2020 at 1133 hrs	
<b>Location:</b>	London Gatwick Airport	
<b>Type of Flight:</b>	Commercial Air Transport (Passenger)	
<b>Persons on Board:</b>	Crew - 6	Passengers - 139
<b>Injuries</b>	Crew - None	Passengers - None
<b>Nature of Damage:</b>	None	
<b>Commander's Licence:</b>	Airline Transport Pilot's Licence	
<b>Commander's Age:</b>	56 years	
<b>Commander's Flying Experience:</b>	13,479 hours (of which 12,755 were on type) Last 90 days - 128 hours Last 28 days - 47 hours	
<b>Information Source:</b>	Aircraft Accident Report Form submitted by the operator and further enquires by the AAIB

**Synopsis**

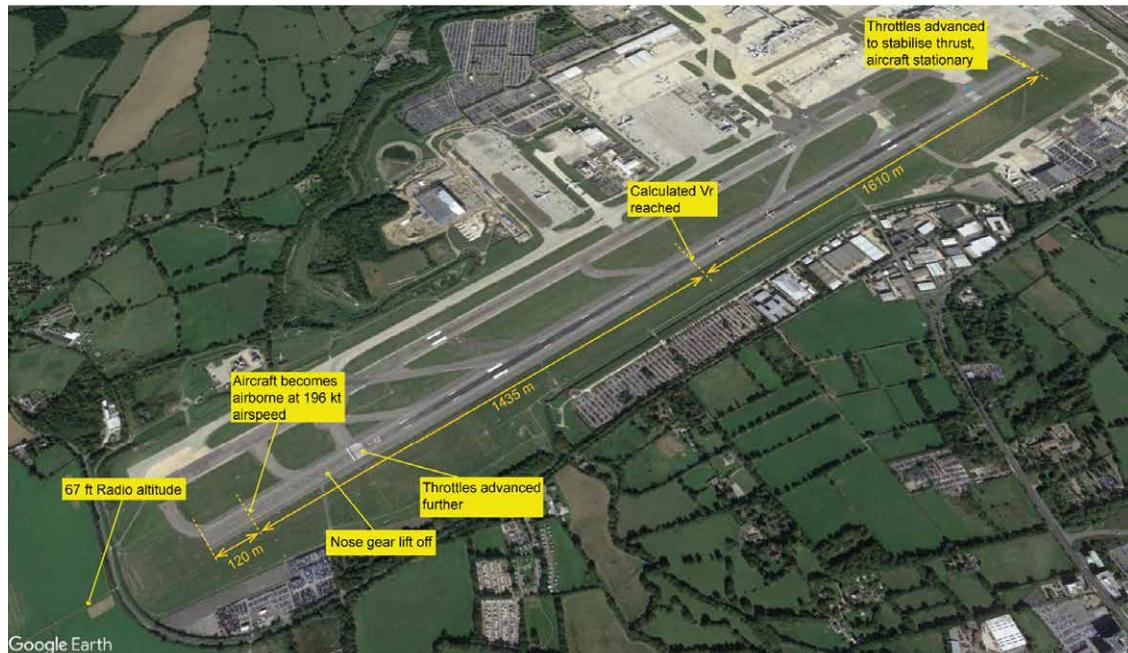
This showed that the nosewheel lifted off at 189 kt. The aircraft was airborne approximately 120 m prior to the end of the runway at 196 kt and 13 seconds after the planned rotation speed. Figure 1 shows the takeoff roll and highlights key speeds and heights. The data also showed the thrust was slightly increased just prior to the rotation.

**Figure 1**  
CN-RGJ's takeoff roll showing significant heights and speeds

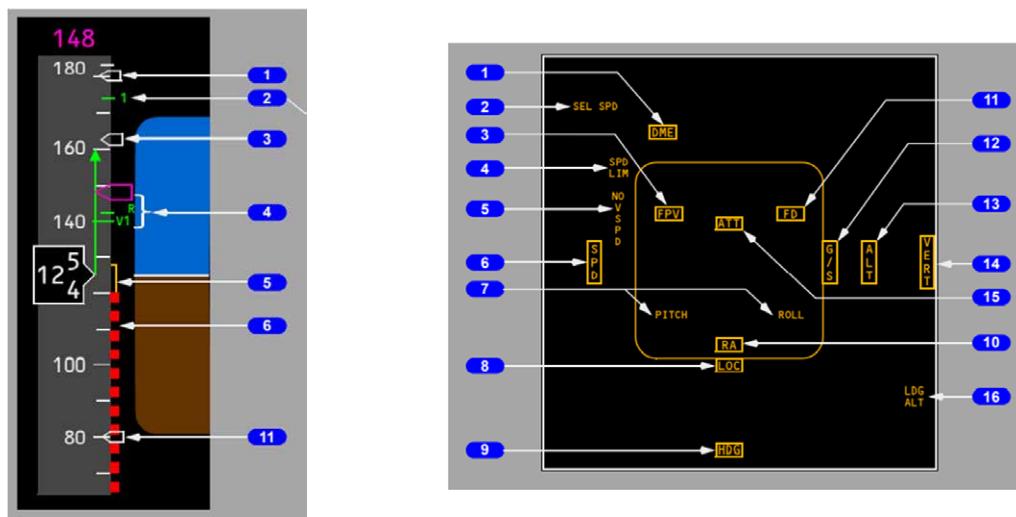
Takeoff V speeds are normally loaded into the FMC during the preflight procedure after the takeoff performance has been calculated. The procedure requires the crew to enter the aircraft weight, enter any assumed temperature or fixed derate and then enter the planned takeoff flap setting and V speeds. The  $V_2$  speed is then selected on the MCP. The  $V_1$  and  $V_R$  speed are displayed on the speed tape as shown in Figure 2. If the V speeds are not entered a NO VSPD message is displayed in amber on the PFD.

**Figure 2**  
PFD speed tape showing V speeds (label 4) and  
PFD fail flags showing NO VSPD (label 5)
