Serious incident to the Airbus A340-313 registered F-GLZO on 19 August 2017 at Bogotá El Dorado airport (Colombia)

Time	01:16 ⁽¹⁾
Operator	Air France
Type of flight	Commercial air transport
Persons on board	Captain (PM), first officer 1 (PF), first officer 2 (relief pilot), 7 cabin crew, 219 passengers

Windshear during rotation for take-off

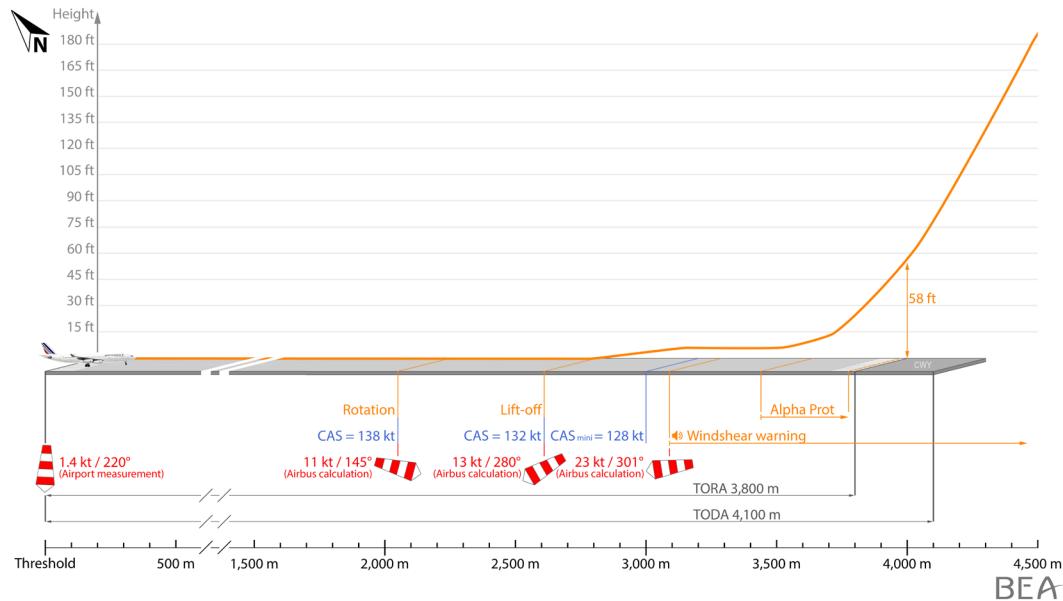
Figure 1: path of F-GLZO

The runway threshold was overflowed at a height of 58 ft, more than the 35 ft required by the regulations. The referenced obstacles in the take-off funnel were also overflowed with a sufficient margin.

Twenty-one seconds after lift-off, the WINDSHEAR warning stopped. The height was then 193 ft and the pitch was 13° and decreasing. Five seconds later, at a height of 258 ft, the calibrated airspeed reached V2⁽⁹⁾ i.e. 145 kt.

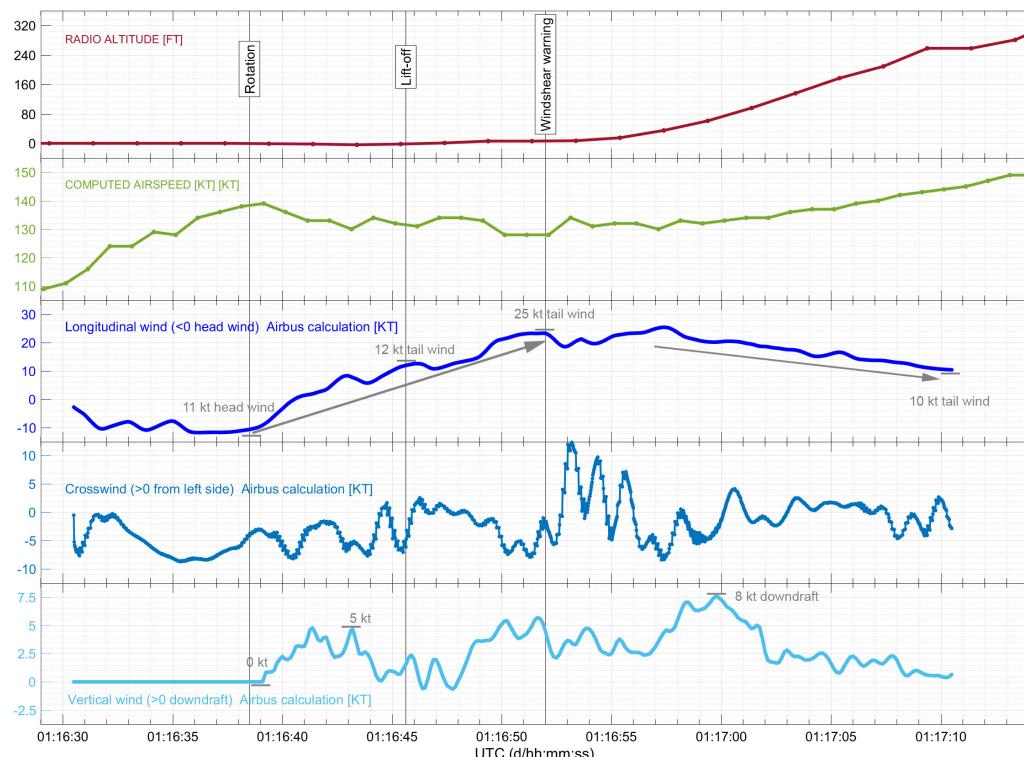
Figure 2: calculated wind speed

This wind speed was calculated in the body-fixed reference frame of the aeroplane and takes into account the ground effect and acceleration biases.

During the take-off run between 01:16:39 and 01:16:45, the longitudinal wind changed from a headwind speed of 9 kt to a tailwind speed of 12 kt. The vertical wind speed increased from 0 kt to a maximum downdraft speed of 5 kt.

After lift-off at 01:16:45, the longitudinal wind speed continued to increase until reaching a maximum tailwind speed of 25 kt, 12 s later. The vertical wind mostly remained a downdraft with a speed of around 4 kt. The crosswind varied rapidly between a right crosswind of 8 kt and a left crosswind of 13 kt.

From 01:16:57, i.e. 12 s after lift-off, the tailwind speed decreased from 25 kt to 10 kt in a period of 13 seconds. The downdraft speed reached a maximum of 8 kt before decreasing to 0 kt. The crosswind speed also dropped.

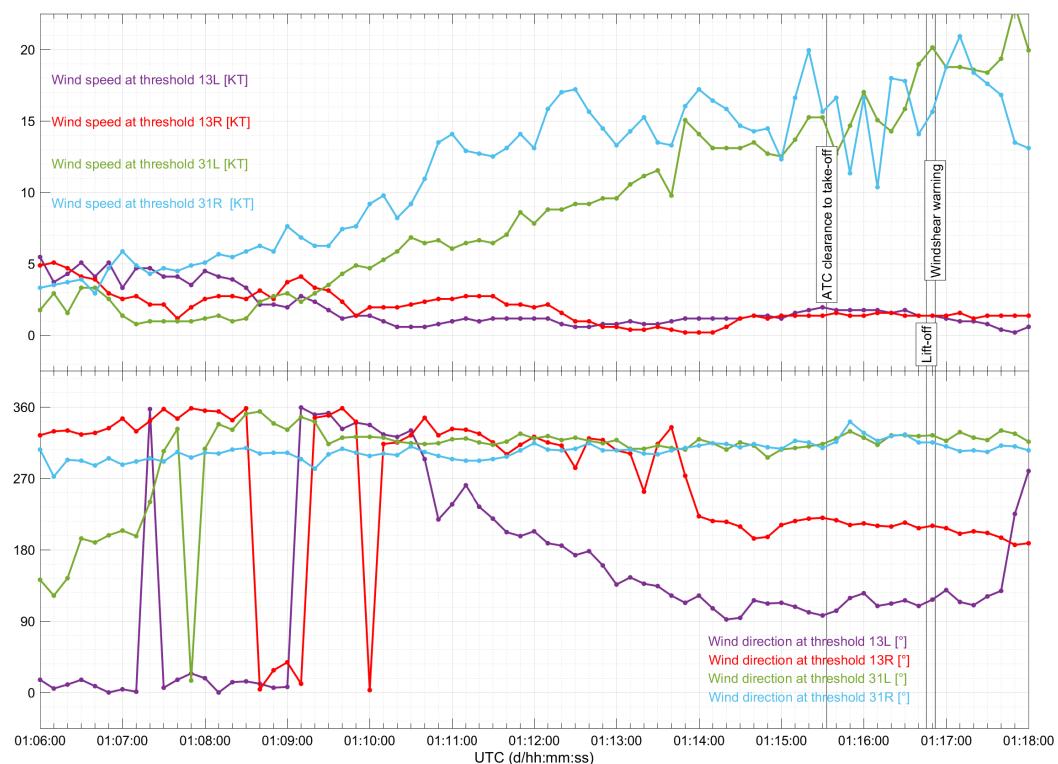
Figure 3: wind at four QFU in the ten minutes before take-off

The airport is equipped with anemometers at each of the four runway thresholds which measure the instantaneous wind every ten seconds. The wind data recorded by these anemometers in the ten minutes preceding the take-off show differences in terms of both speed and direction, between thresholds 13 and thresholds 31 (Figure 3). For runway 13R, in red on the graph, the wind speed was stable at around 2 kt and its direction varied from 360° to 210°.

Runway threshold	Wind speed (kt)	Direction (°)
13R	1.4	220
13L	2.0	97
31R	15.6	308
31L	15.3	313

The differences in terms of direction and strength between the four runway thresholds persisted for around 13 minutes covering the take-off period. Such differences could alert flight crews and controllers of the possible presence of windshear.

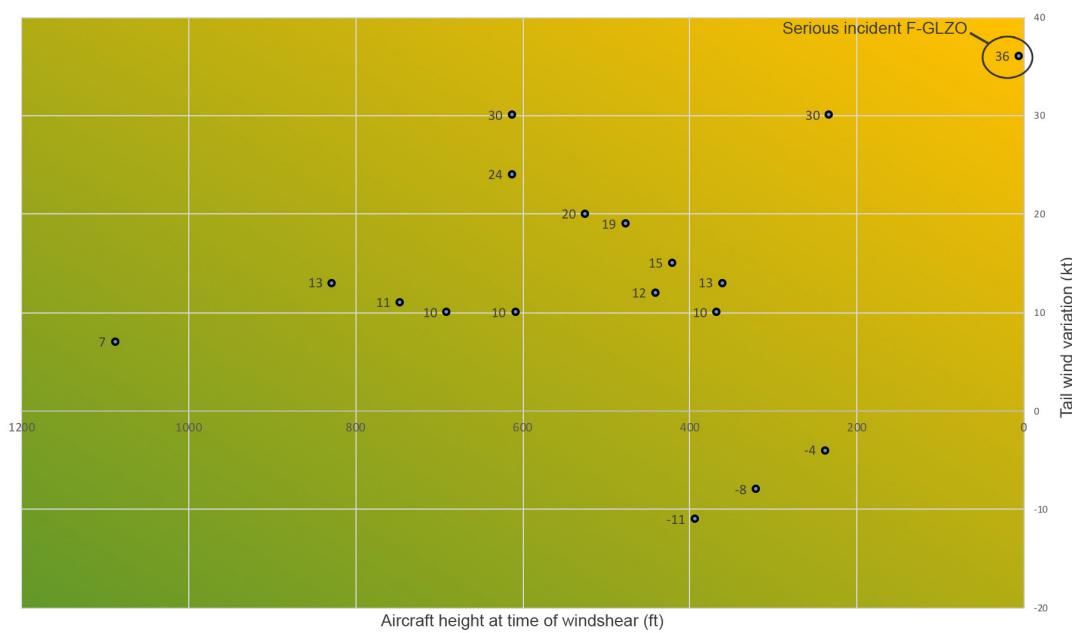
Figure 6 - Distribution of windshear in terms of ground height and strength

According to the Air France flight analysis data, there were 21 windshears at take-off or in climb-out at all the airports used, all fleets together, between 1 January 2015 and 19 August 2017, i.e. approximately 1 per 33 thousand flights (Figure 6). The windshear experienced the day of the event was both the greatest in terms of tailwind variation and occurred at the lowest height.
